FINAL  
KNKT.14.12.29.04

# KOMITE NASIONAL KESELAMATAN TRANSPORTASI

Aircraft Accident Investigation Report

**PT. Indonesia Air Asia**  
**Airbus A320-216; PK-AXC**  
**Karimata Strait**  
**Coordinate 3°37'19"S - 109°42'41"E**  
**Republic of Indonesia**  
**28 December 2014**

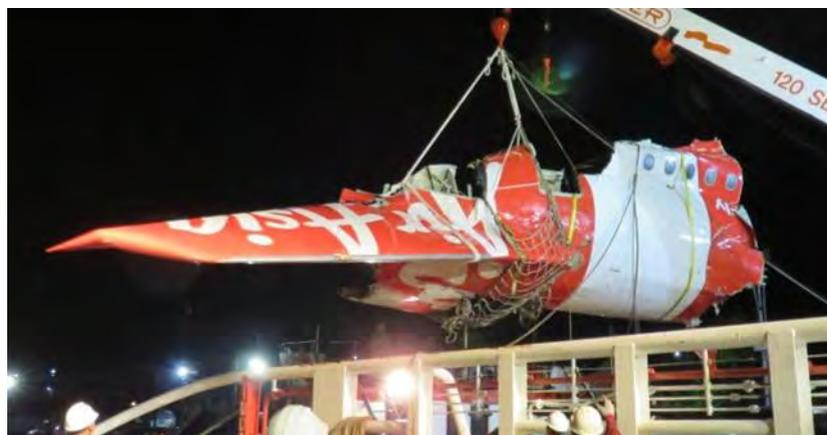
**Figure 3: The recovered tail section being transferred to Kumai Harbour**

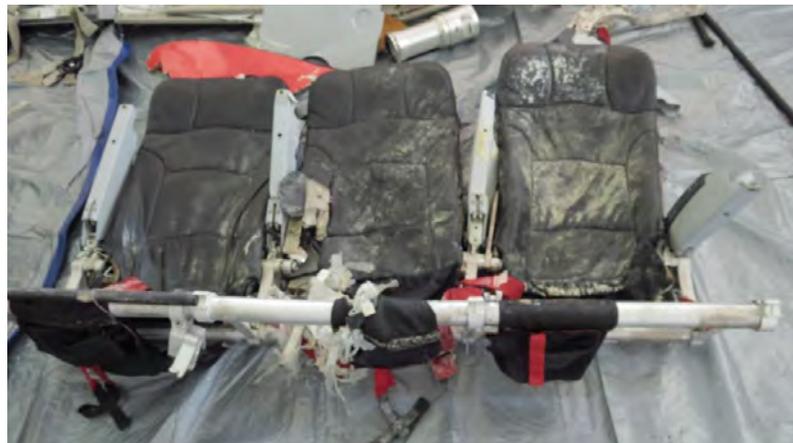
**Figure 4: One section of passenger seats**

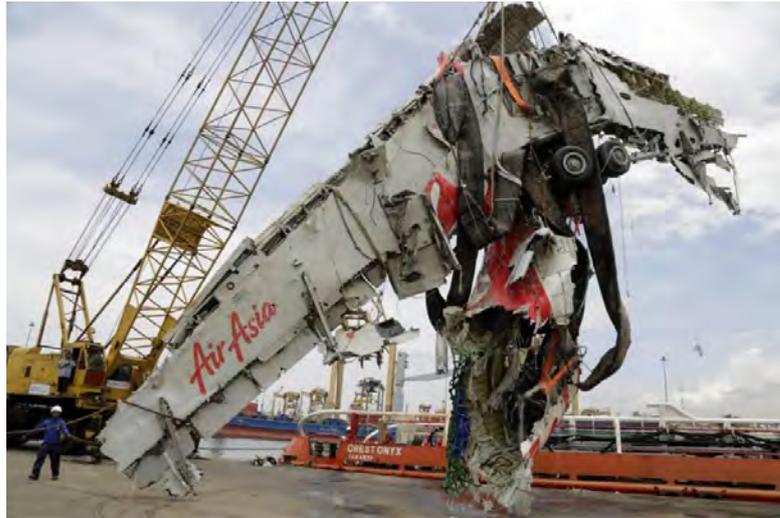
**Figure 5: Centre fuselage section including the wings and main landing gears**

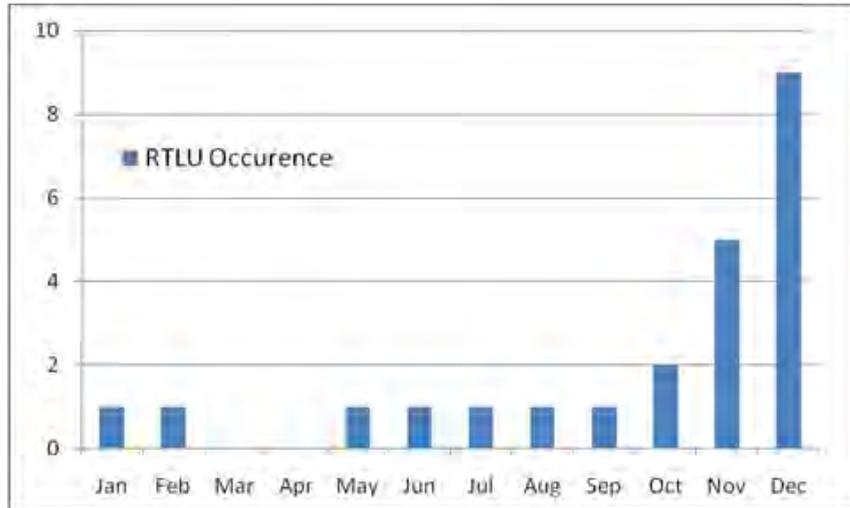
**Figure 7: Numbers of the RTLU Occurrences in 2014**

The workaround solution of the maintenance staff on the RTLU problems were mostly by resetting computer by either resetting the FAC push button and followed by AFS test or pulling the associated CBs and the rectification was performed according to the A320 TSM.

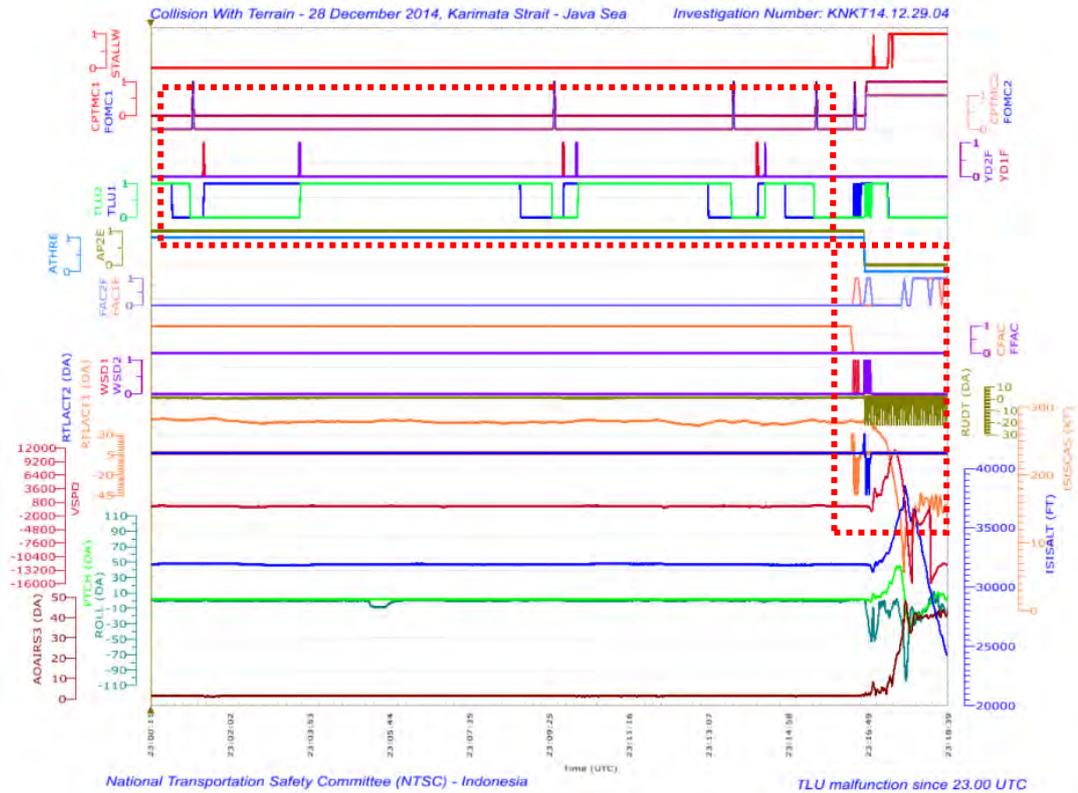
**Figure 20: RTLU problems and pilot actions**

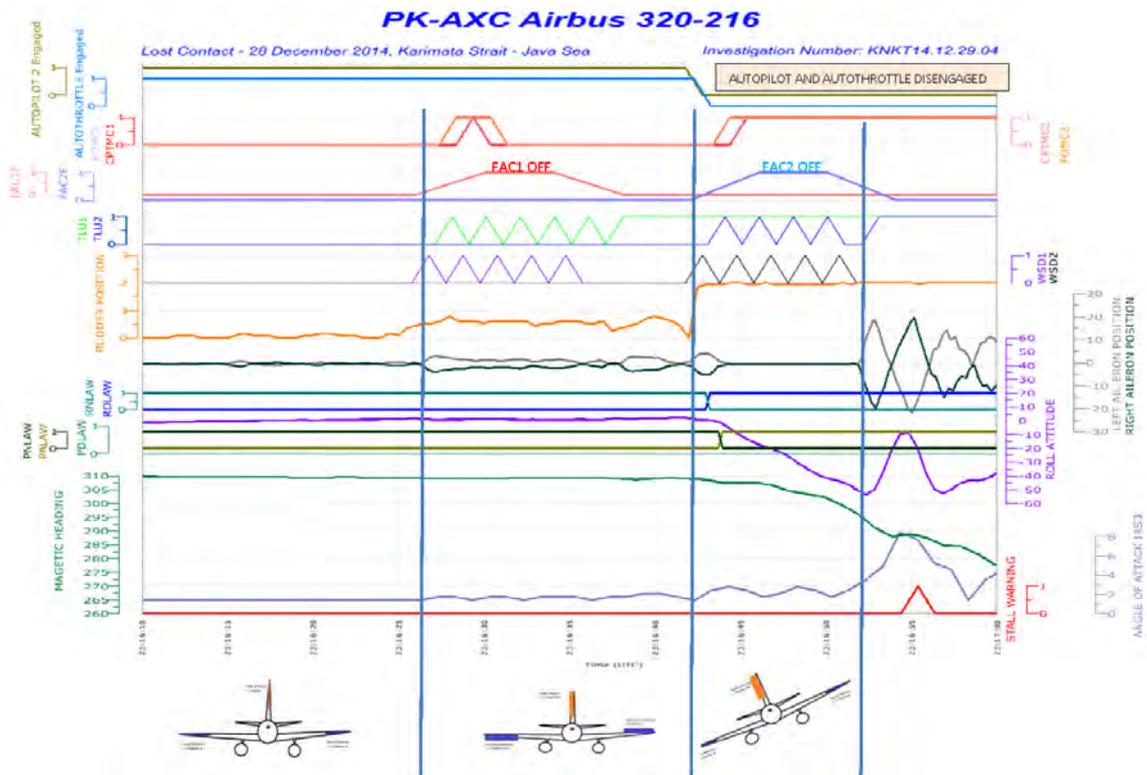
The fifth Master Caution at 2316:28 UTC was triggered by FAC 1 FAULT.

**Figure 21: FDR parameters after the fifth Master Caution**

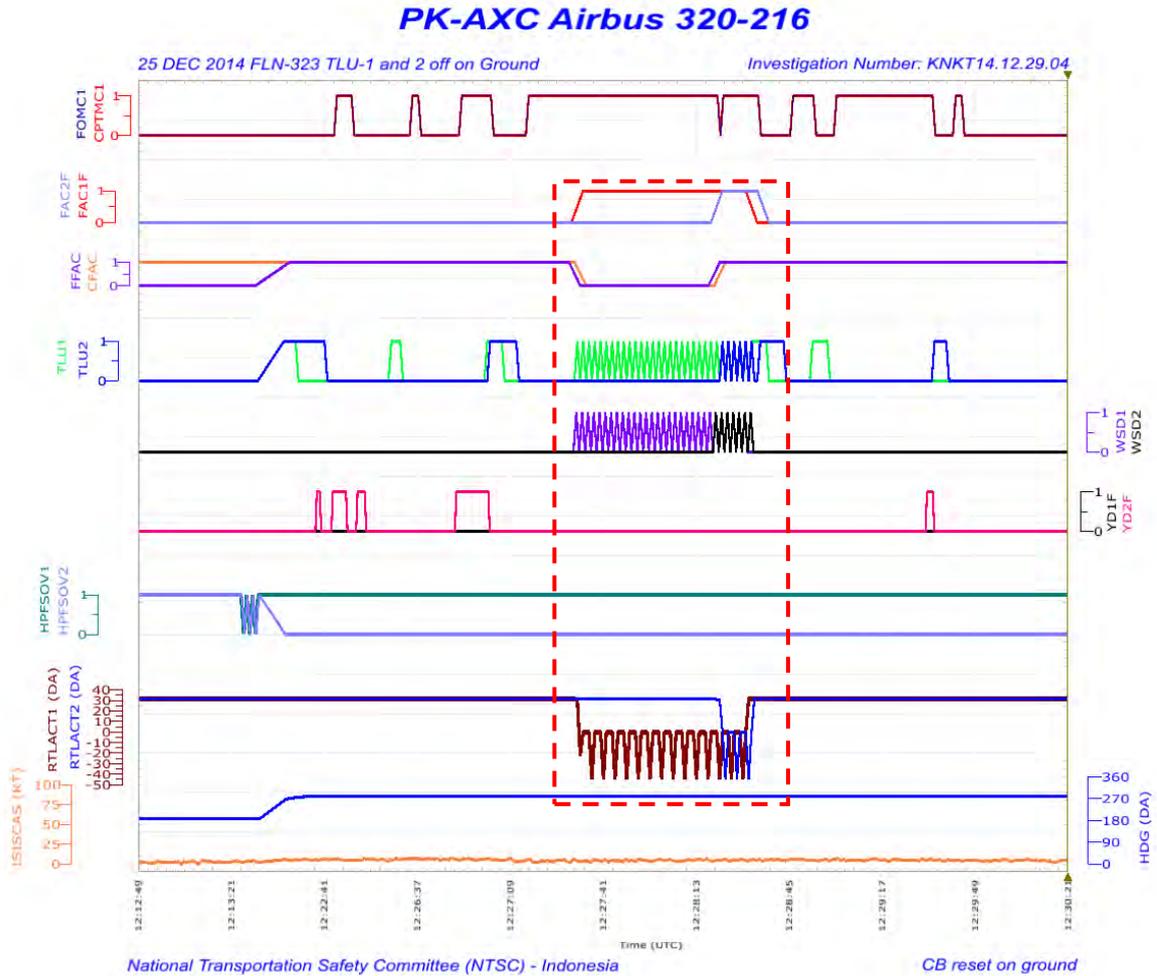
**Figure 24: The FDR parameters of FAC fault followed by CB reset on the ground at 25 December 2014**

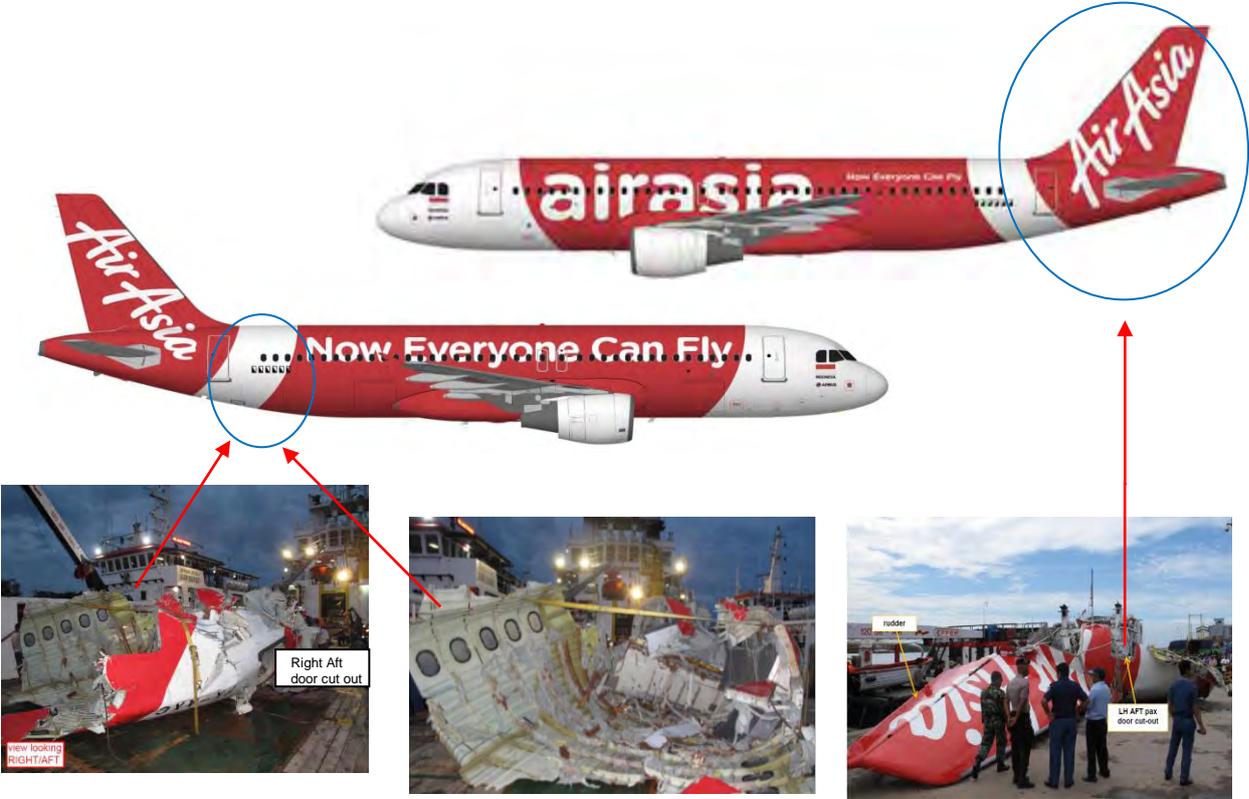
Figure 32: Pictures of identified parts and its original position

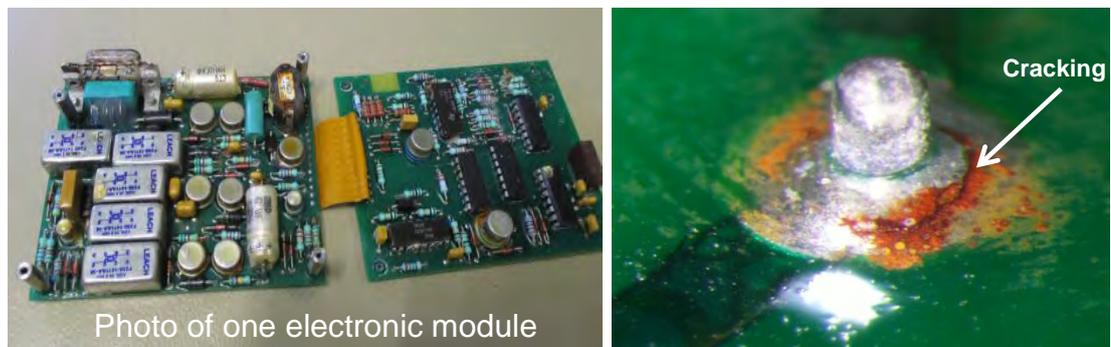
- The cracking of a solder joint of both channel A and B resulted in loss of electrical continuity and led to RTLU failure.
- The existing maintenance data analysis led to unresolved repetitive faults occurring with shorter intervals. The same fault occurred 4 times during the flight.

**Figure 35: Electronic Module of RTLUs**
