# THE PENTAGON BUILDING PERFORMANCE REPORT

January 2003

## ABSTRACT

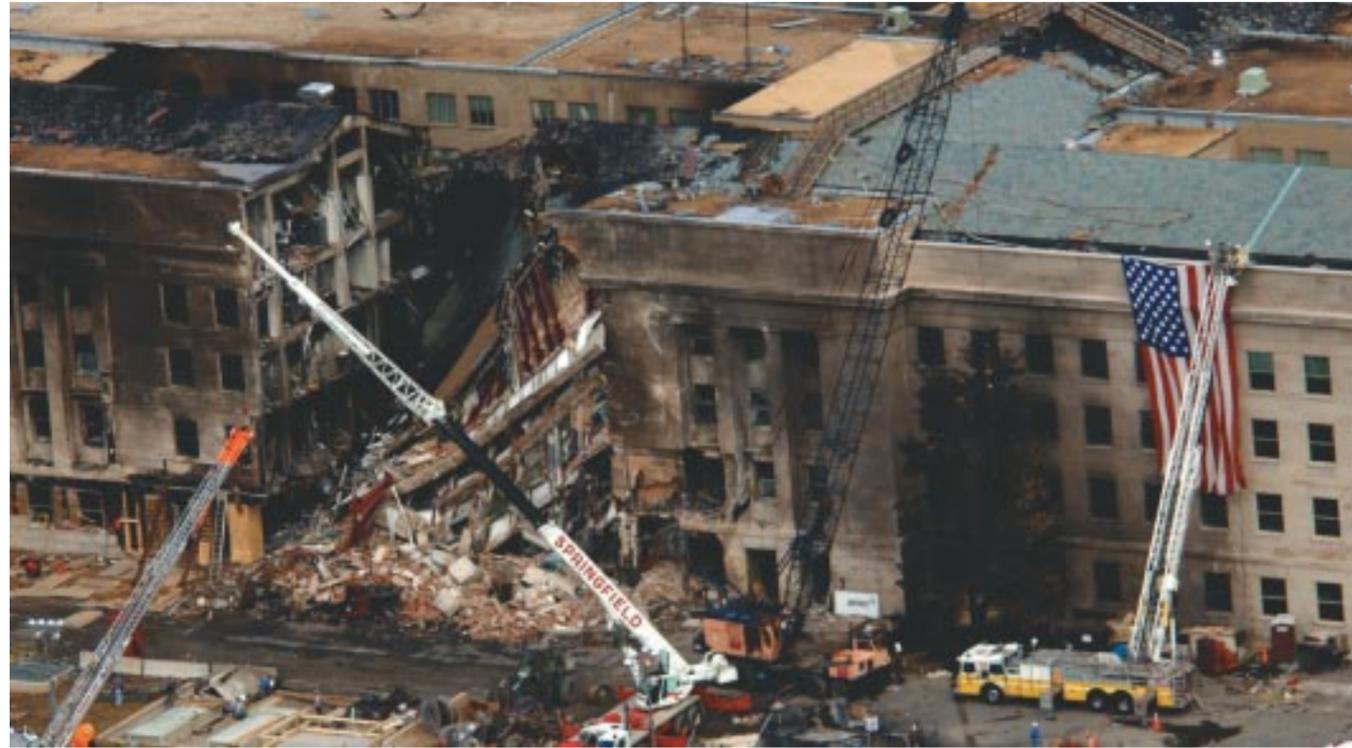
Figure 1.3 Crash damage

Figure 1.3 presents an exterior view of the extent of damage from the crash, including a collapsed portion of Ring E at the point of impact, beyond which the impact destruction from the decelerating aircraft continues; the subsequent devastation from the fire is also evident. The superior performance of the improved window system incorporated during the renovation is evident on the right.

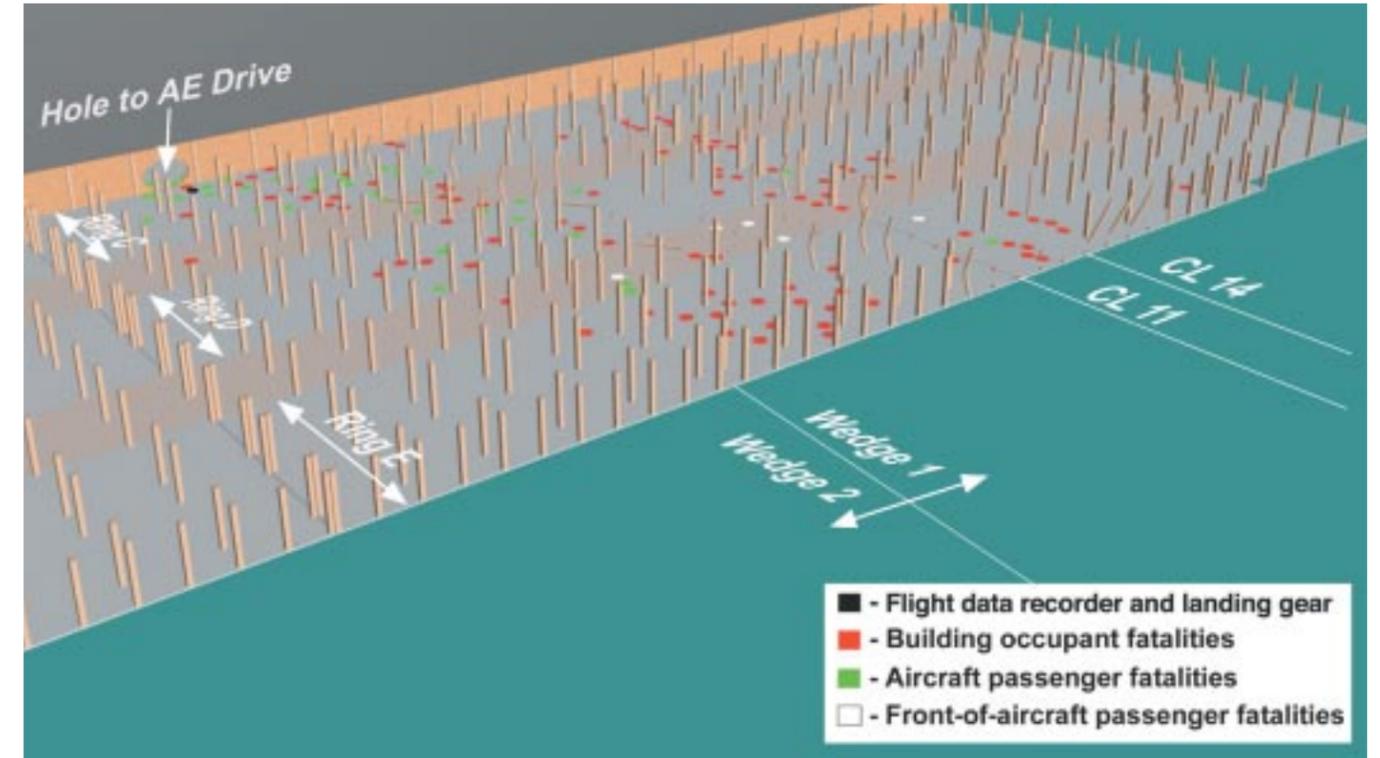
Data provided by the Federal Bureau of Investigation included the locations where fatalities were found in the building. This information is reproduced as figures 3.17 and 3.18.

Figure 3.17 Fatalities found in first story

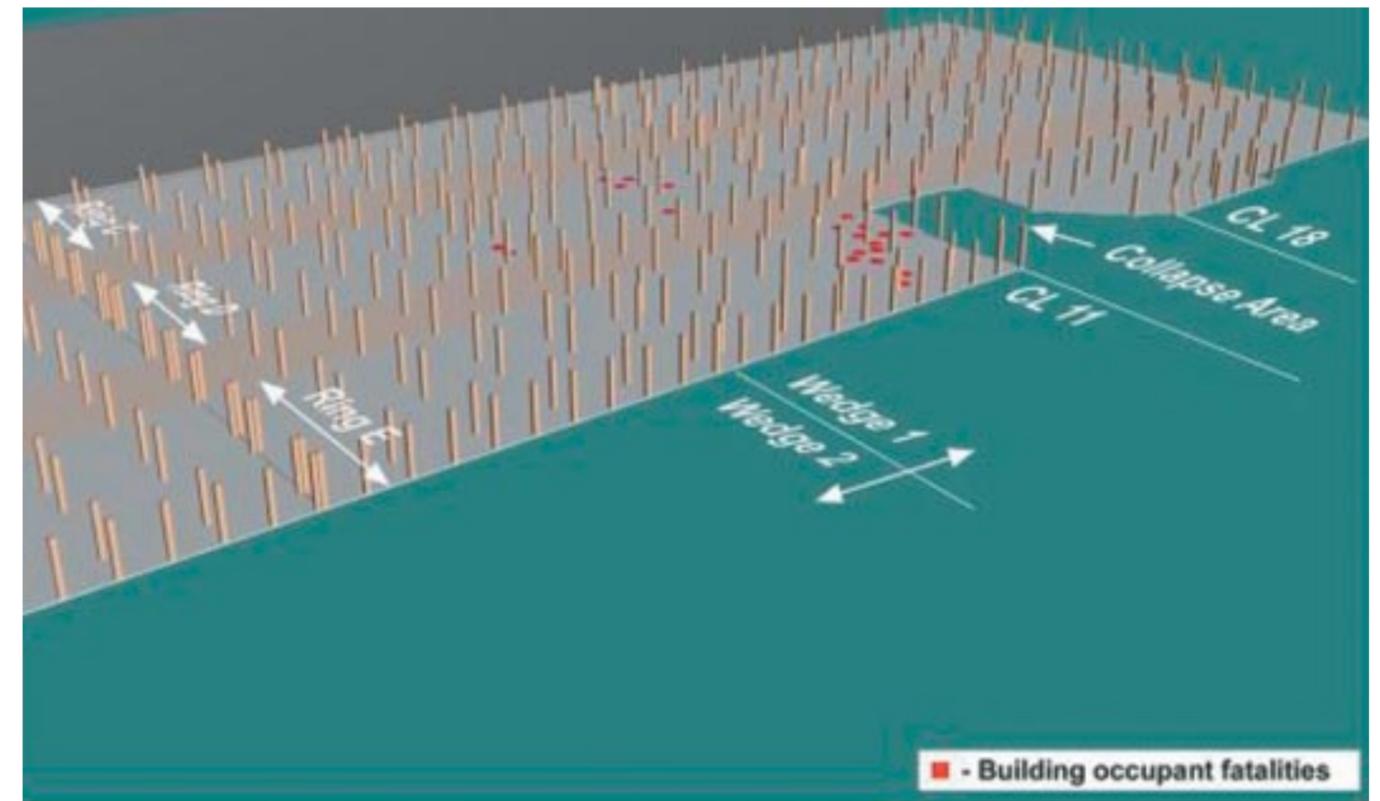
No fatalities from the aircraft were found on the second floor (figure 3.18). The figure shows no fatalities in the collapsed area above the first floor. In fact, it is likely that there were upper-floor fatalities in this area, but their remains were found on the first-floor level after the building collapsed.

Figure 3.18 Fatalities found in second story

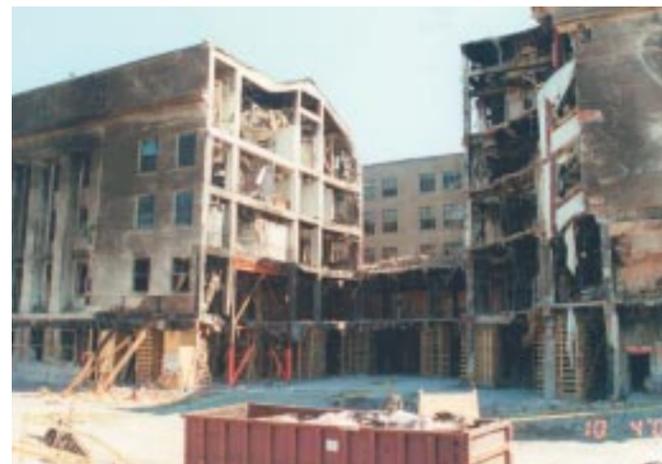
By the time the full Pentagon BPS team visited the site, all debris from the aircraft and structural collapse had been removed (figure 5.1) and shoring was in place wherever there was severe structural damage. The design team charged with reconstructing the Pentagon was assessing the building and preparations were being made to demolish the areas for reconstruction. Consequently, the Pentagon BPS team never had direct access to the structural debris as it existed immediately after the aircraft impact and subsequent fire.

Figure 5.1 Impact area with debris removed

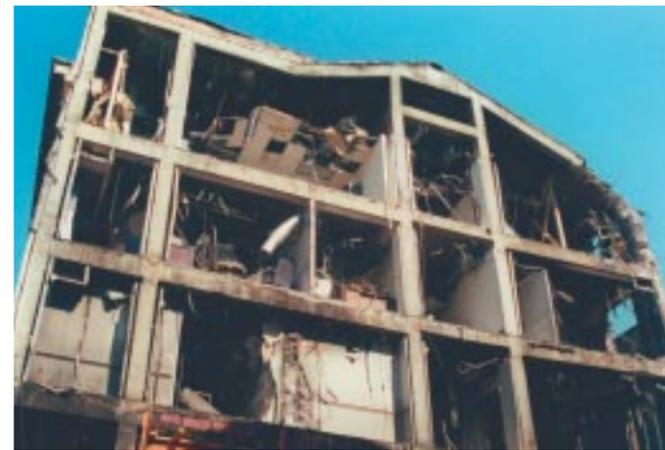
The collapsed portion of Ring E was immediately south of an expansion joint on column line 11 (figures 5.2 and 5.3). The collapsed area extended south from the expansion joint to approxi-

Figure 5.2 Beams and columns on north side of expansion joint

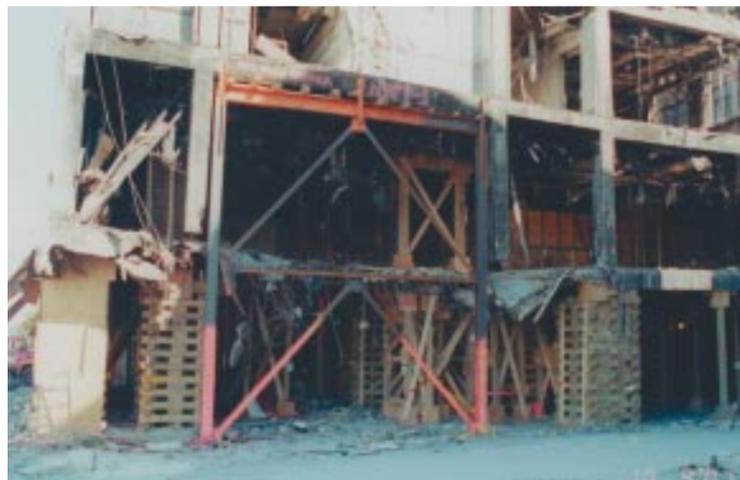
Figure 5.5 Missing first-floor columns 11A, 11B, and 11C

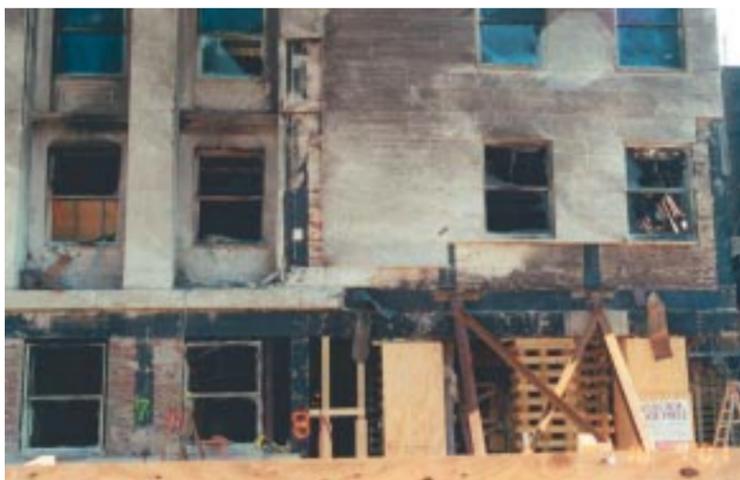
Figure 5.6 Facade damage to the north of the impact area

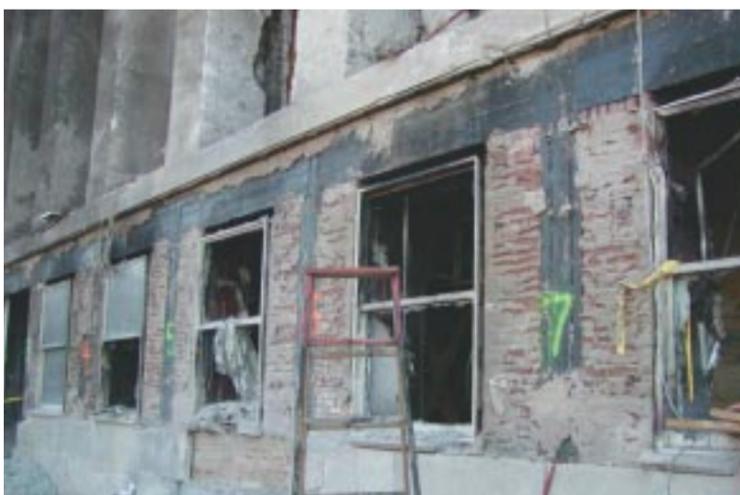
Figure 5.7 First-floor facade damage to the north of the impact area

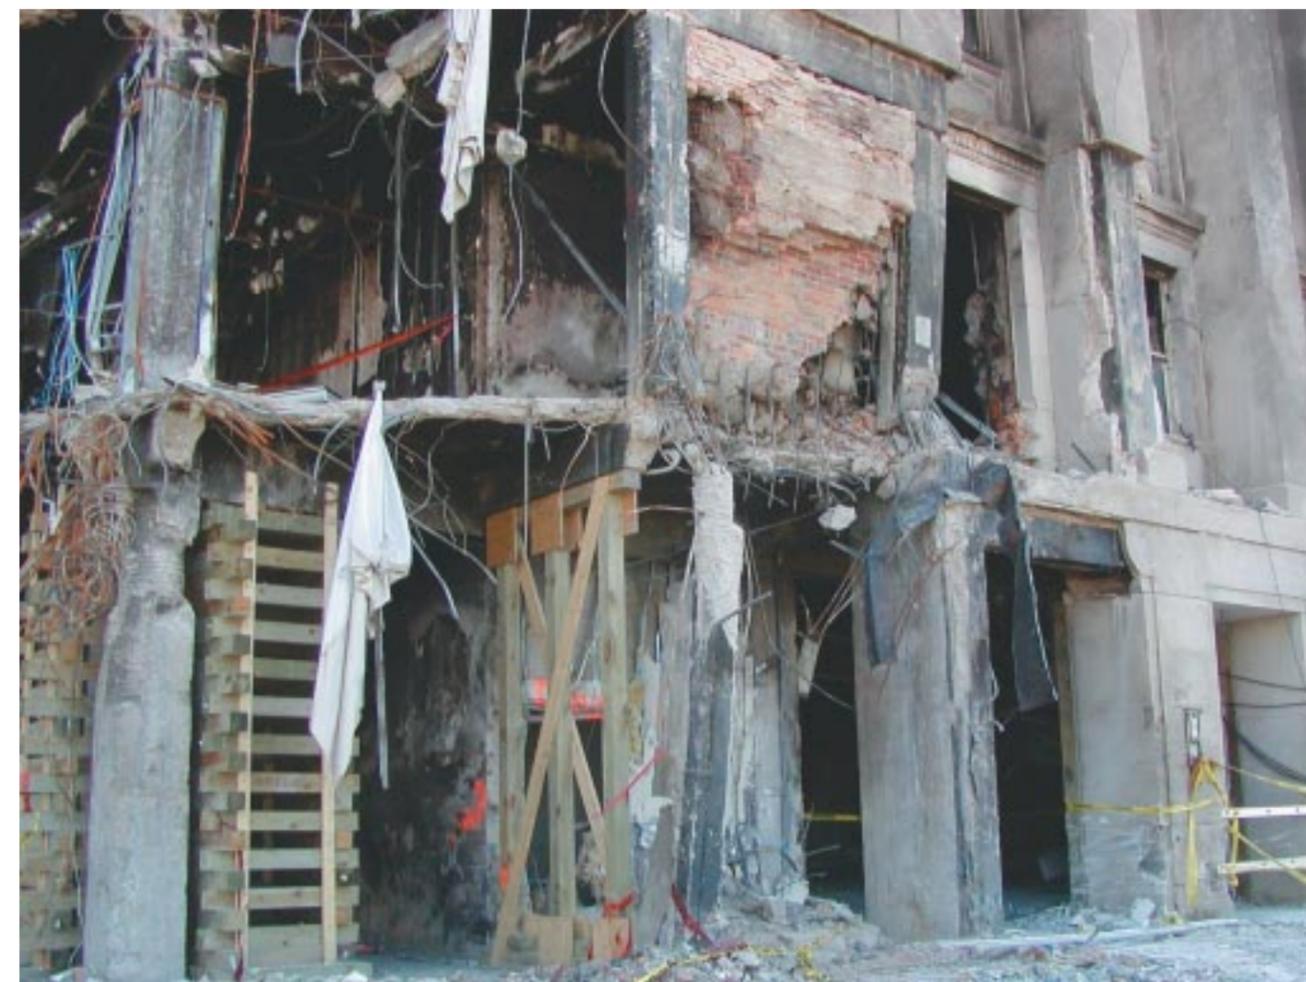
Figure 5.8 Facade damage to the south of the impact area

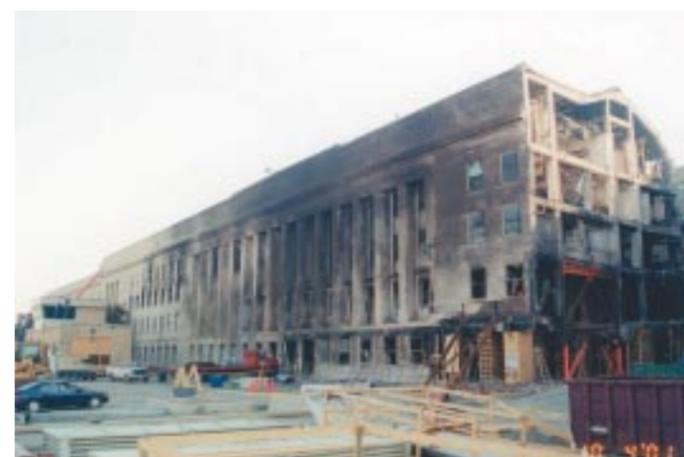
Figure 5.9 Exterior evidence of fire to the north of the impact area

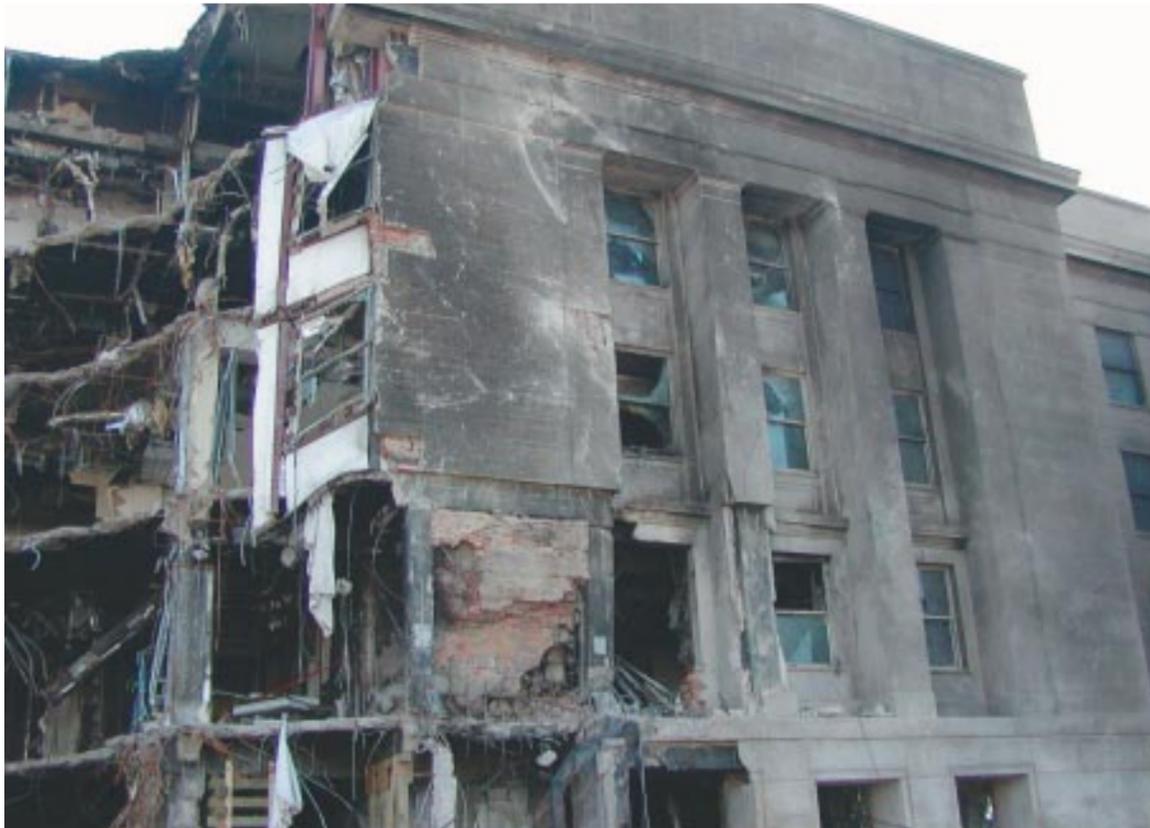
The west facade of the Pentagon was severely scarred by debris impact, particularly to the south of the collapse area (figure 5.11). Just above the second-floor slab, the exterior columns on column lines 18 and 19

Figure 5.11 Debris scars at upper levels south of impact area

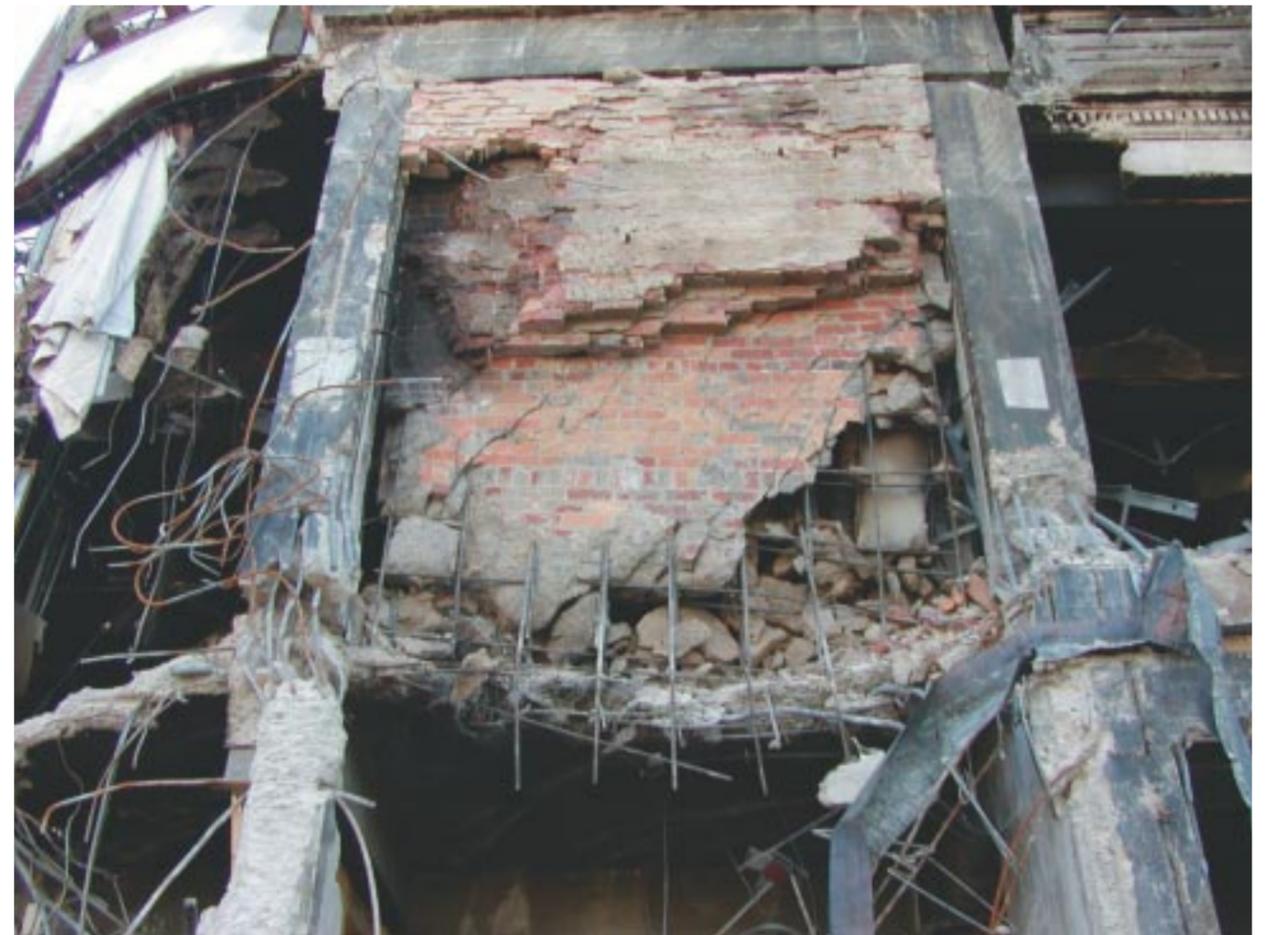
Figure 5.12 Gashes from impact of right wing

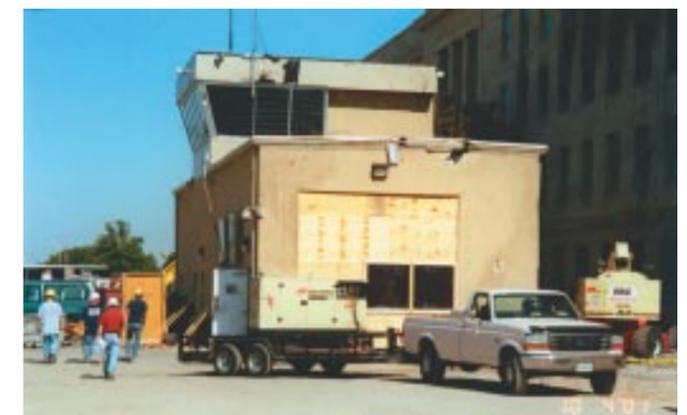
Figure 5.13 Damage to fire station

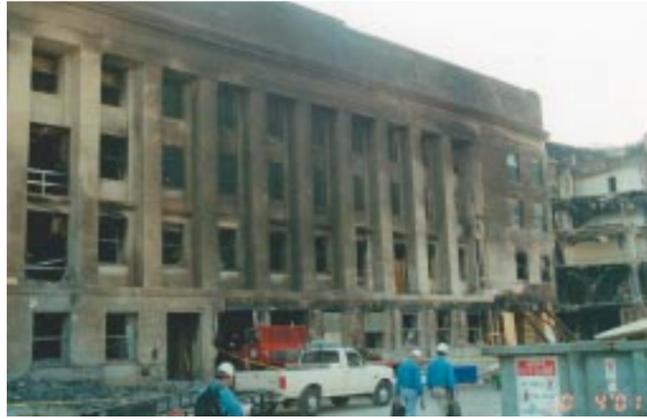
Figure 5.14 Upgraded windows in place

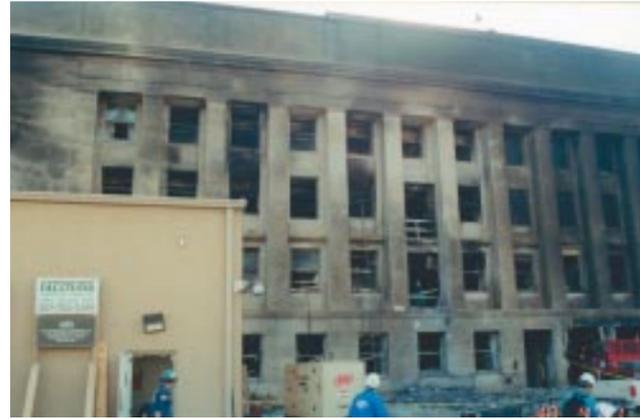
Figure 5.15 Broken conventional windows

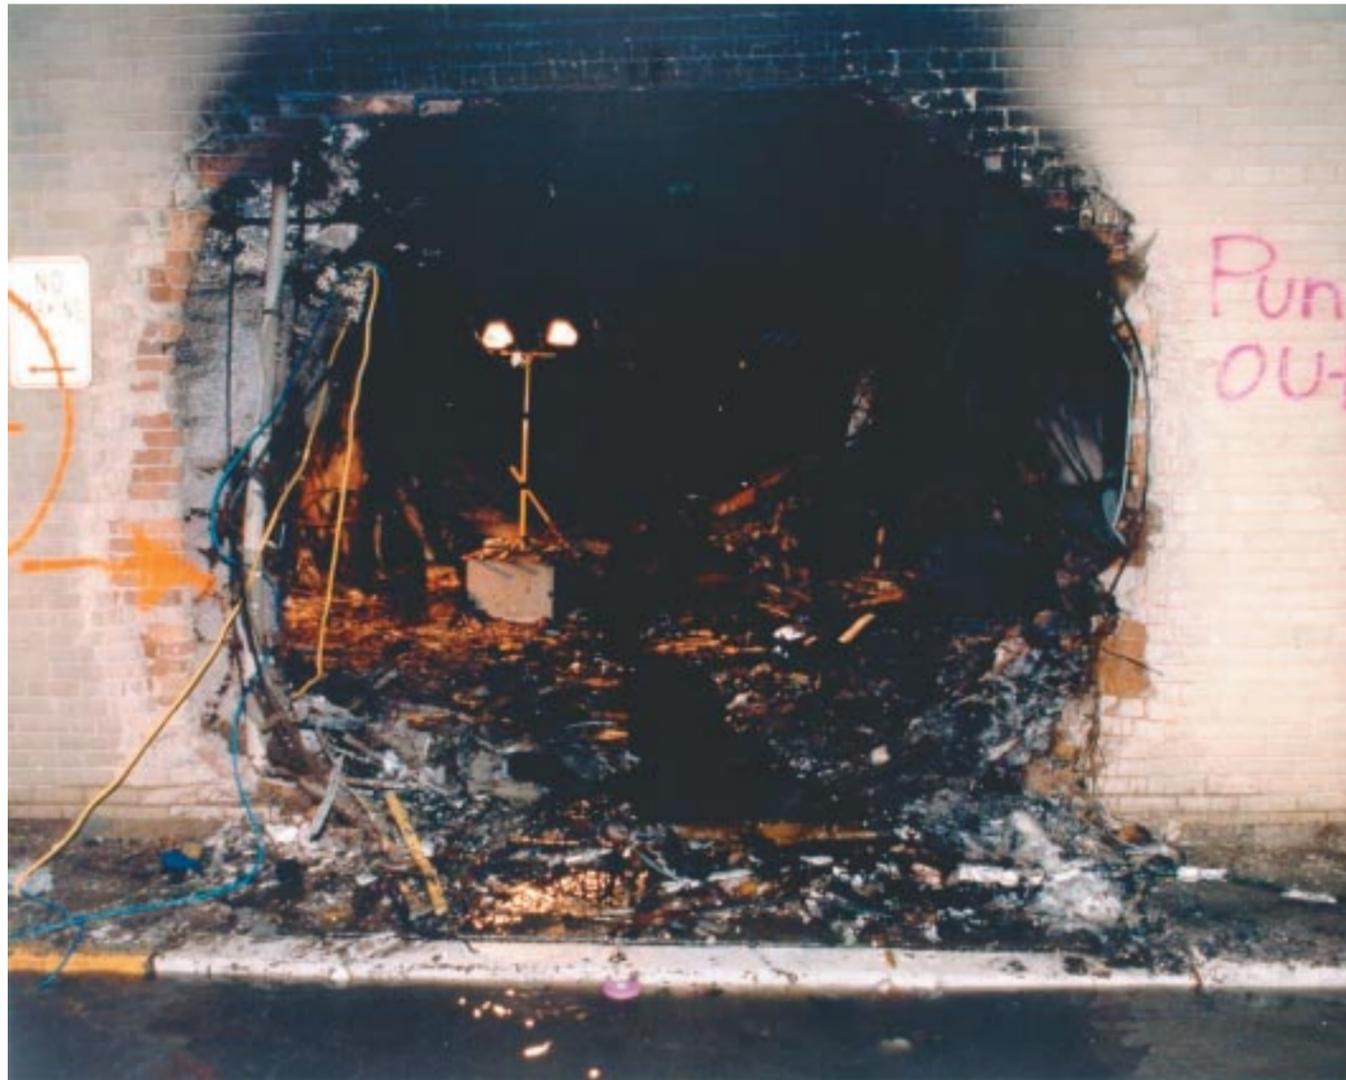
Figure 5.16 Hole to AE Drive

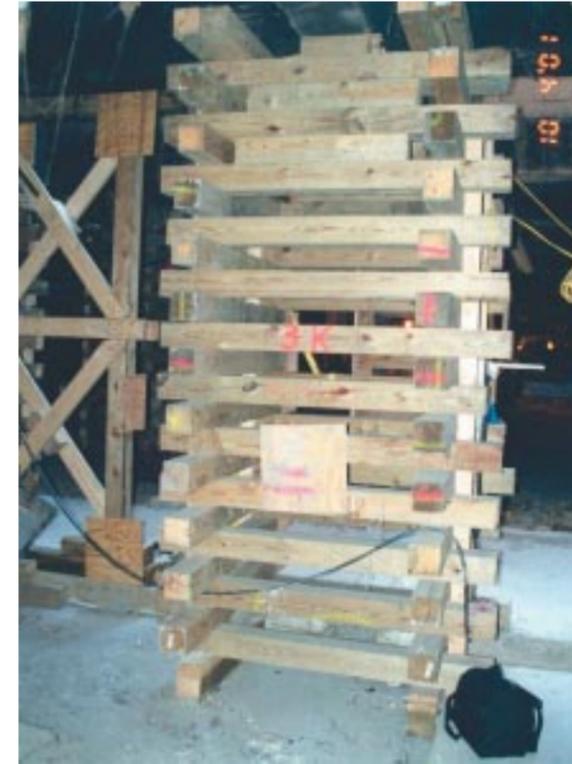
Figure 5.17 Column missing at location 3K

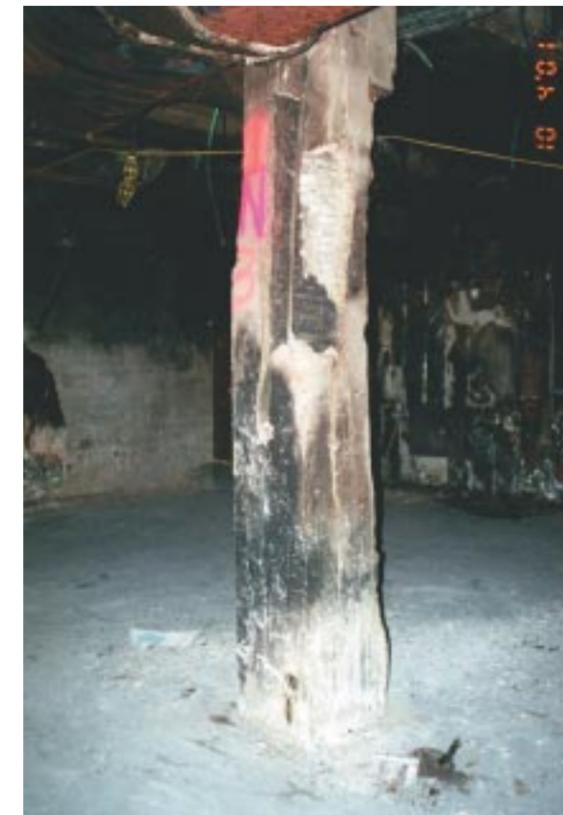
Figure 5.19 Column 3N damaged by impact and fire

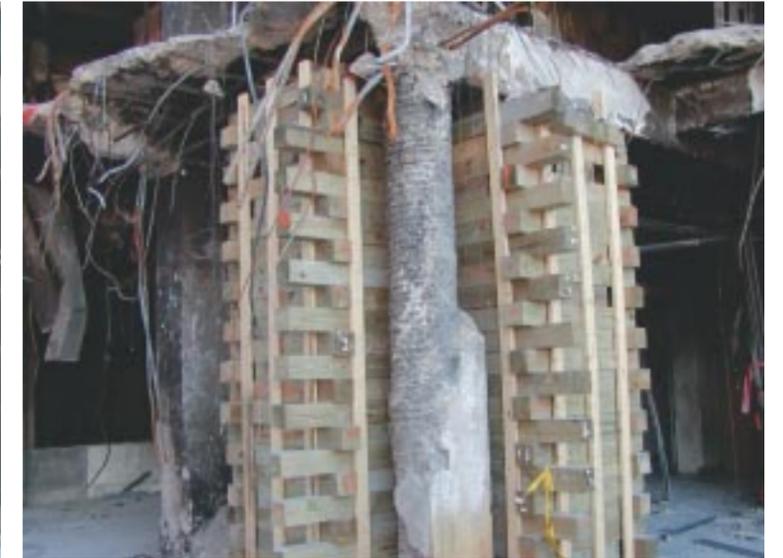
Figure 5.18 Column 15B with concrete cover removed by impact

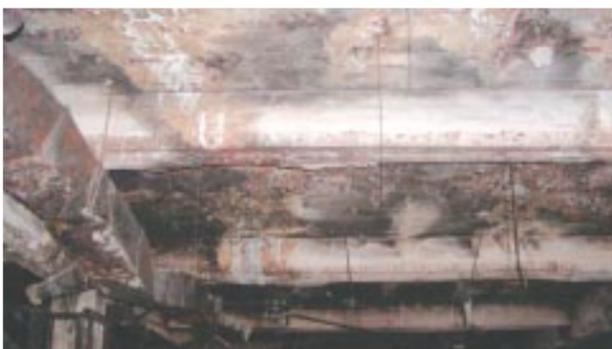
Figure 5.25 Impact and fire damage near column line C

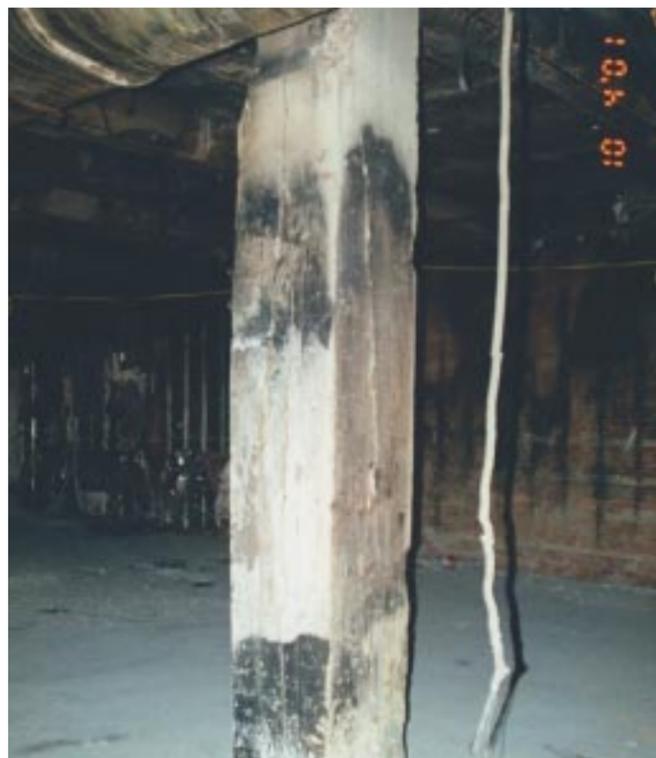
Figure 5.24 Cracked column 5N

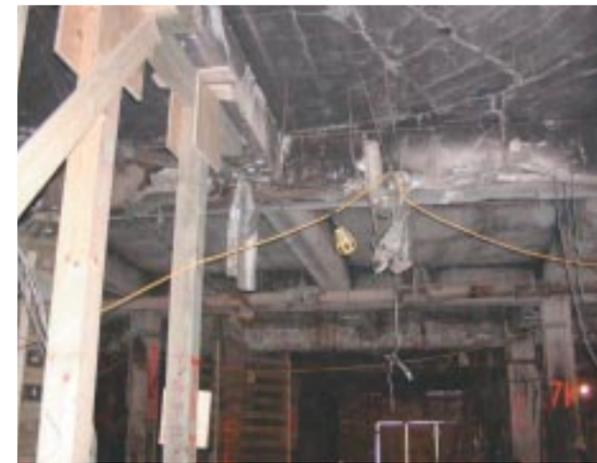
Figure 5.26 Impact damage near column 6K

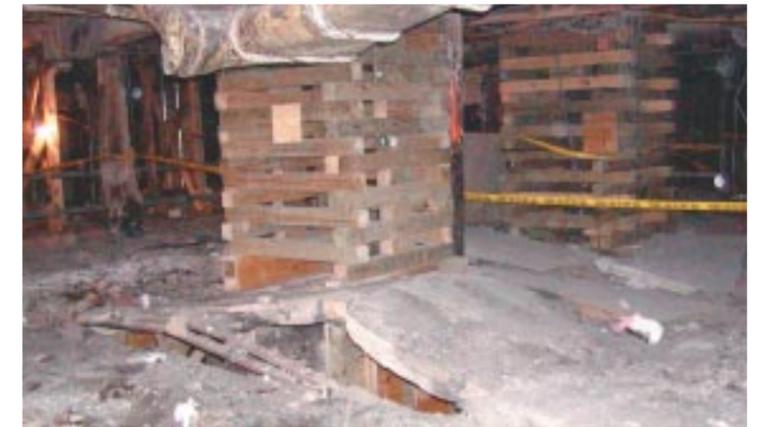
Figure 5.27 Breached second-floor slab

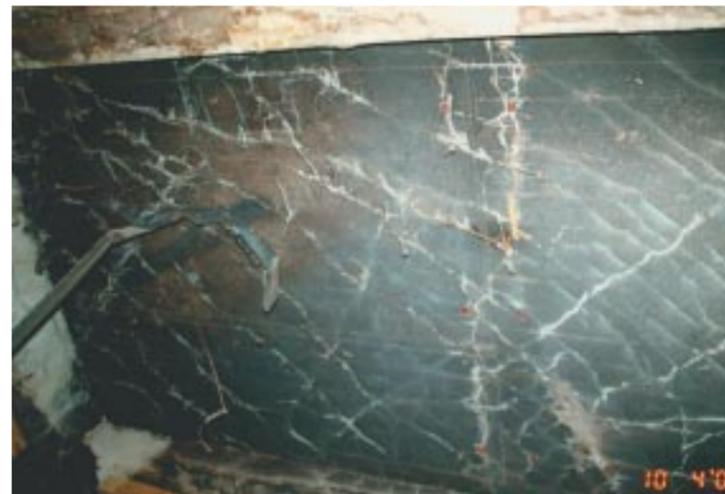
Figure 5.28 Crack patterns in second-floor slab

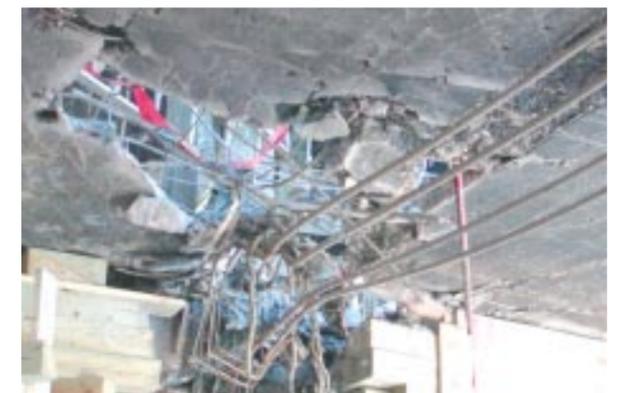
Figure 5.29 Concrete stripped from floor beam

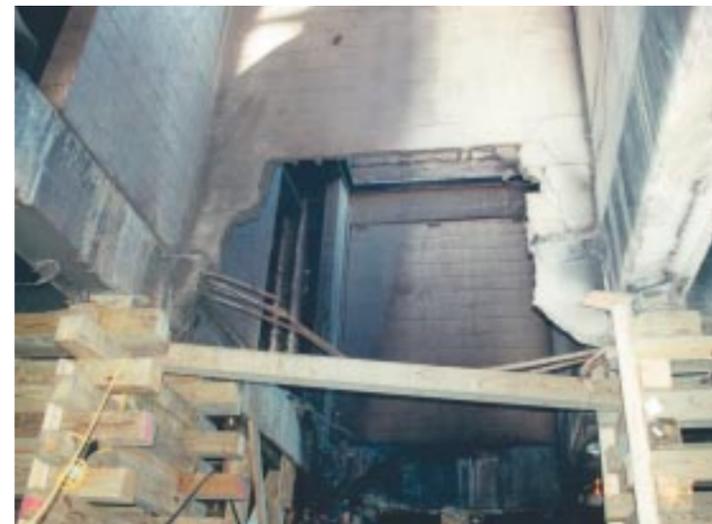
Figure 5.30 Missing beam in air shaft

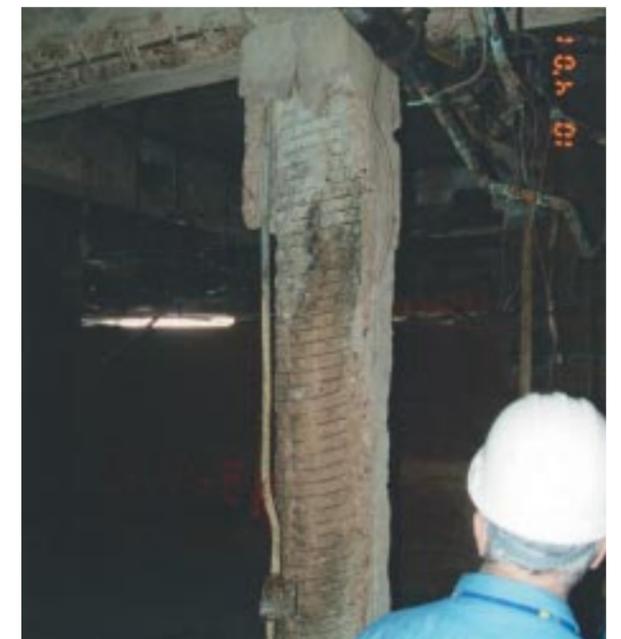
Figure 5.31 Fire damage to column in second story

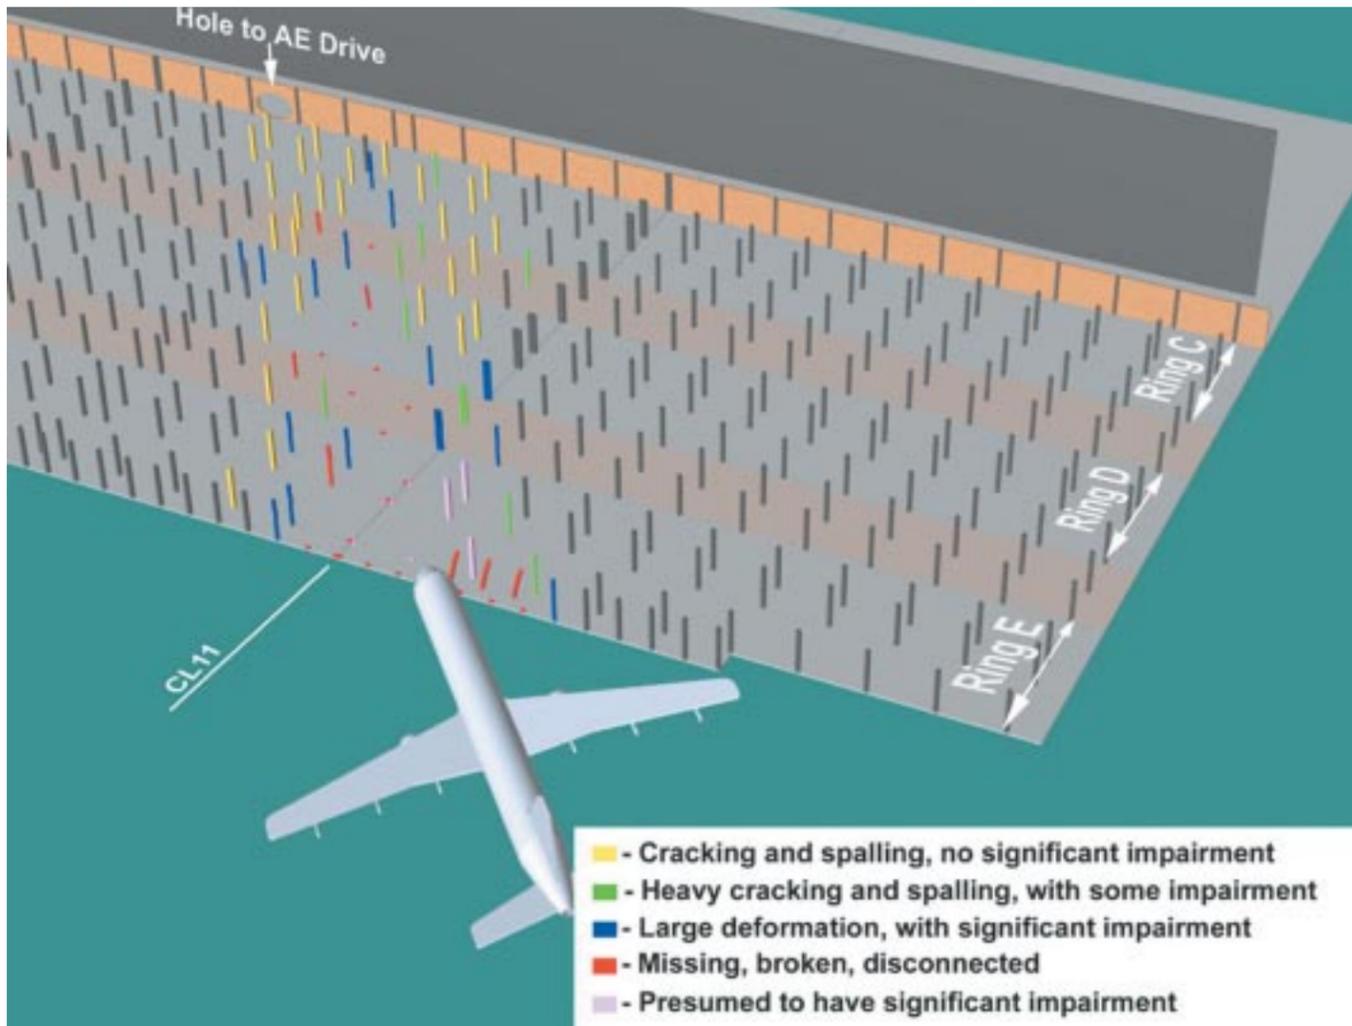
Damage to the first-floor columns is summarized in figures 6.2 and 6.3. In formulating opinions about columns in the collapse area, the BPS team interpreted photographs taken after impact and before collapse.

Figure 6.2 Damage to columns in first story viewed along path of aircraft

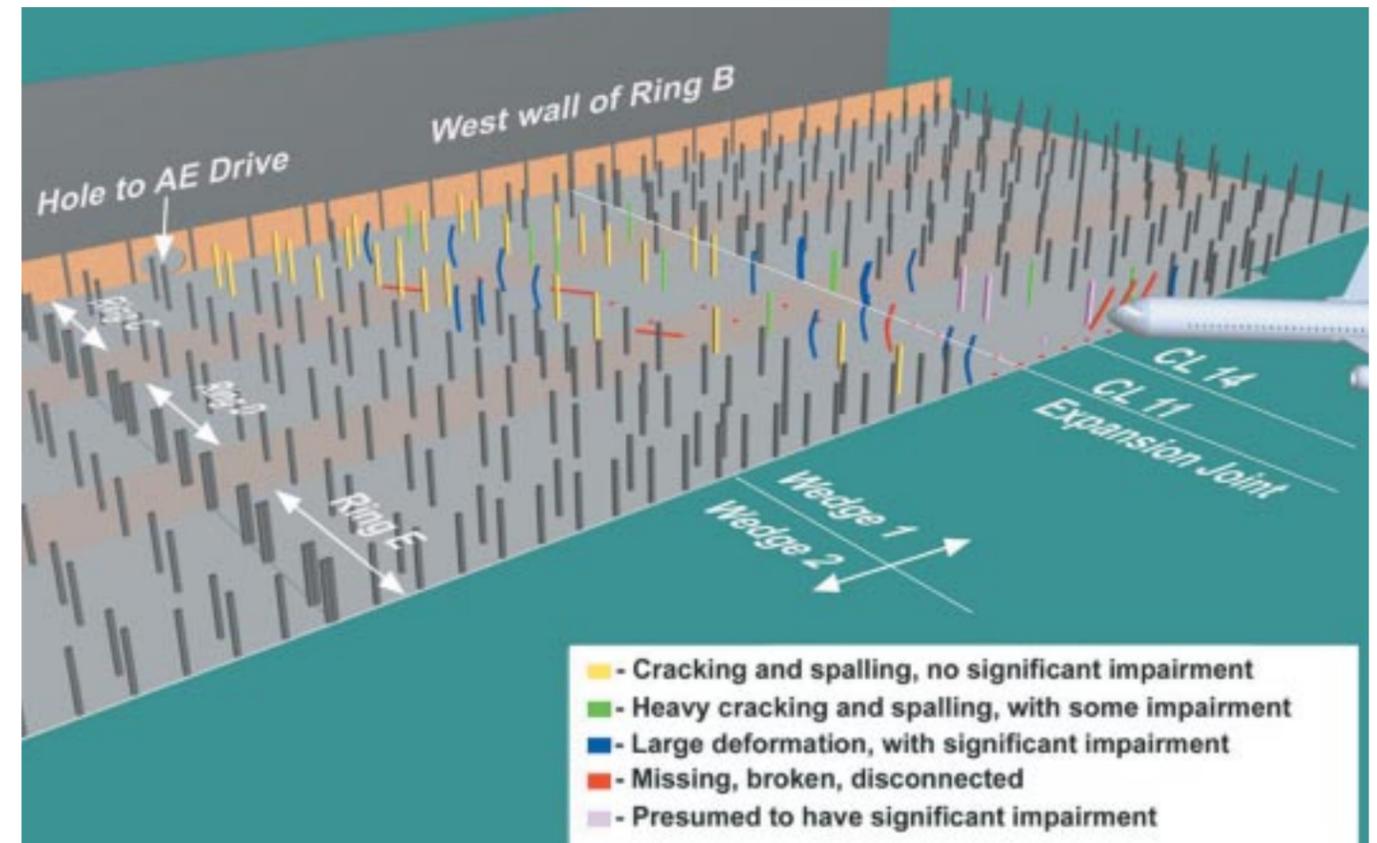
Figure 6.3 Damage to columns in first story viewed across path of aircraft

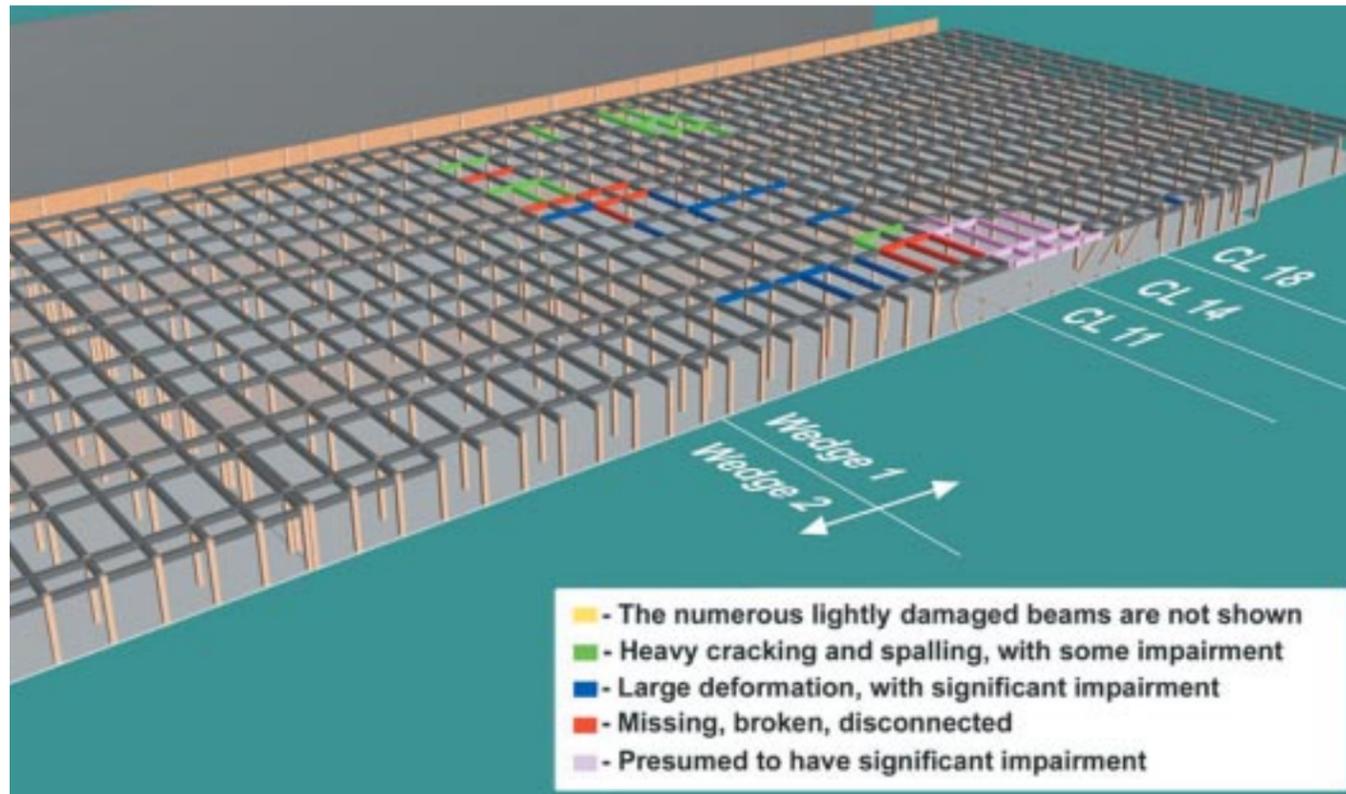
Figure 6.4 Damage to second-story beams

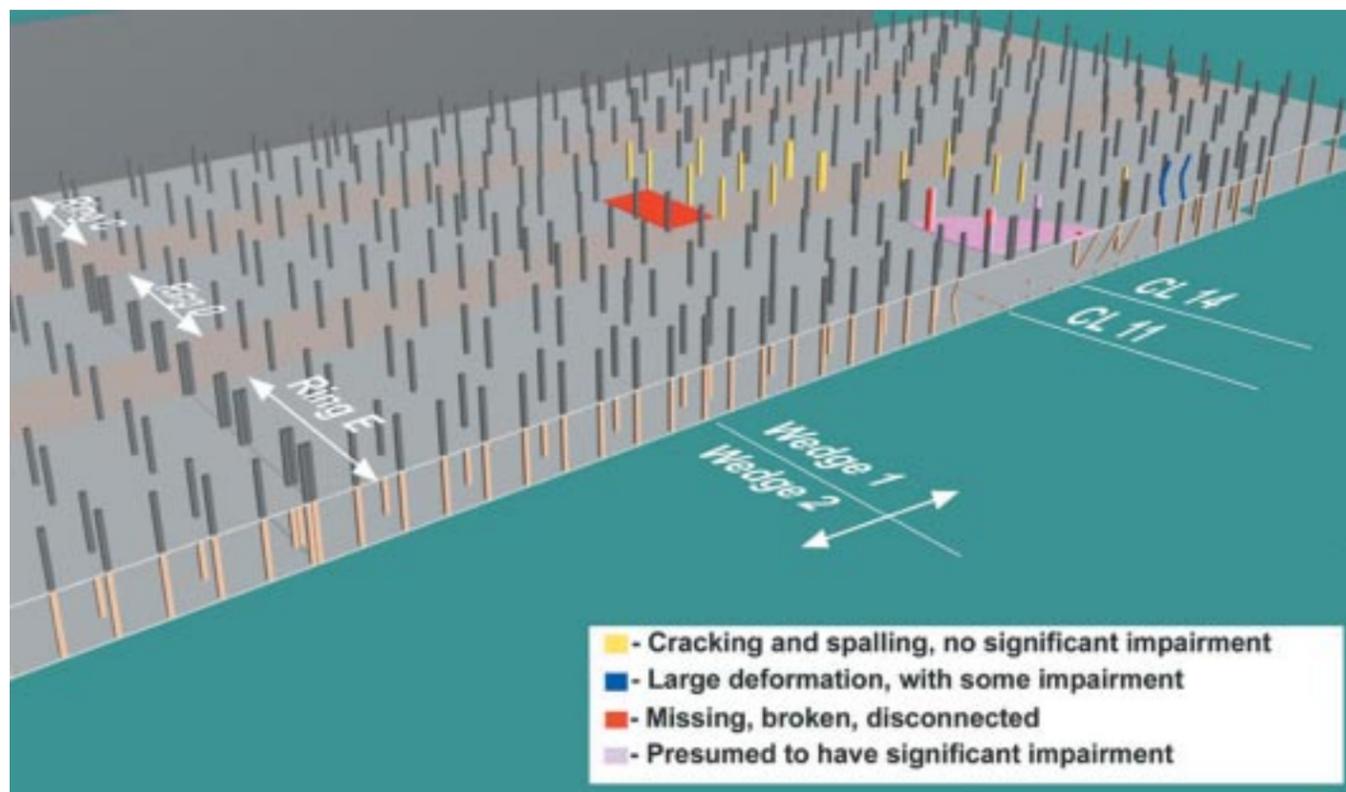
Figure 6.5 Damage to columns and slab in second story

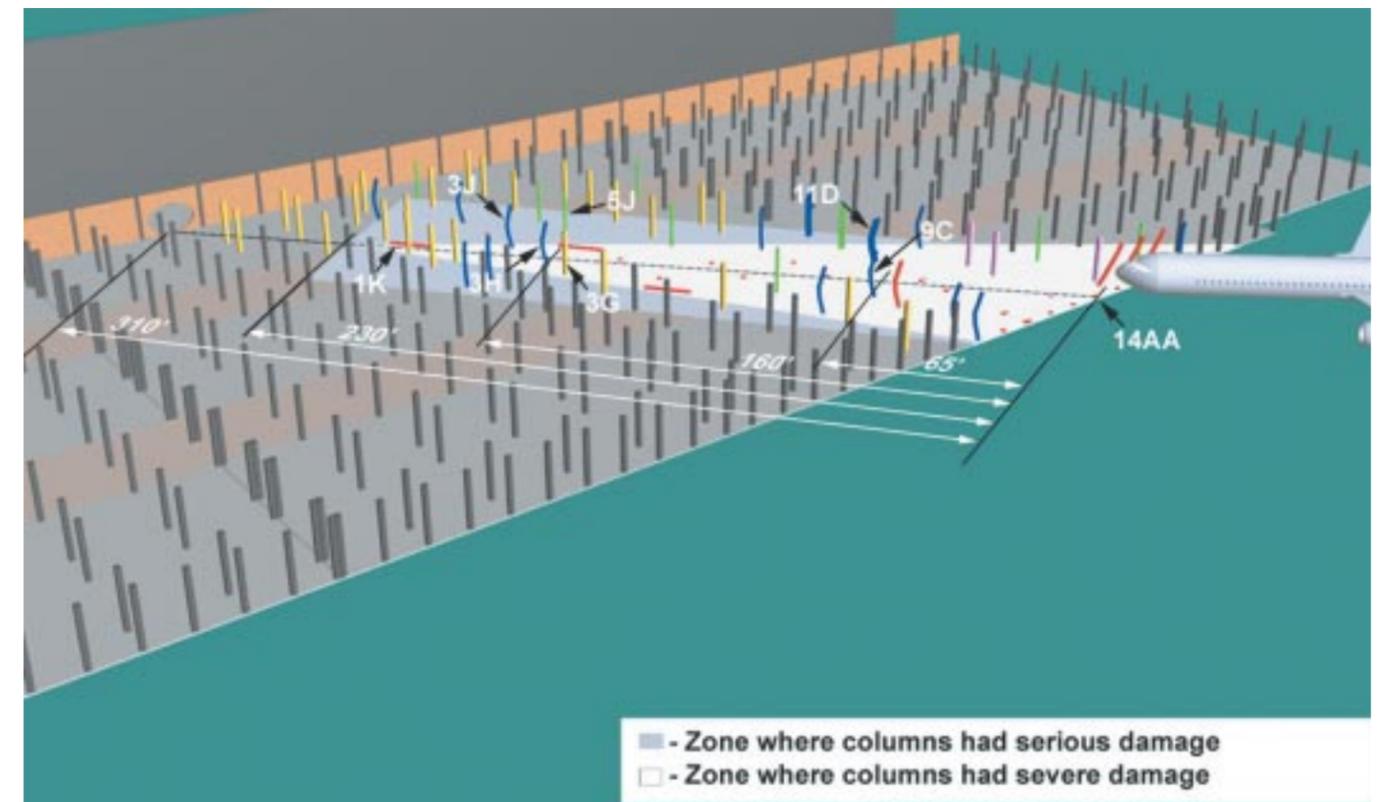
Figure 6.6 Damage regions in first story

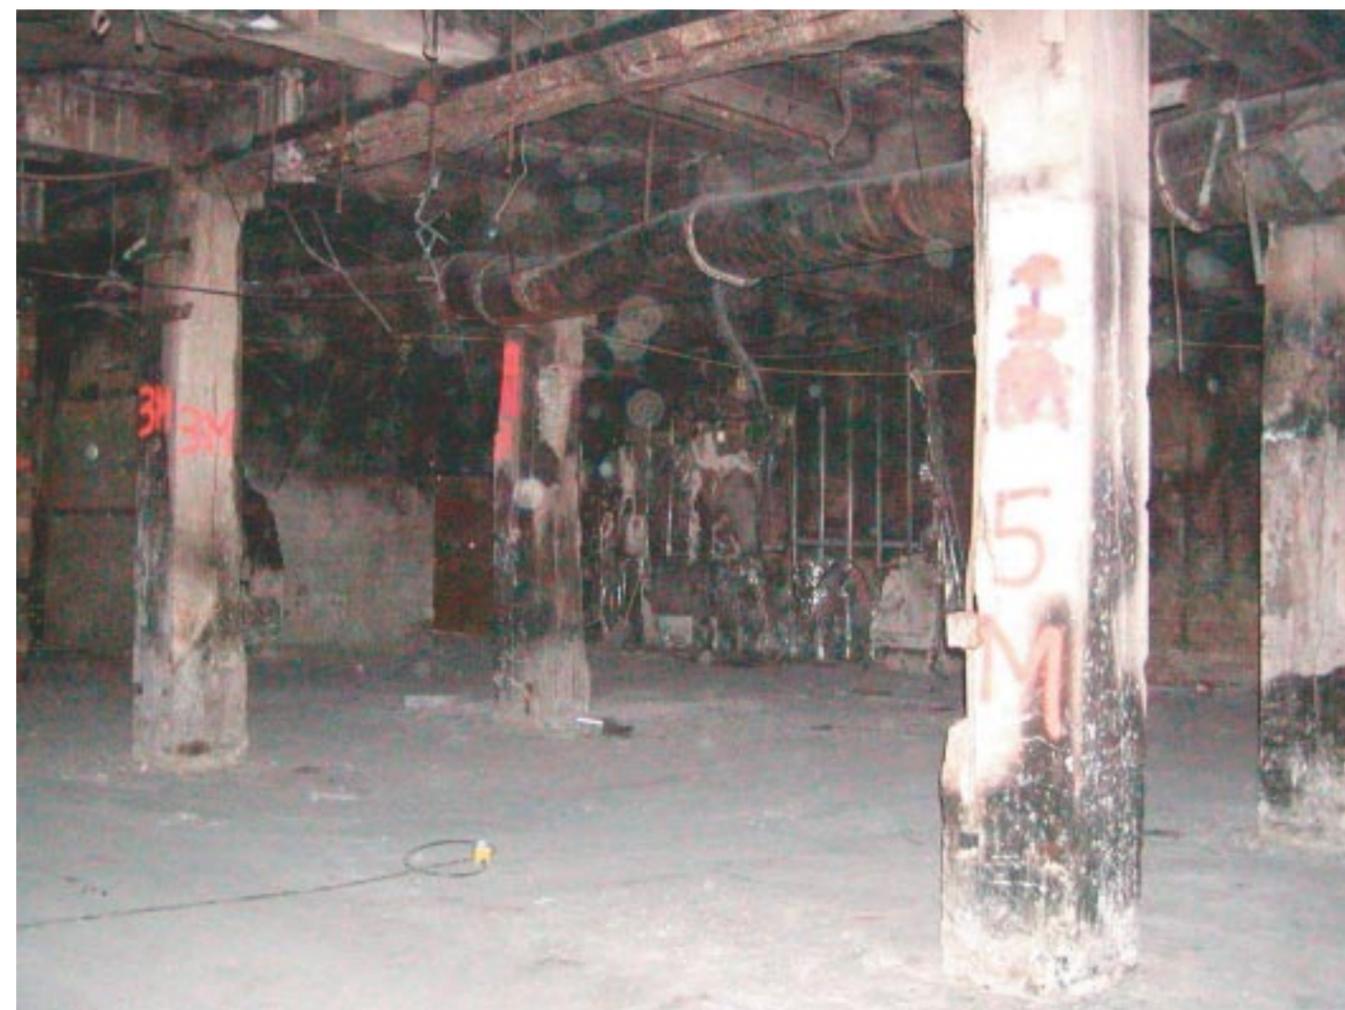
Figure 6.8 First-story columns 5N and 5M

Figures 6.8 and 6.9 show first-floor columns 5M, 5N, 3M, and 3N at the time of the BPS team visit. These columns are located in Ring C, toward the end of the damage path. All four sustained
