# THE PENTAGON BUILDING PERFORMANCE REPORT

January 2003

## ABSTRACT

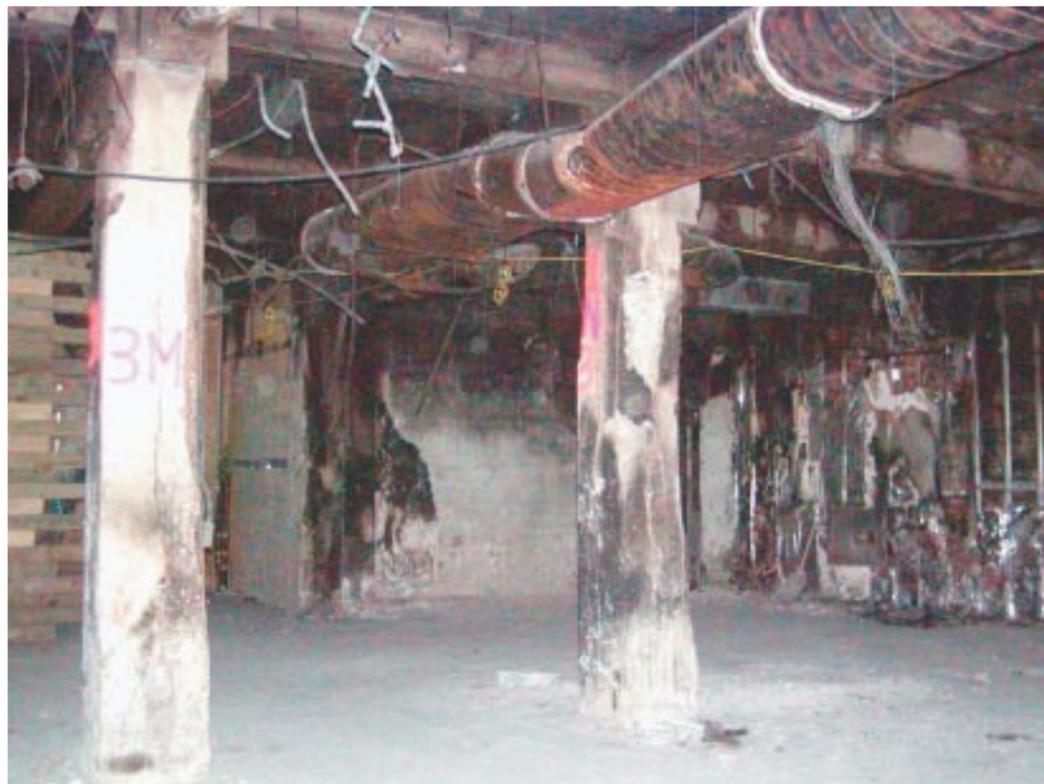
Figure 6.9 First-story columns 3M and 3N

Figures 6.8 and 6.9 show first-floor columns 5M, 5N, 3M, and 3N at the time of the BPS team visit. These columns are located in Ring C, toward the end of the damage path. All four sustained

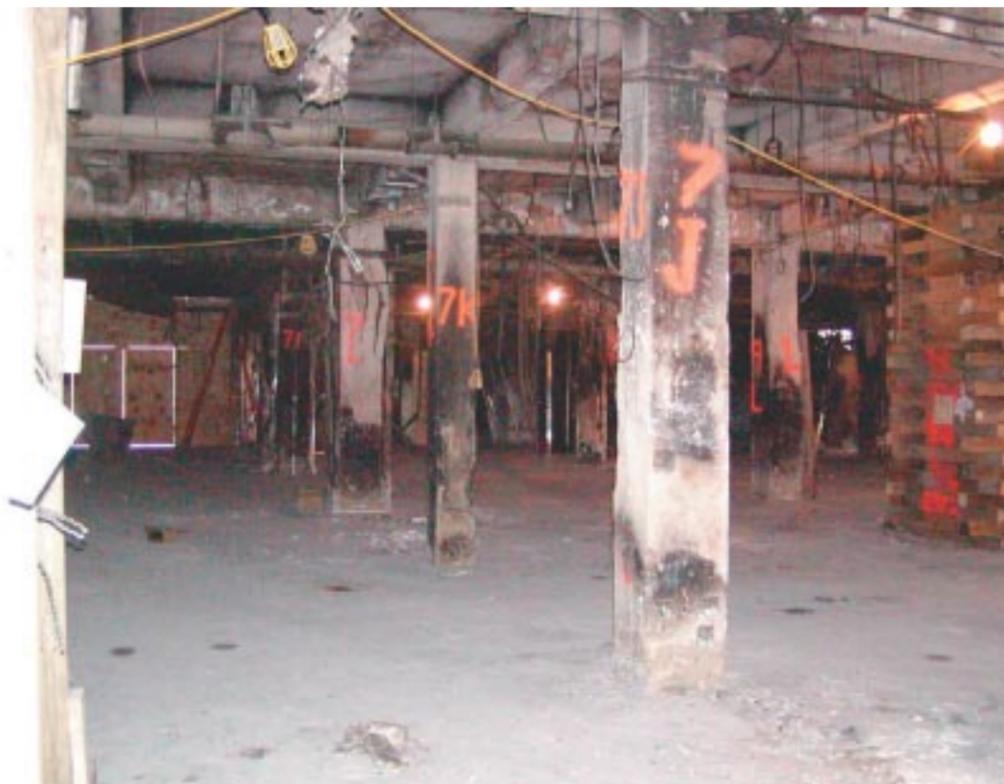
Figure 6.10 First-story columns 7J, 7K, and 7L

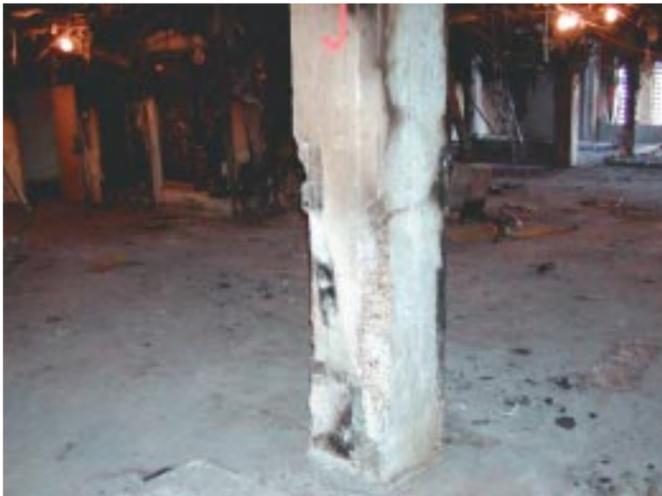
Figure 6.11 First-story column 7J

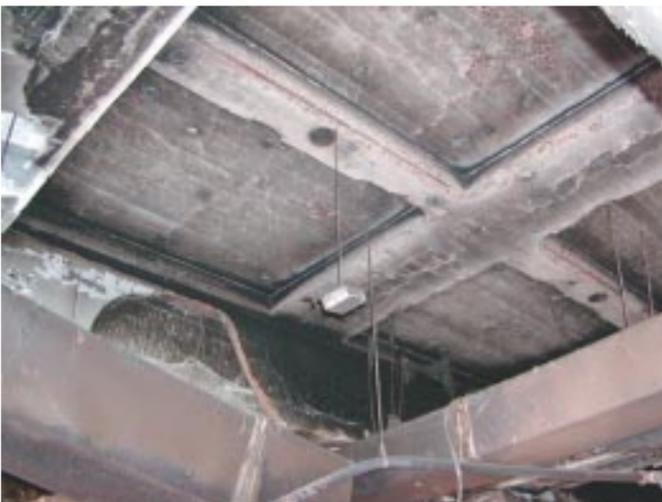
Figure 6.12 Fire damage to third-floor (light well) beams

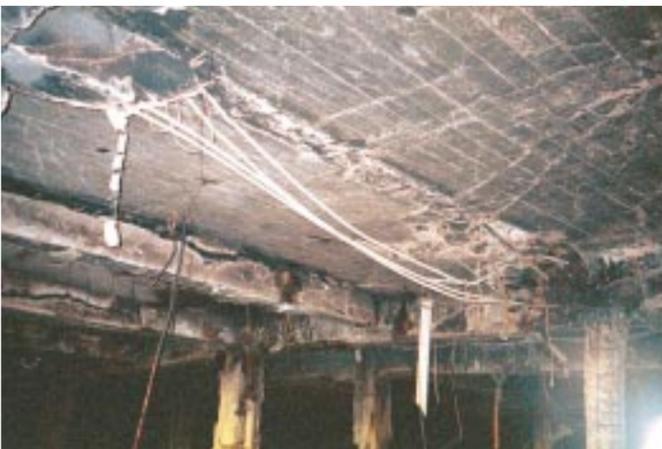
Figure 6.13 Concrete stripped from second-floor beam at grid 9 between grids A and B; extensive cracking in slab

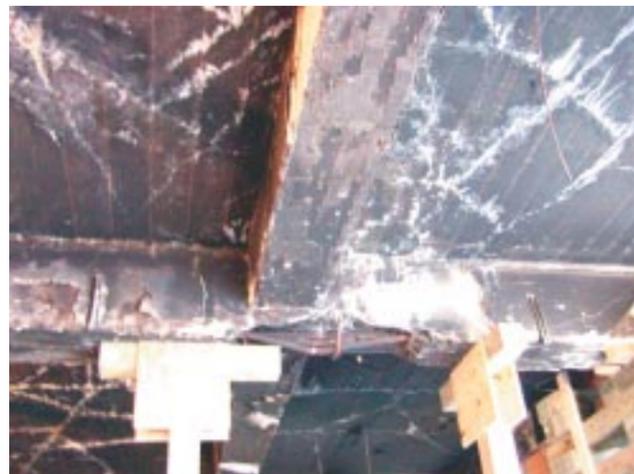
Figure 6.14 Fire-damaged second-floor beams

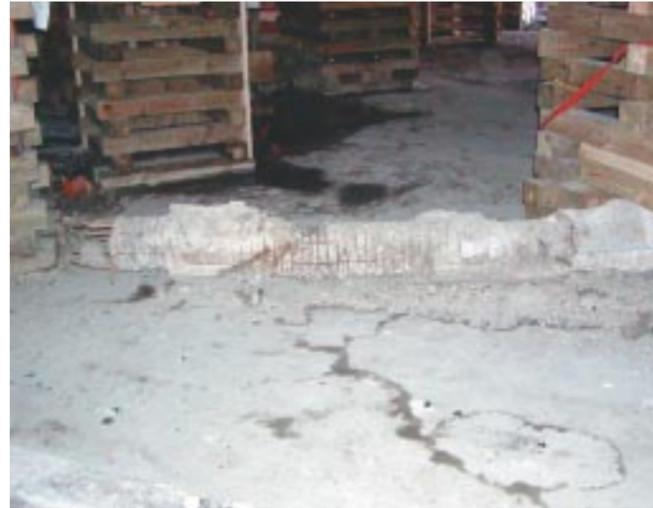
Figure 7.5a Column impacted and torn off at supports

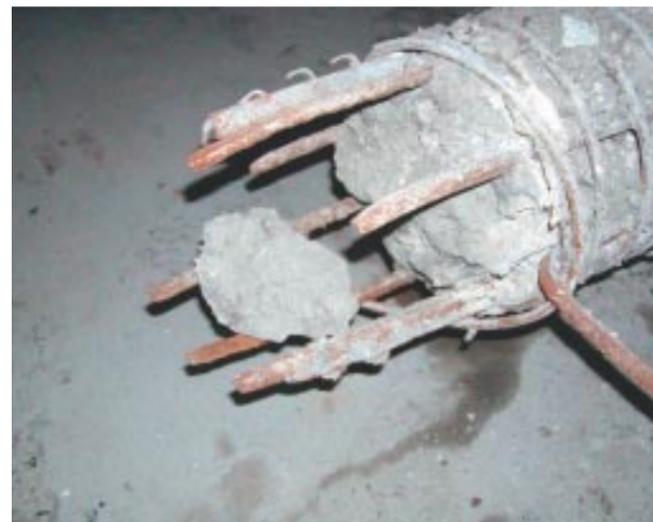
Figure 7.5b Ends of fractured reinforcing bars showing necking

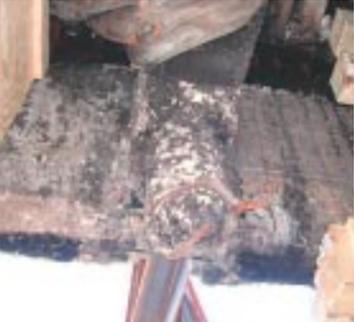
| COLUMN LABEL | DESCRIPTION OF DAMAGE | PHOTO (IF AVAILABLE) |
|--|---|---|
| 10AA | <ul style="list-style-type: none"> <li>• Missing</li> <li>• Remaining upper section connected to is stripped to spiral reinforcement</li> <li>• Shored</li> </ul> | |

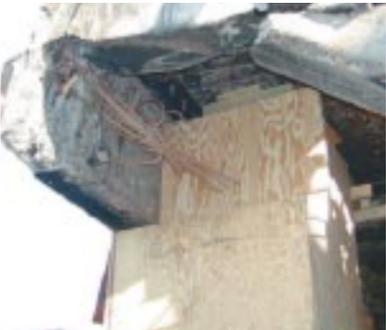
| COLUMN LABEL | DESCRIPTION OF DAMAGE | PHOTO (IF AVAILABLE) |
|--|---|---|
| 11AA | <ul style="list-style-type: none"> <li>• Missing</li> <li>• Remnants of 8 #8 deformed bars visible at ceiling</li> <li>• Shored</li> </ul> | |

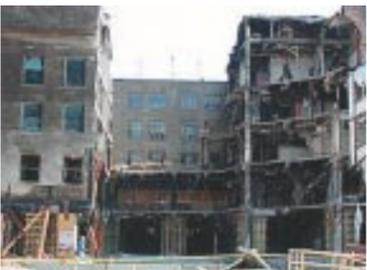
| COLUMN LABEL | DESCRIPTION OF DAMAGE | PHOTO (IF AVAILABLE) |
|--|---|---|
| 12AA,<br>13AA,14AA,15AA,<br>16AA, 17AA | <ul style="list-style-type: none"> <li>• Missing</li> </ul> | |

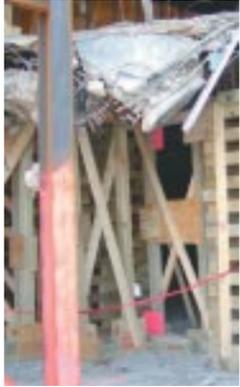
| COLUMN LABEL | DESCRIPTION OF DAMAGE | PHOTO (IF AVAILABLE) |
|---|---|---|
| 11A | <ul style="list-style-type: none"> <li>• Missing</li> <li>• Shored</li> </ul> | |

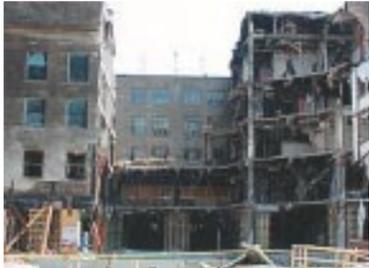
| COLUMN LABEL | DESCRIPTION OF DAMAGE | PHOTO (IF AVAILABLE) |
|---|---|---|
| 13A,15A | <ul style="list-style-type: none"> <li>• Missing</li> </ul> | |

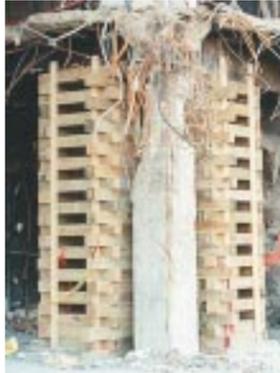
| COLUMN LABEL | DESCRIPTION OF DAMAGE | PHOTO (IF AVAILABLE) |
|---|---|---|
| 17A | <ul style="list-style-type: none"> <li>• Stripped to spiral reinforcement at top of column</li> <li>• Shored</li> </ul> | |

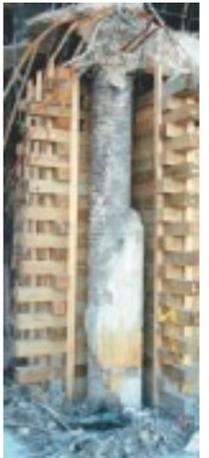
| COLUMN LABEL | DESCRIPTION OF DAMAGE | PHOTO (IF AVAILABLE) |
|---|--|---|
| 15B | <ul style="list-style-type: none"> <li>• Spalled to spiral reinforcement from midheight to top</li> <li>• Shored</li> </ul> | |

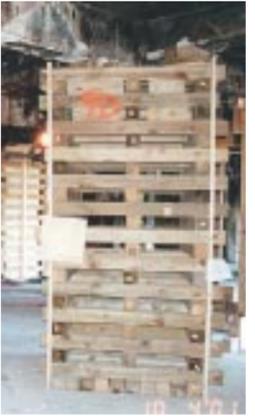
| COLUMN LABEL | DESCRIPTION OF DAMAGE | PHOTO (IF AVAILABLE) |
|---|--|---|
| 9D | <ul style="list-style-type: none"> <li>• Missing</li> <li>• Shored</li> </ul> | |

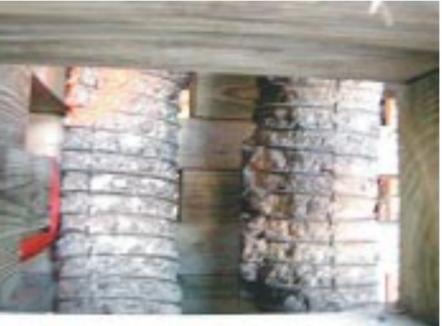
| COLUMN LABEL | DESCRIPTION OF DAMAGE | PHOTO (IF AVAILABLE) |
|---|--|---|
| 11D | <ul style="list-style-type: none"> <li>• Bowed</li> <li>• Stripped to spiral reinforcement</li> <li>• Shored</li> </ul> | |

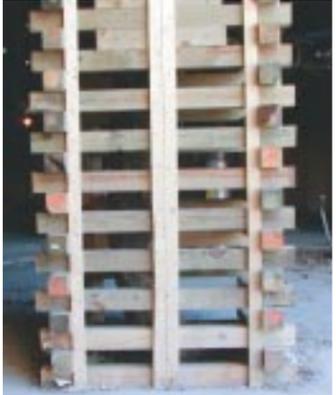
| COLUMN LABEL | DESCRIPTION OF DAMAGE | PHOTO (IF AVAILABLE) |
|---|--|---|
| 13D | <ul style="list-style-type: none"> <li>• Stripped to spiral reinforcement</li> <li>• Bowed to Northeast</li> <li>• Shored</li> </ul> | |

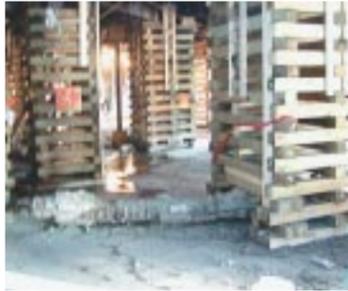
| COLUMN LABEL | DESCRIPTION OF DAMAGE | PHOTO (IF AVAILABLE) |
|---|--|--|
| 5E | <ul style="list-style-type: none"> <li>• Downed</li> <li>• Stripped to spiral reinforcement</li> <li>• Shored</li> </ul> | |

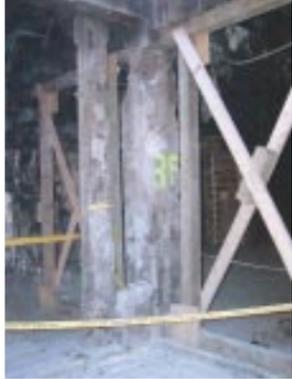
| COLUMN LABEL | DESCRIPTION OF DAMAGE | PHOTO (IF AVAILABLE) |
|---|--|--|
| 3F | <ul style="list-style-type: none"> <li>• Spalled to spiral reinforcement at top</li> </ul> | |

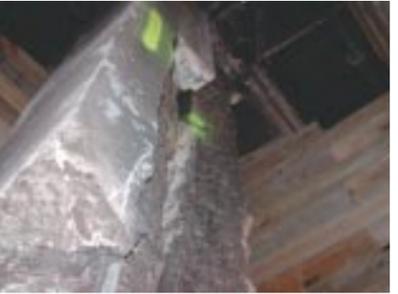
| COLUMN LABEL | DESCRIPTION OF DAMAGE | PHOTO (IF AVAILABLE) |
|---|---|---|
| 11F | <ul style="list-style-type: none"> <li>• Impacted, bowed</li> <li>• Stripped to spiral reinforcement</li> <li>• Shored</li> </ul> | |

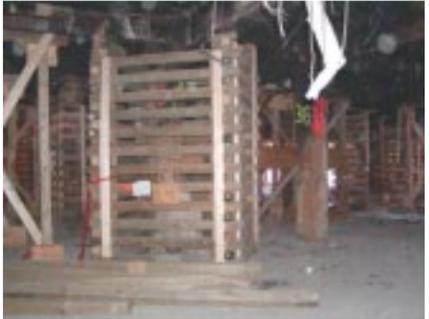
| COLUMN LABEL | DESCRIPTION OF DAMAGE | PHOTO (IF AVAILABLE) |
|---|---|---|
| 3G | <ul style="list-style-type: none"> <li>• Slightly blackened</li> </ul> | |

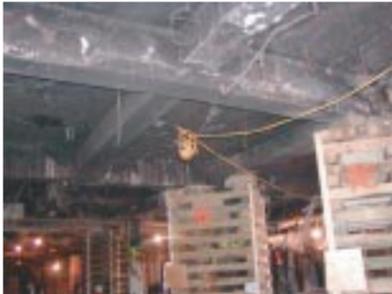
| COLUMN LABEL | DESCRIPTION OF DAMAGE | PHOTO (IF AVAILABLE) |
|---|---|---|
| 9G | <ul style="list-style-type: none"> <li>• Moderate spalling</li> <li>• Steel visible on northwest side at midsection</li> </ul> | |

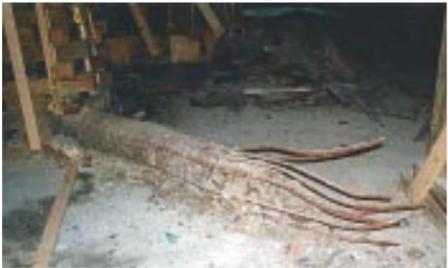
| COLUMN LABEL | DESCRIPTION OF DAMAGE | PHOTO (IF AVAILABLE) |
|---|---|---|
| 5H | <ul style="list-style-type: none"> <li>• Downed</li> <li>• Stripped to spiral reinforcement</li> <li>• Shored</li> </ul> | |

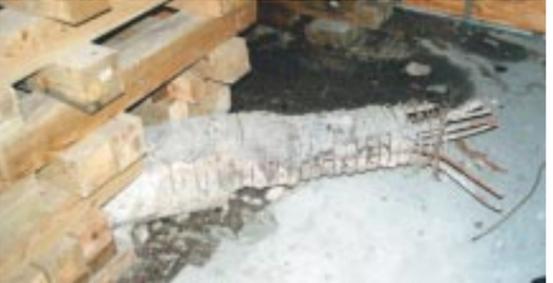
| COLUMN LABEL | DESCRIPTION OF DAMAGE | PHOTO (IF AVAILABLE) |
|---|--|---|
| 1K-South | <ul style="list-style-type: none"> <li>• Downed</li> <li>• Stripped to spiral reinforcement</li> <li>• Shored</li> </ul> | |

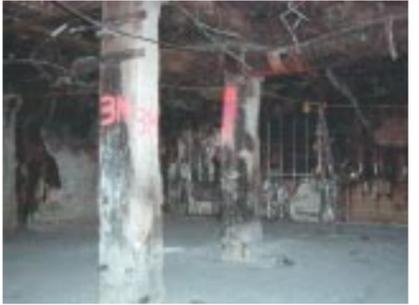
| COLUMN LABEL | DESCRIPTION OF DAMAGE | PHOTO (IF AVAILABLE) |
|---|--|---|
| 3M-North | <ul style="list-style-type: none"> <li>• Damaged (per FBI)</li> </ul> | |
