# Investigation of Controlled Flight into Terrain

## Descriptions of Flight Paths for Selected Controlled Flight into Terrain (CFIT) Aircraft Accidents, 1985-1997

Project Memorandum  
DOT-TSC-FA9D1-99-01  
March 1999

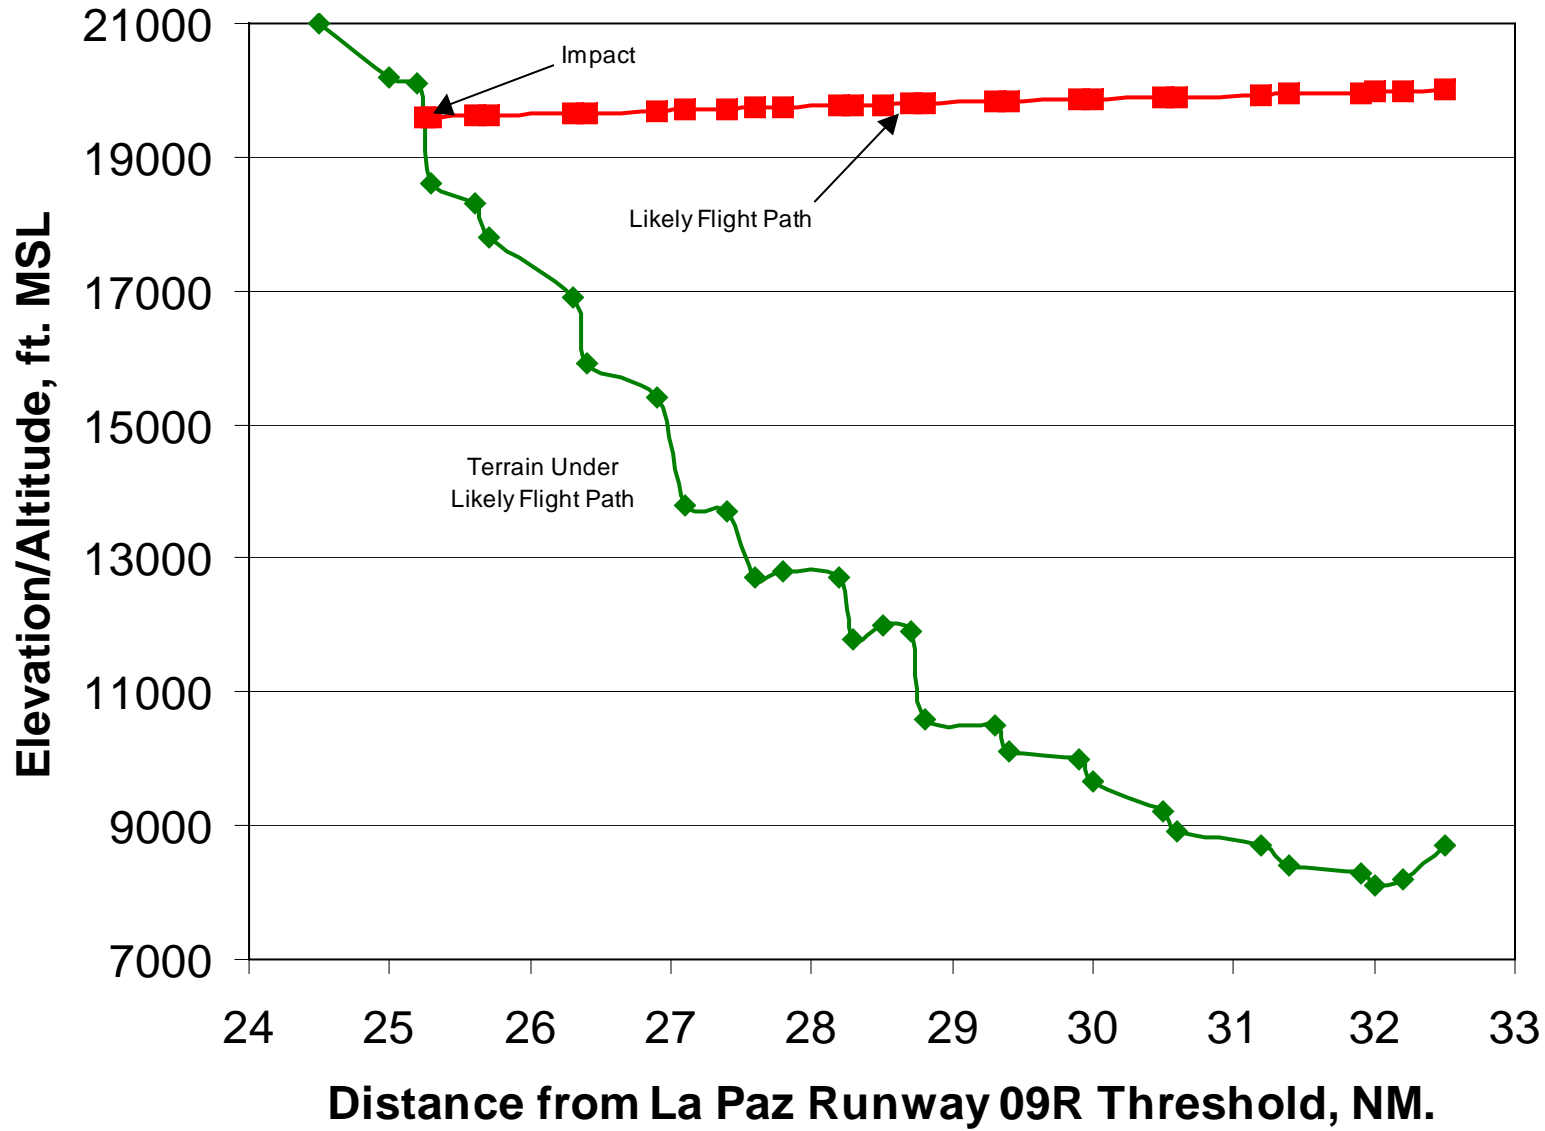
The aircraft had reported crossing the DAKON intersection, 55 NM southeast of La Paz, at 25,000 ft. MSL. They were then cleared by La Paz ATC to descend to 18,000 feet, and the crew acknowledged this clearance. Although the accident aircraft was supposed to be approaching La Paz along airway UA 320, on a 134° radial from the La Paz VOR, it veered significantly off course beyond DAKON; the impact location is along the 106° radial from La Paz. Investigators speculate the flight crew were maneuvering to avoid weather in the vicinity, and that impact occurred with the aircraft in cruise configuration, in a shallow descent. Dark night, weather, and lack of visual references in the area all contributed to the crew's inability to see and avoid the high terrain in their path. (10)

Table 2 presents altitude and elevation information for this accident. This information is presented graphically in Figure 1.

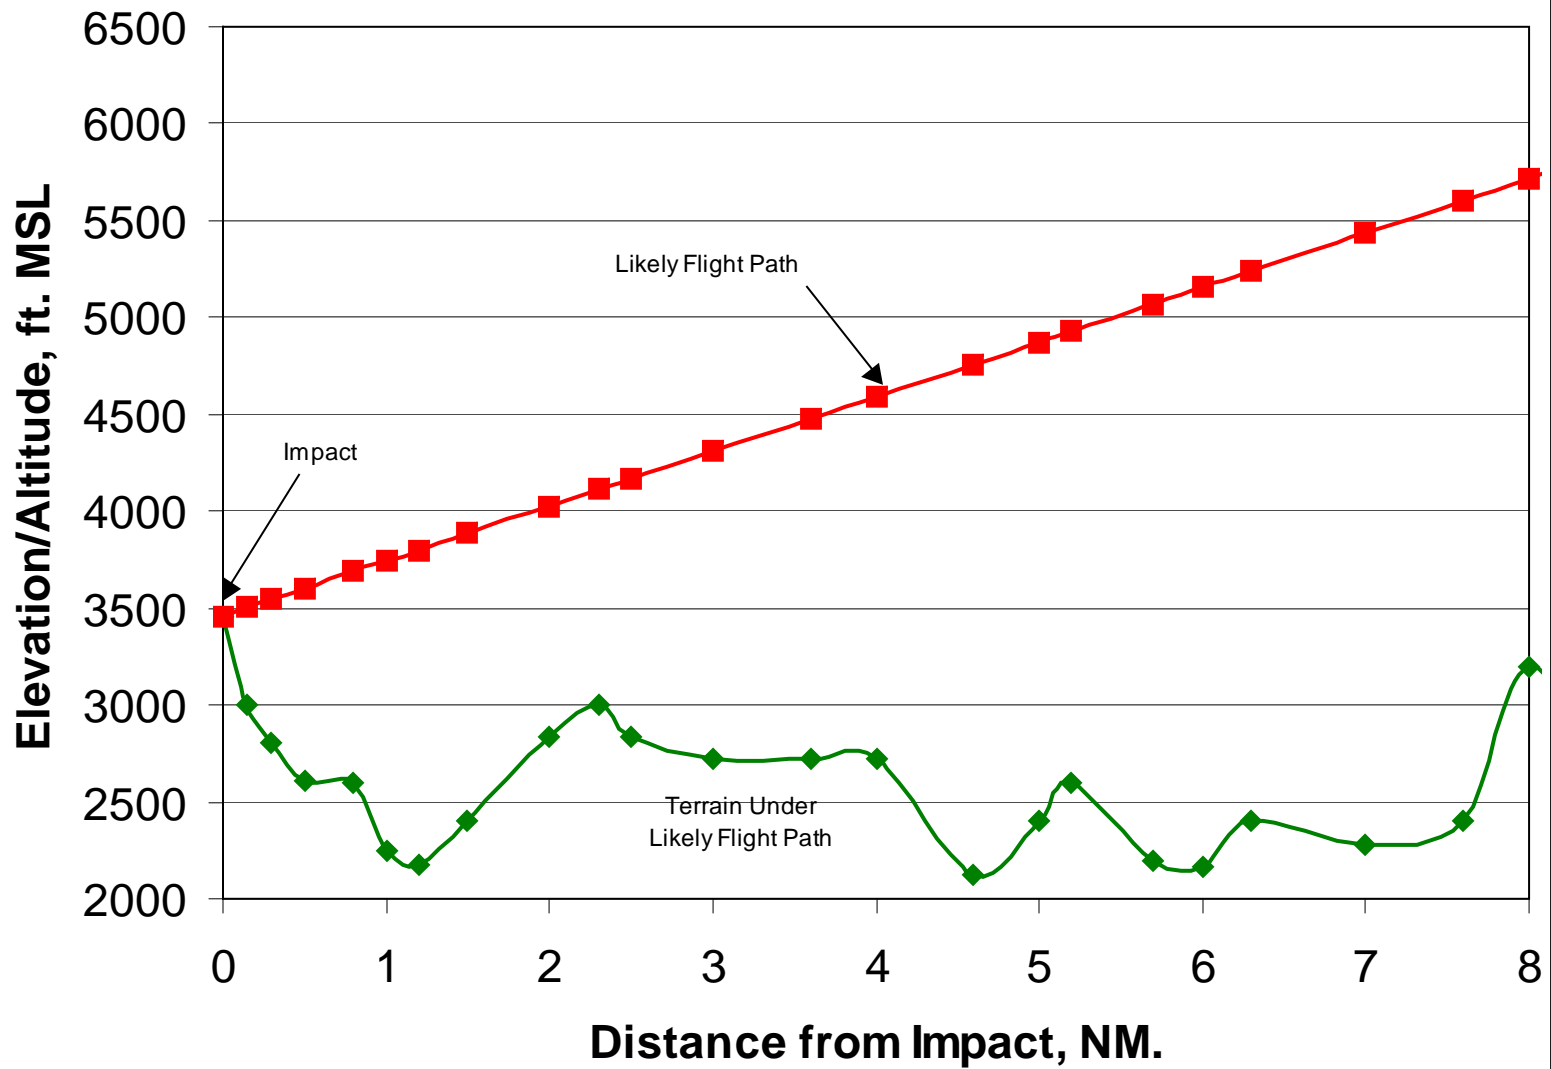
Figure 2.  
Flat Rock, NC -- PA-31T -- N600CM -- 8/23/85

A few minutes before the accident, the pilot of N600CM reported to ATC “35 (nautical miles) from the airport, VFR (visual flight rules) for landing.” At the Asheville, NC terminal radar approach control facility, controllers observed the flight in a steady descent from 9700’ to 3600’ in the vicinity of the accident site. The pilot, flying VFR, was just under the cloud ceiling, dangerously close to the uninhabited and unlit mountain peaks in the area. Lacking visual reference, the pilot did not see Stone Mountain until it was too late to react. (12)

N600CM was not equipped with FDR, CVR or GPWS. Table 3 presents altitude and elevation information for this accident. This information is presented graphically in Figure 2.

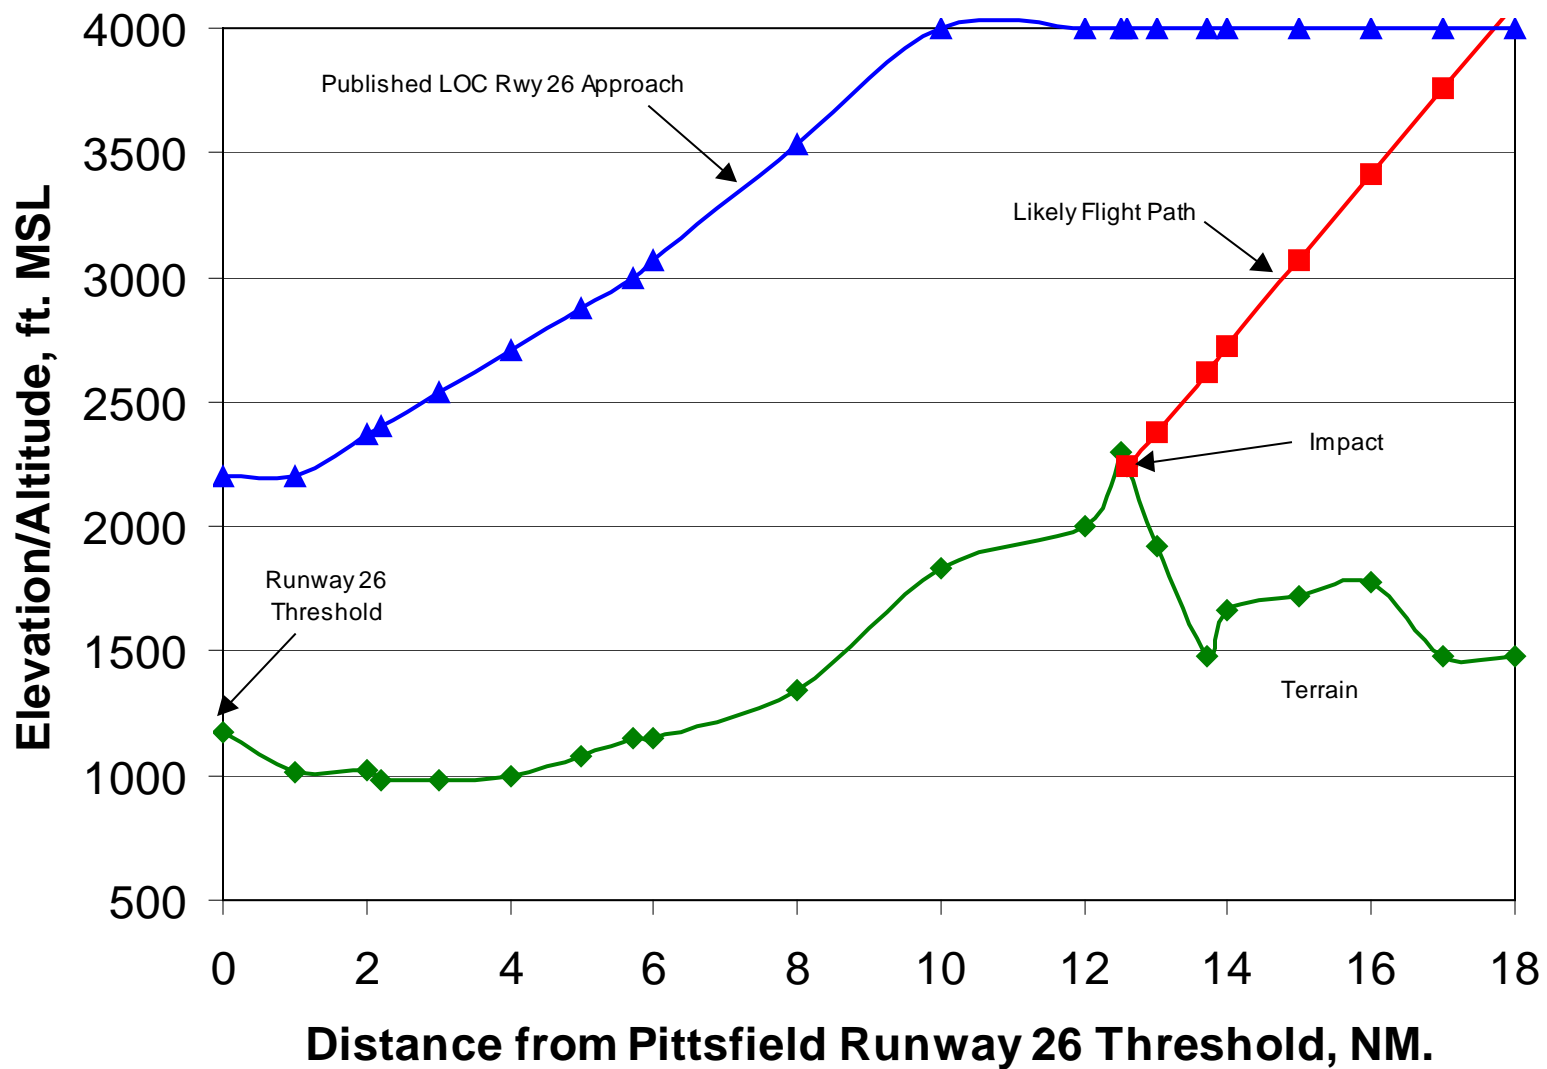
Figure 3.  
Windsor, MA -- Be-100 -- N65TD -- 12/10/86

Shortly before the accident, the pilot of N65TD reported “five tango delta, procedure turn inbound Pittsfield,” which indicated the aircraft was beginning its approach. The aircraft apparently began its descent prematurely, deviating well below the published LOC Runway 26 approach procedure. In conditions of very limited visibility, the aircraft descended into the terrain. (13)

N65TD not equipped with FDR, CVR or GPWS. Table 4 presents altitude and elevation information for this accident. This information is presented graphically in Figure 3.

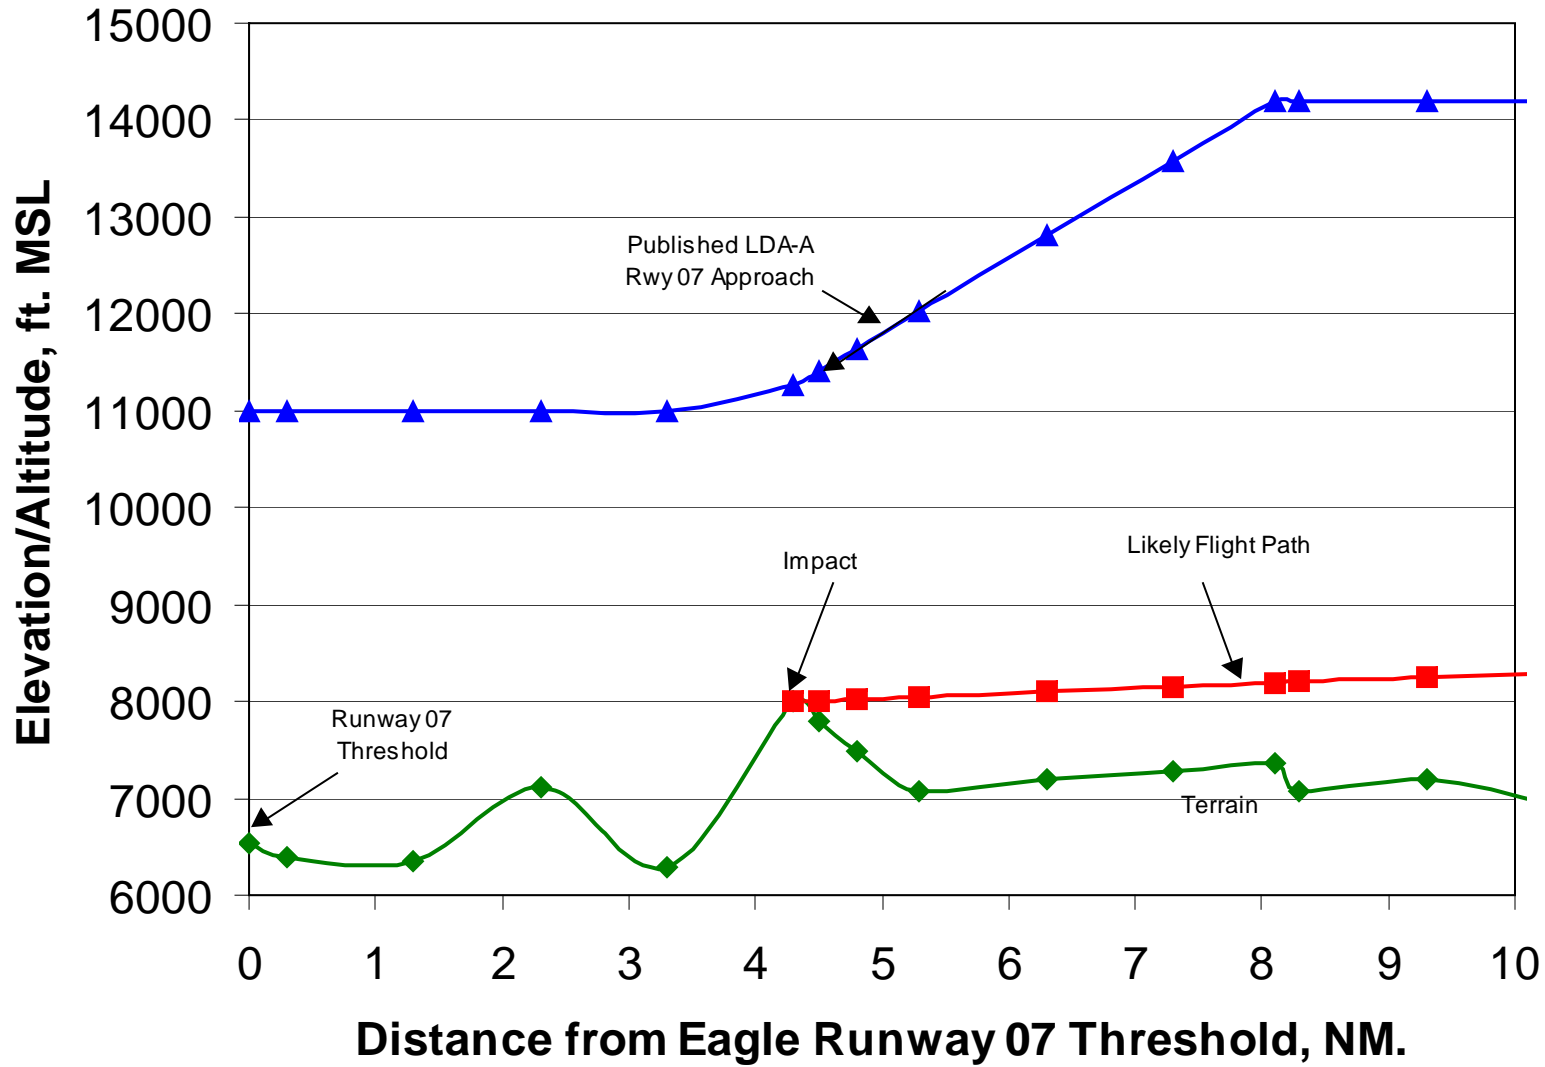
The pilot of N31SK reported passing the STUPE intersection, and was cleared by ATC for landing at Eagle. Shortly before the accident, the pilot reported “eight to ten miles out, and it's clear to Eagle.” From the position and heading of the aircraft at impact, investigators assumed the pilot had elected to fly the circle-to-land LDA-A Runway 07 approach to Eagle. The pilot descended well below the altitudes specified for this approach, but may have done so because he could see the airport. Post-crash investigation showed the pilot would have had the airport in sight for all but the last one to three seconds of flight, when the uninhabited, unlit mountain ridge obstructed his view. Only a very small adjustment to the aircraft's controls would have been required to gain the additional 22' of altitude necessary to clear the ridge. However, lacking visual reference, the pilot was unable to see the terrain until it was too late. (14)

N31SK not equipped with FDR, CVR or GPWS. Table 5 presents altitude and elevation information for this accident. This information is presented graphically in Figure 4.

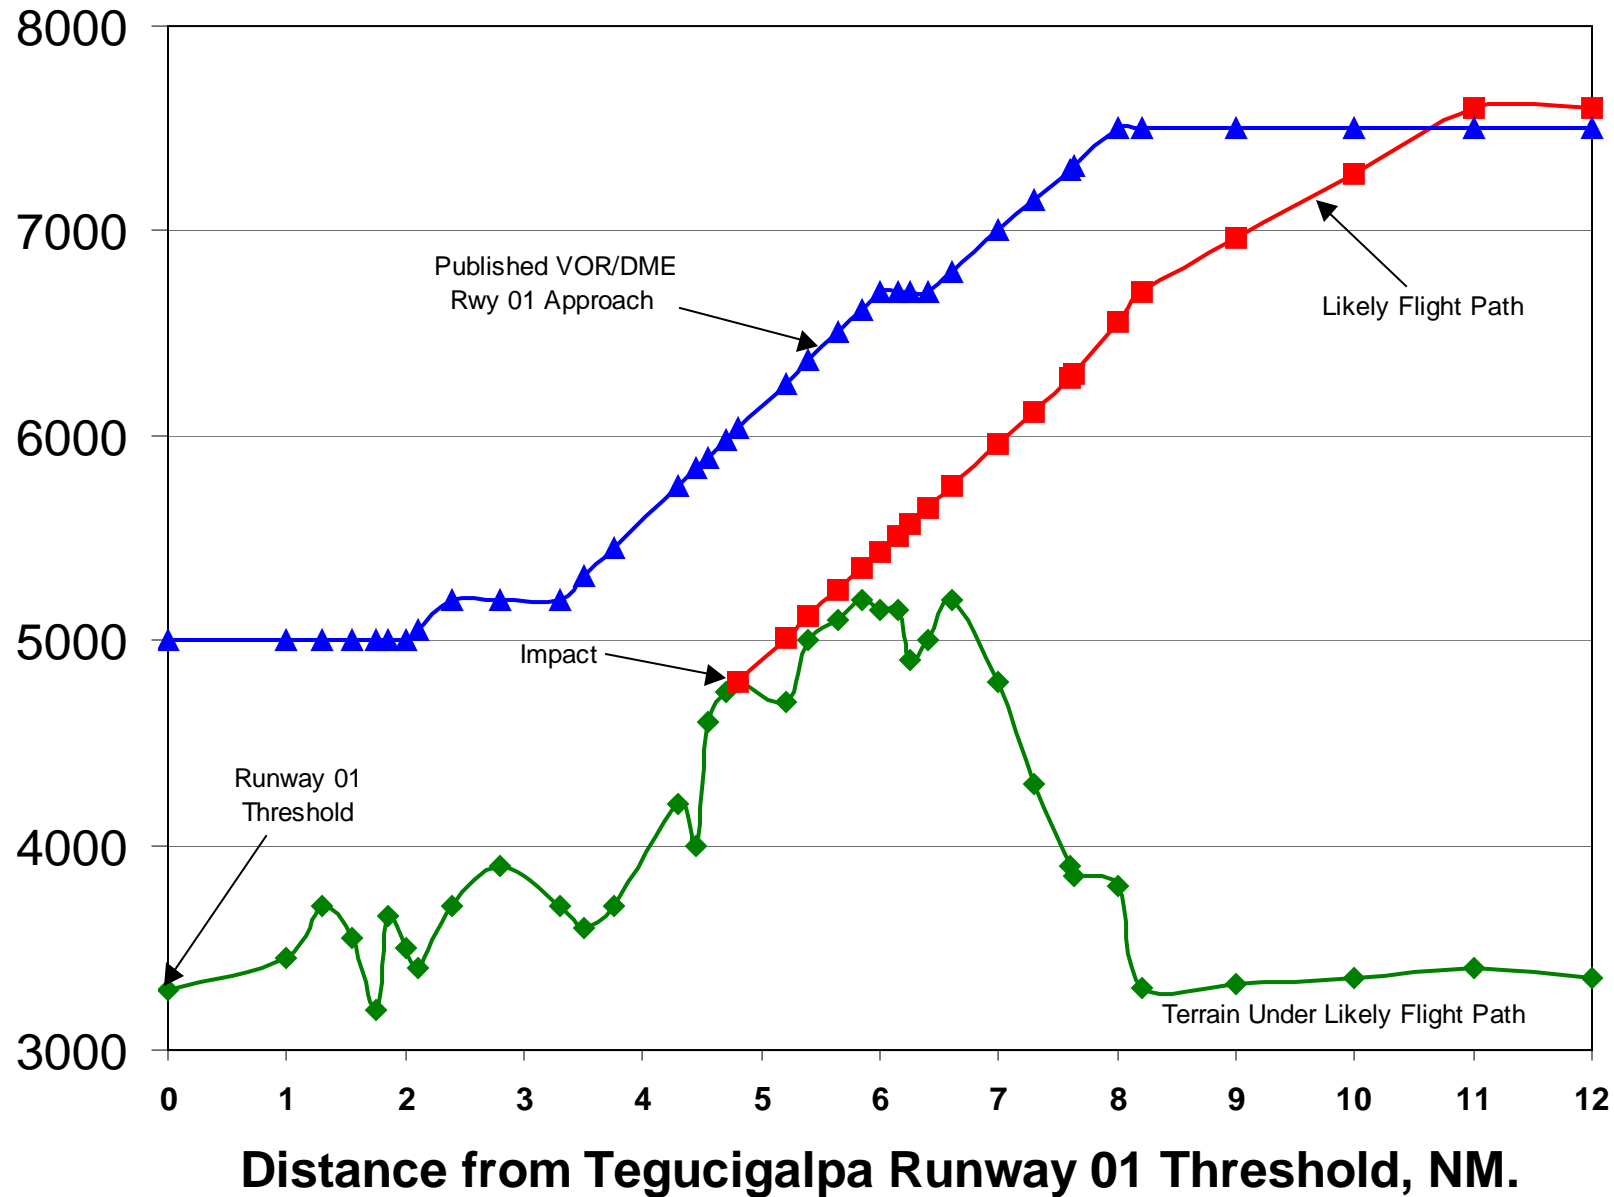
Figure 5.  
Tegucigalpa, Honduras -- B-727-200 -- N88705 -- 10/21/89

SAHSA-414 was cleared by Tegucigalpa ATC for the VOR/DME Runway 01 approach, which includes a series of three step-downs from the initial approach fix altitude of 7500' MSL to avoid high terrain in the neighborhood of the airport. Rather than following the prescribed step-down procedure, however, the crew began a continuous descent from about 7600' MSL at about 11 NM from the airport to the accident site. The aircraft's descent profile was well below the published step-down course for the entire approach. (15)

N88705 was equipped with FDR, CVR and GPWS. However, because Honduran law did not require installation, the GPWS had been disconnected at the time of the accident. Table 6 presents altitude and elevation information for this accident. This information is presented graphically in Figure 5.

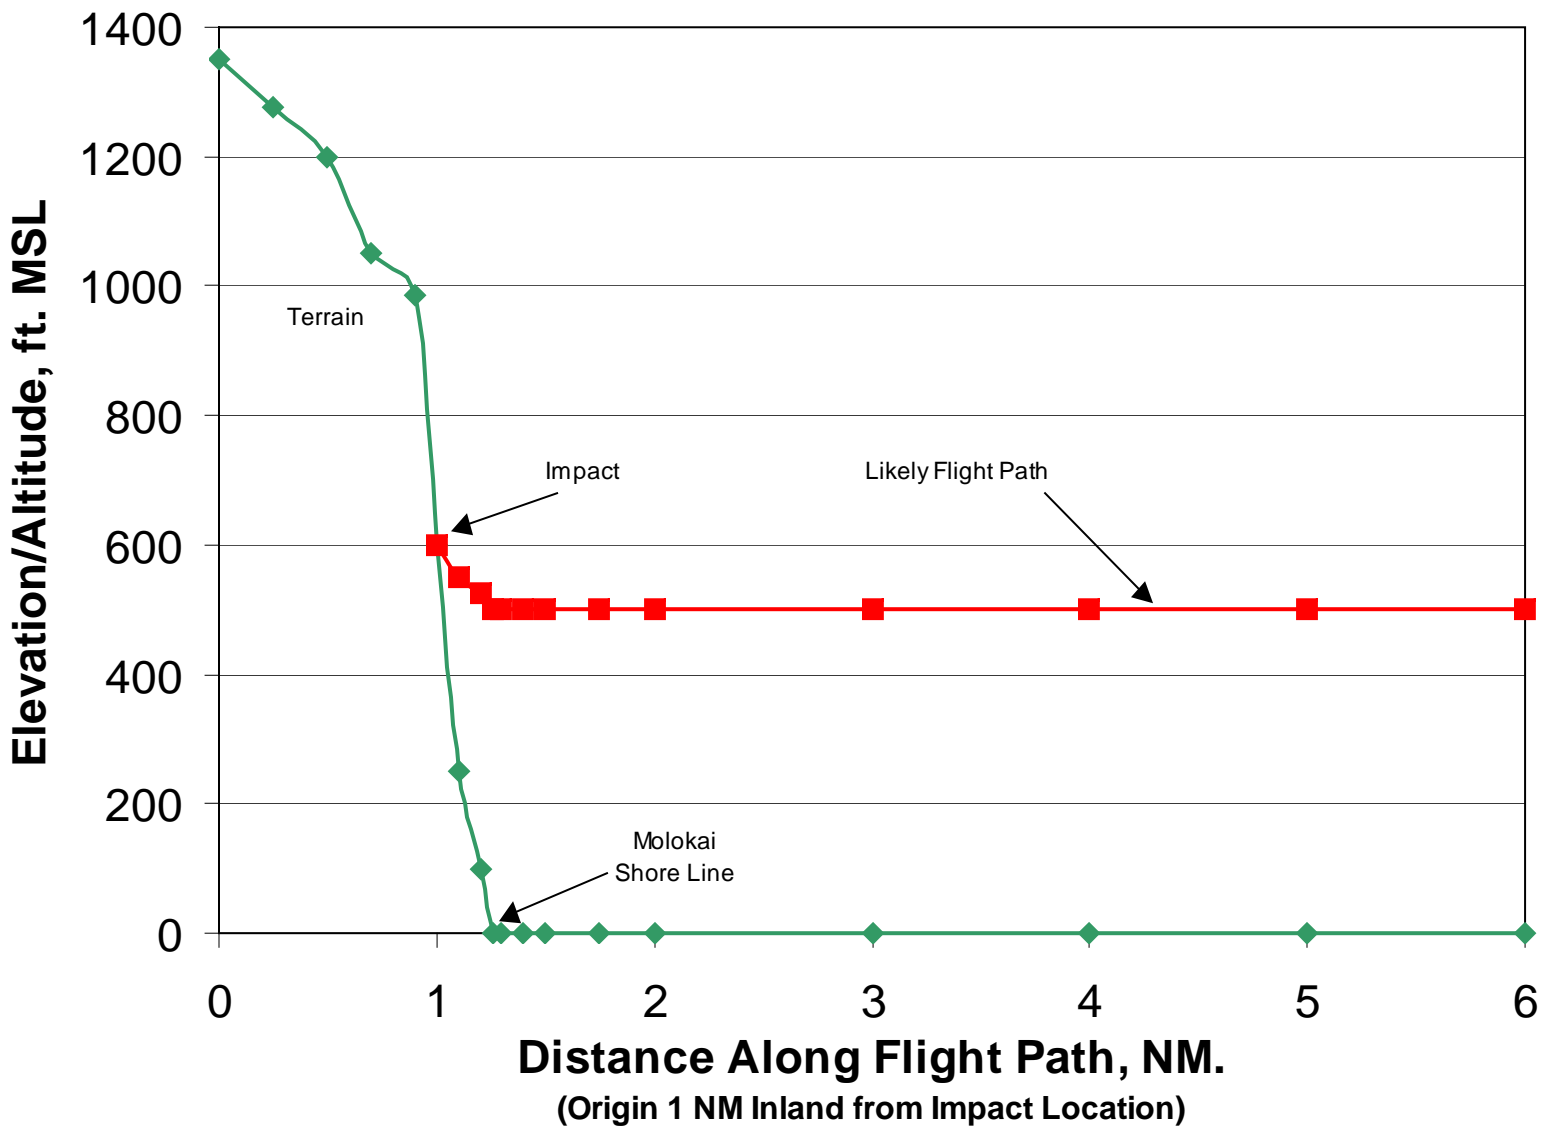
Radar plots of flight 1712 show that it climbed to an altitude of about 1000' MSL following takeoff, then descended to 500' MSL at a point about five miles from the Molokai coast. It is likely the aircraft encountered the localized weather at this point and descended below the cloud ceiling to maintain visual contact with the terrain as is required under visual flight rules. At a point about two miles southeast of Halawa Point, the aircraft turned on a heading of 260° magnetic. The crew made this turn intending to fly their regular route parallel to and just offshore from the north coast of Molokai. However, because of limited visibility, they made this turn prematurely, heading the aircraft directly towards very steep terrain on Halawa Point. Lacking visual references, they were unable to see the terrain ahead until it was too late. (16)

N707PV not equipped with FDR, CVR or GPWS. Table 7 presents altitude and elevation information for this accident. This information is presented graphically in Figure 6.

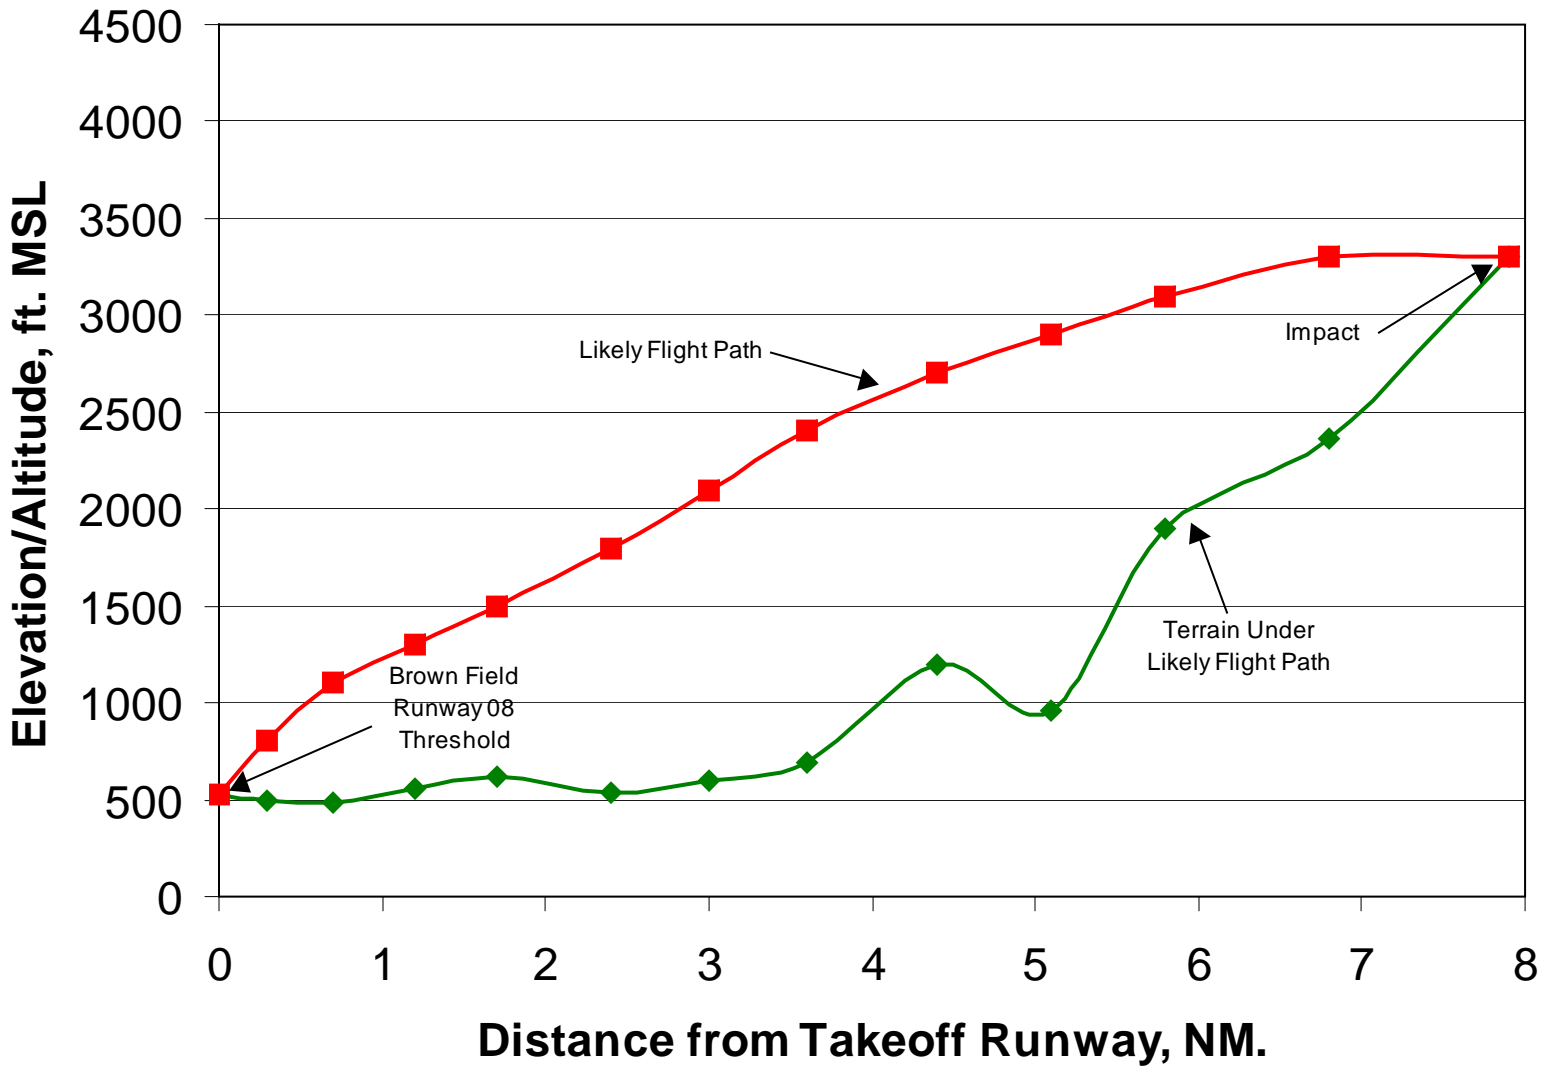
Figure 7.  
San Diego, CA -- HS-125 -- N831LC -- 3/16/91

Because a late night departure was planned, the aircraft had been positioned at Brown Field on the outskirts of San Diego due to a noise curfew in effect at San Diego-Lindbergh field. While waiting for his passengers to arrive, the pilot, who was unfamiliar with local procedures and terrain, had three separate conversations with the local Flight Service Station (FSS). During these conversations, the FSS specialist suggested it would save time if the flight departed under visual flight rules and picked up its IFR clearance once airborne. The pilot indicated reluctance to climb through 3000' MSL without an IFR clearance, as that would involve flight into the San Diego Terminal Control Area (TCA) whose "floor" was 3000' MSL. The pilot then stated: "... so I would be better off if I headed right northeast and stayed down ... below three thousand." The FSS specialist replied "That'll be fine." This was a fatal mis-communication: the pilot had been referencing 3000' MSL, while the FSS specialist understood the pilot's altitude reference as 3000' above ground level. (17)

Radar data indicate the flight took off normally and leveled off at approximately 3300' MSL. The pilot had filed an IFR flight plan, but due to a delay in takeoff, this flight plan had expired. Without IFR clearance, the flight could not climb into the San Diego TCA without violating flight rules. Responding to the pilot's request for IFR clearance, the San Diego TRACON controller indicated N831LC's flight plan had "clocked out" but that he would "put it right back in." Shortly afterward, the aircraft impacted Otay Mountain. Because terrain in this location is uninhabited and unlit, the crew of N831LC did not see the mountain until it was too late to avoid impact. (18)

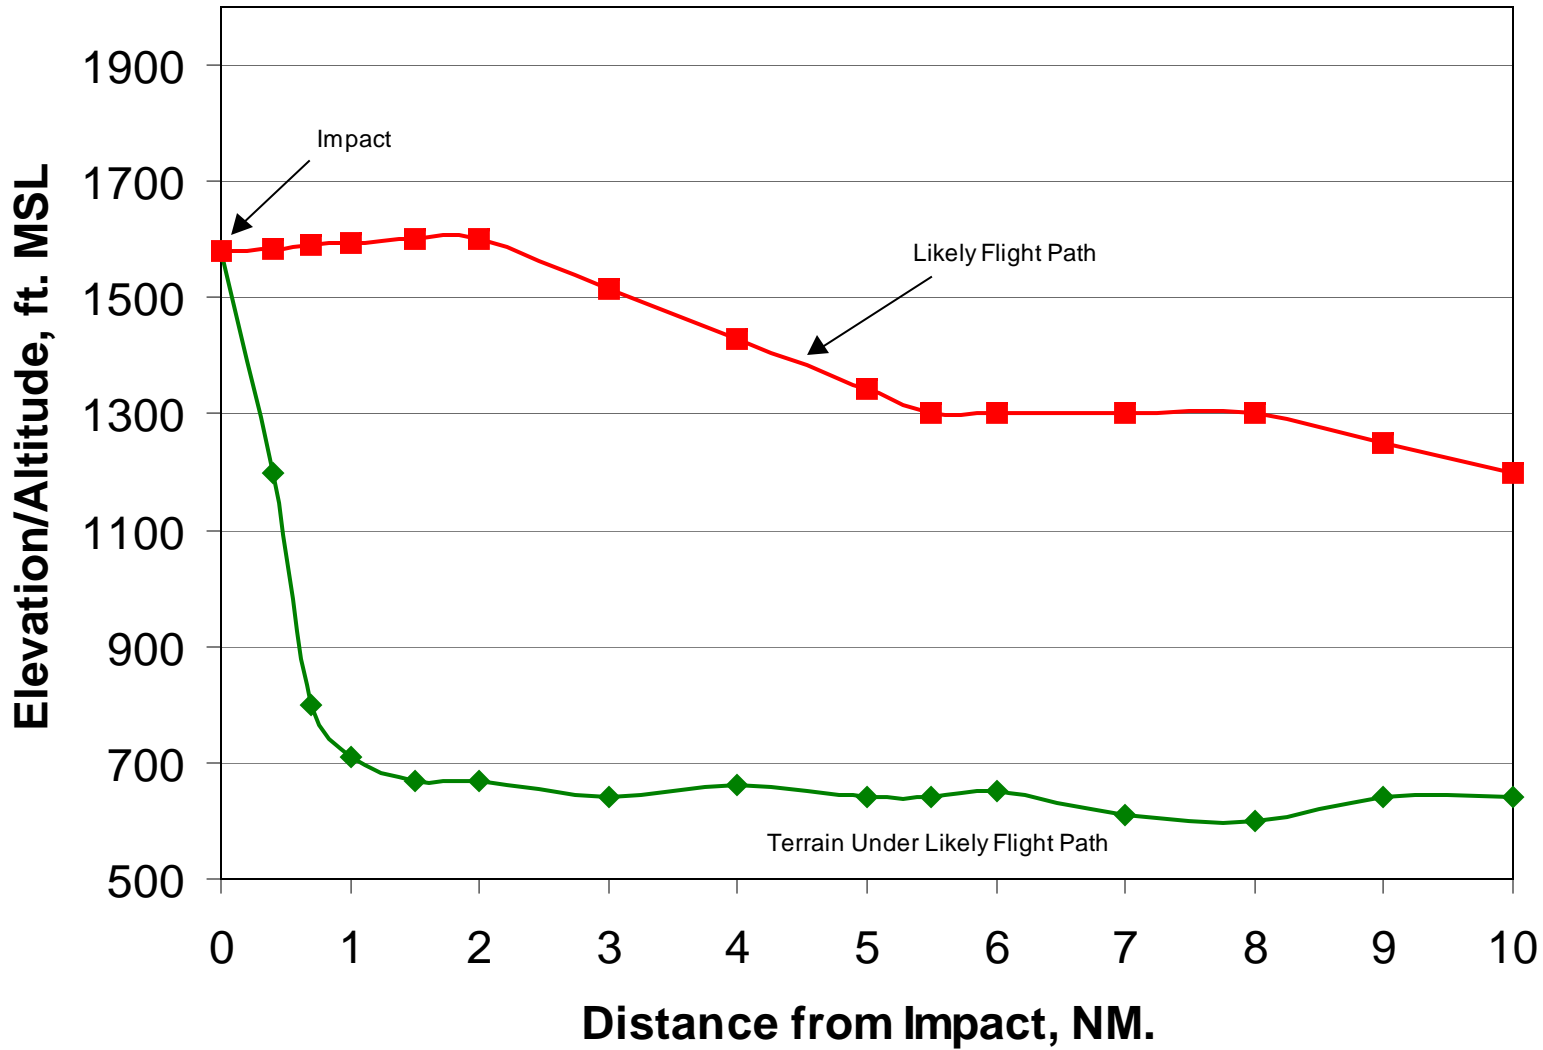
Figure 8.

The Rome accident involved a Beechcraft Be-400 turbojet owned by Bruno's, Inc., a regional grocery store chain, on a business flight from Rome to Huntsville, AL. The aircraft impacted Lavender Mountain, the highest terrain within a 5 NM radius of the airport, shortly after takeoff. Impact occurred at the 1580' MSL level, approximately 120' below the summit, on a heading of 025° magnetic. The aircraft was in cruise configuration. All nine persons aboard were killed. Weather in the accident vicinity was classified as daylight, IMC. The cloud ceiling obscured the tops of the mountains in the area.

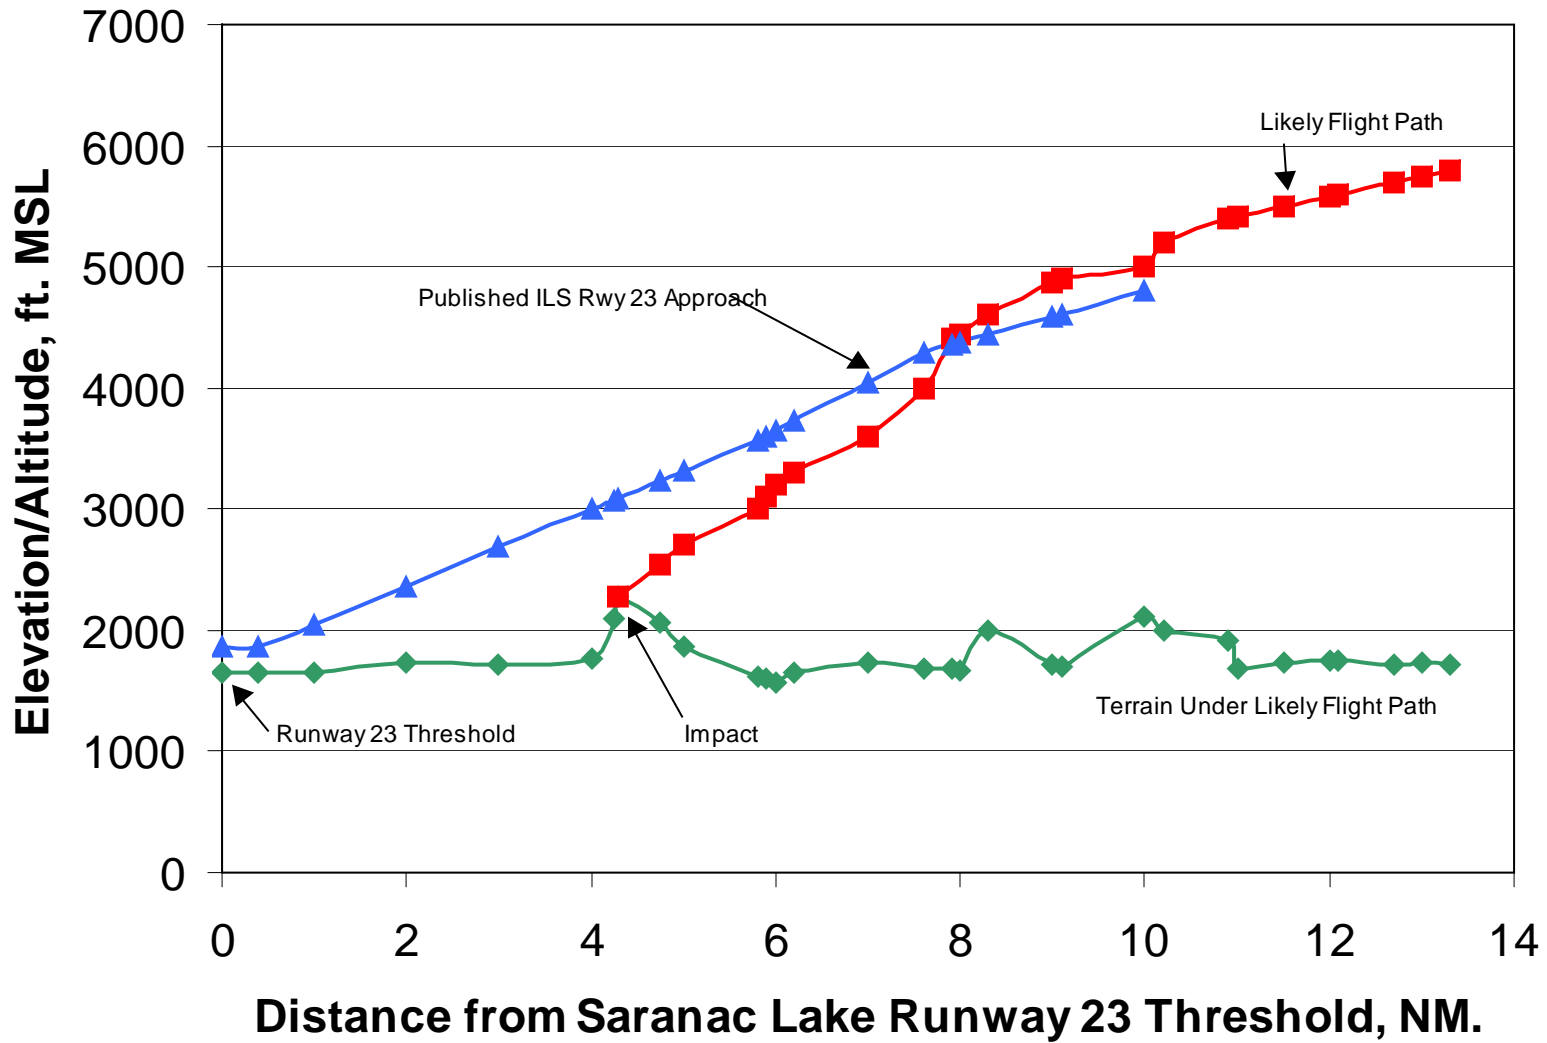
Figure 9.  
Gabriels, NY -- Be-1900C -- N55000 -- 1/3/92

The Gabriels accident involved Commutair Flight 4821, a Beechcraft Be-1900C turboprop, on a regularly scheduled FAR Part 135 commuter flight between Plattsburgh, NY, and Saranac Lake, NY. The aircraft impacted Blue Hill, approximately 4.3 NM from the destination airport, at the 2280' MSL elevation, about 110' below the summit, on a heading of 230° magnetic, on course for runway 23 at Saranac Lake. Four persons were on board; two were killed and two suffered serious injuries. At impact, gear and flaps were retracted. Weather in the accident vicinity was classified as dark night, IMC.

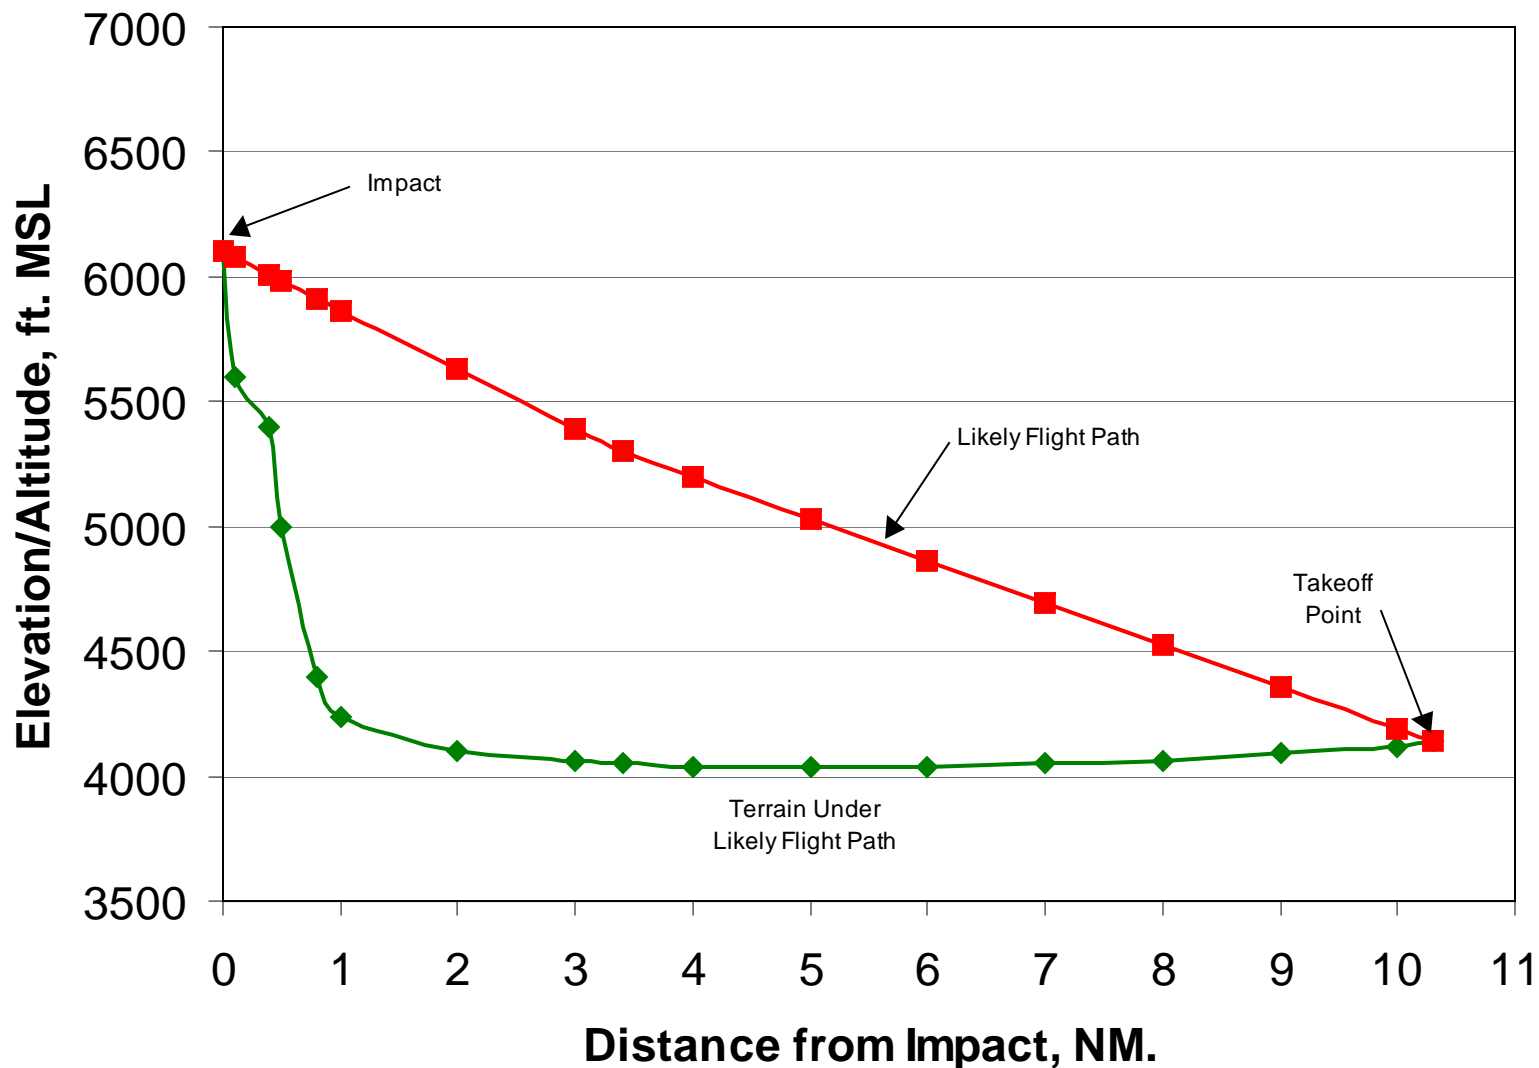
Figure 10.

The Alamogordo accident involved a privately owned Mitsubishi MU-2B-30 turboprop on a personal FAR Part 91 flight from Alamogordo to Burnet, TX. Shortly after takeoff, the aircraft impacted a ridge in the Sacramento Mountains to the east of Alamogordo at the 6100' MSL level, approximately 1500' below the summit, on a heading of 035° magnetic. The aircraft was in cruise configuration; all six persons aboard were killed. Weather in the accident vicinity was classified as dark night, VMC.

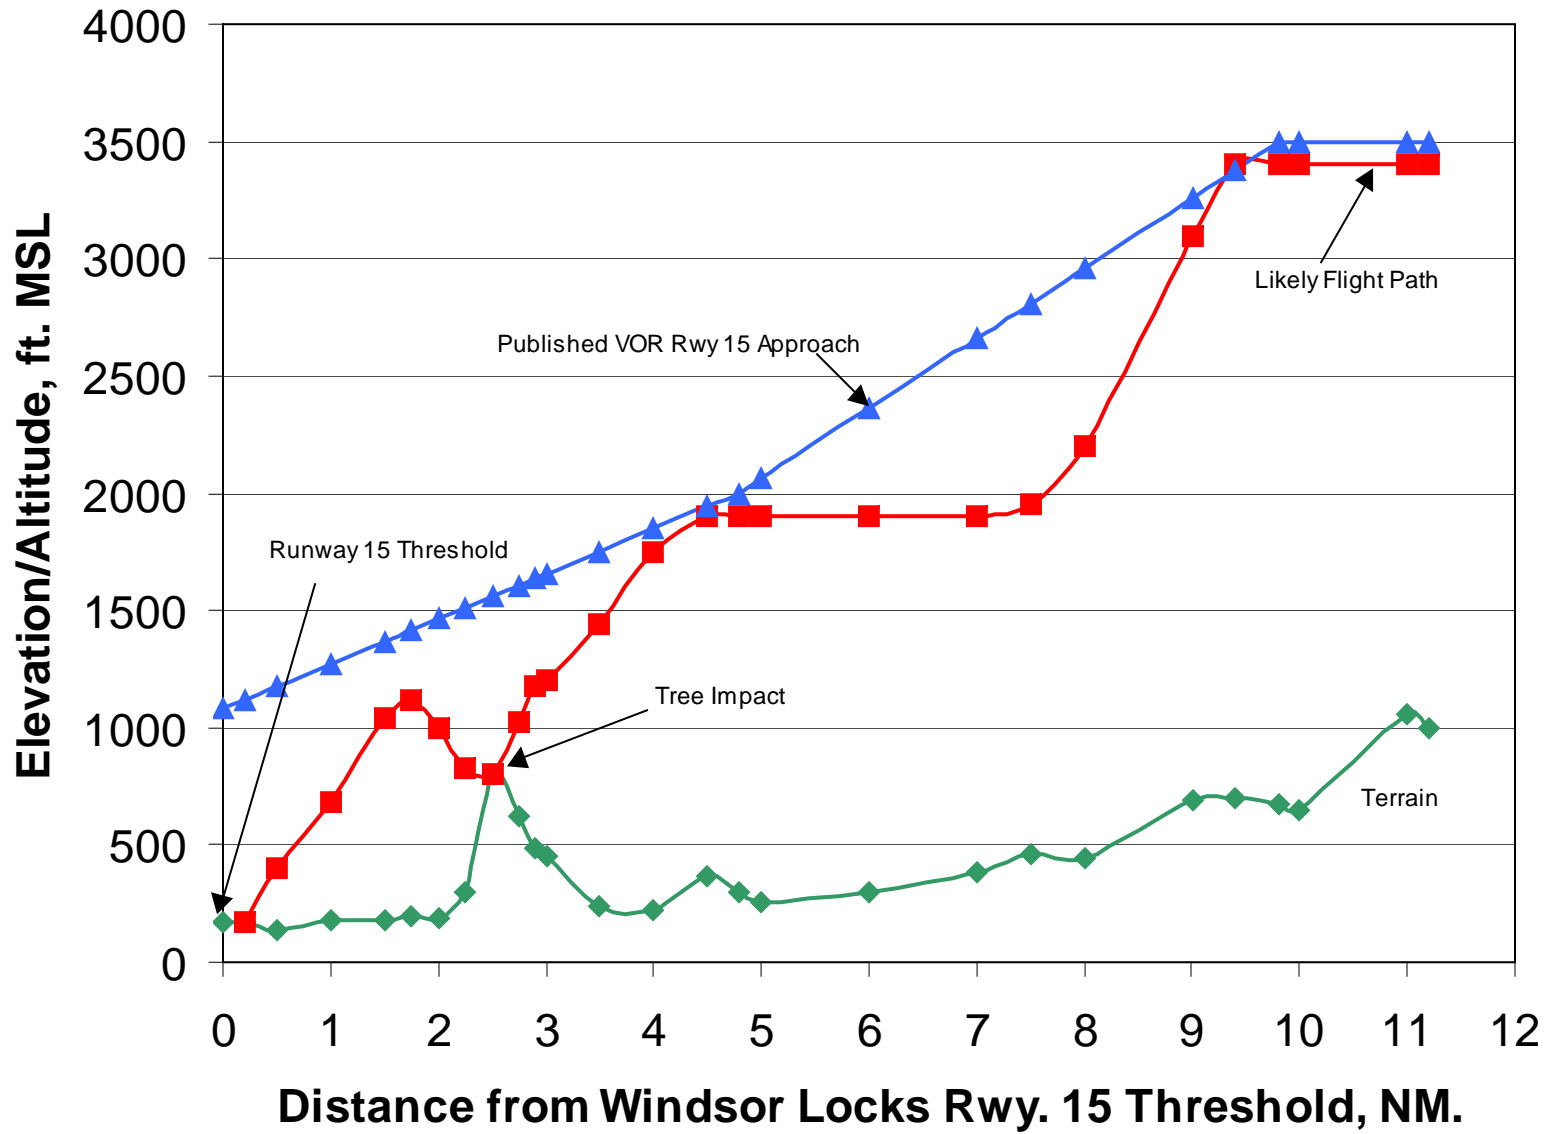
Figure 11.  
East Granby, CT -- MD-83 -- N566AA -- 11/12/95

The East Granby accident involved American Airlines flight 1572, a McDonnell-Douglas MD-83 turbojet on a regularly-scheduled FAR Part 121 flight from Chicago, IL to Hartford-Bradley Field, Windsor Locks, CT. On a VOR approach to Runway 15 at Windsor Locks, the aircraft impacted trees on the summit of a ridgeline approximately 2.5 NM northwest of the runway threshold. Impact occurred on a heading of 149° magnetic, on course for Runway 15. Although one of its engines failed and the other engine and control surfaces were damaged, the crew managed to keep the aircraft airborne and made an emergency landing in the safety overrun area for Runway 33 (the opposite end of Runway 15), destroying an antenna array in the process. Because the crew was able to land the aircraft safely, only one passenger suffered minor injuries in the emergency evacuation process which commenced once flight 1572 had come to a stop. Weather in the accident vicinity was classified as dark night, IMC, and was a strong contributing factor. An extremely powerful cold front was passing through the area at the time, and atmospheric pressure was dropping rapidly, with high winds, windshear and heavy rain. Post-crash investigation showed the pilots had not received an updated weather briefing and had not set their altimeter to the correct barometric pressure reading at the time of the accident, which caused their altimeter to give falsely high readings. (23)
