# Investigation of Controlled Flight into Terrain

## Descriptions of Flight Paths for Selected Controlled Flight into Terrain (CFIT) Aircraft Accidents, 1985-1997

Project Memorandum  
DOT-TSC-FA9D1-99-01  
March 1999

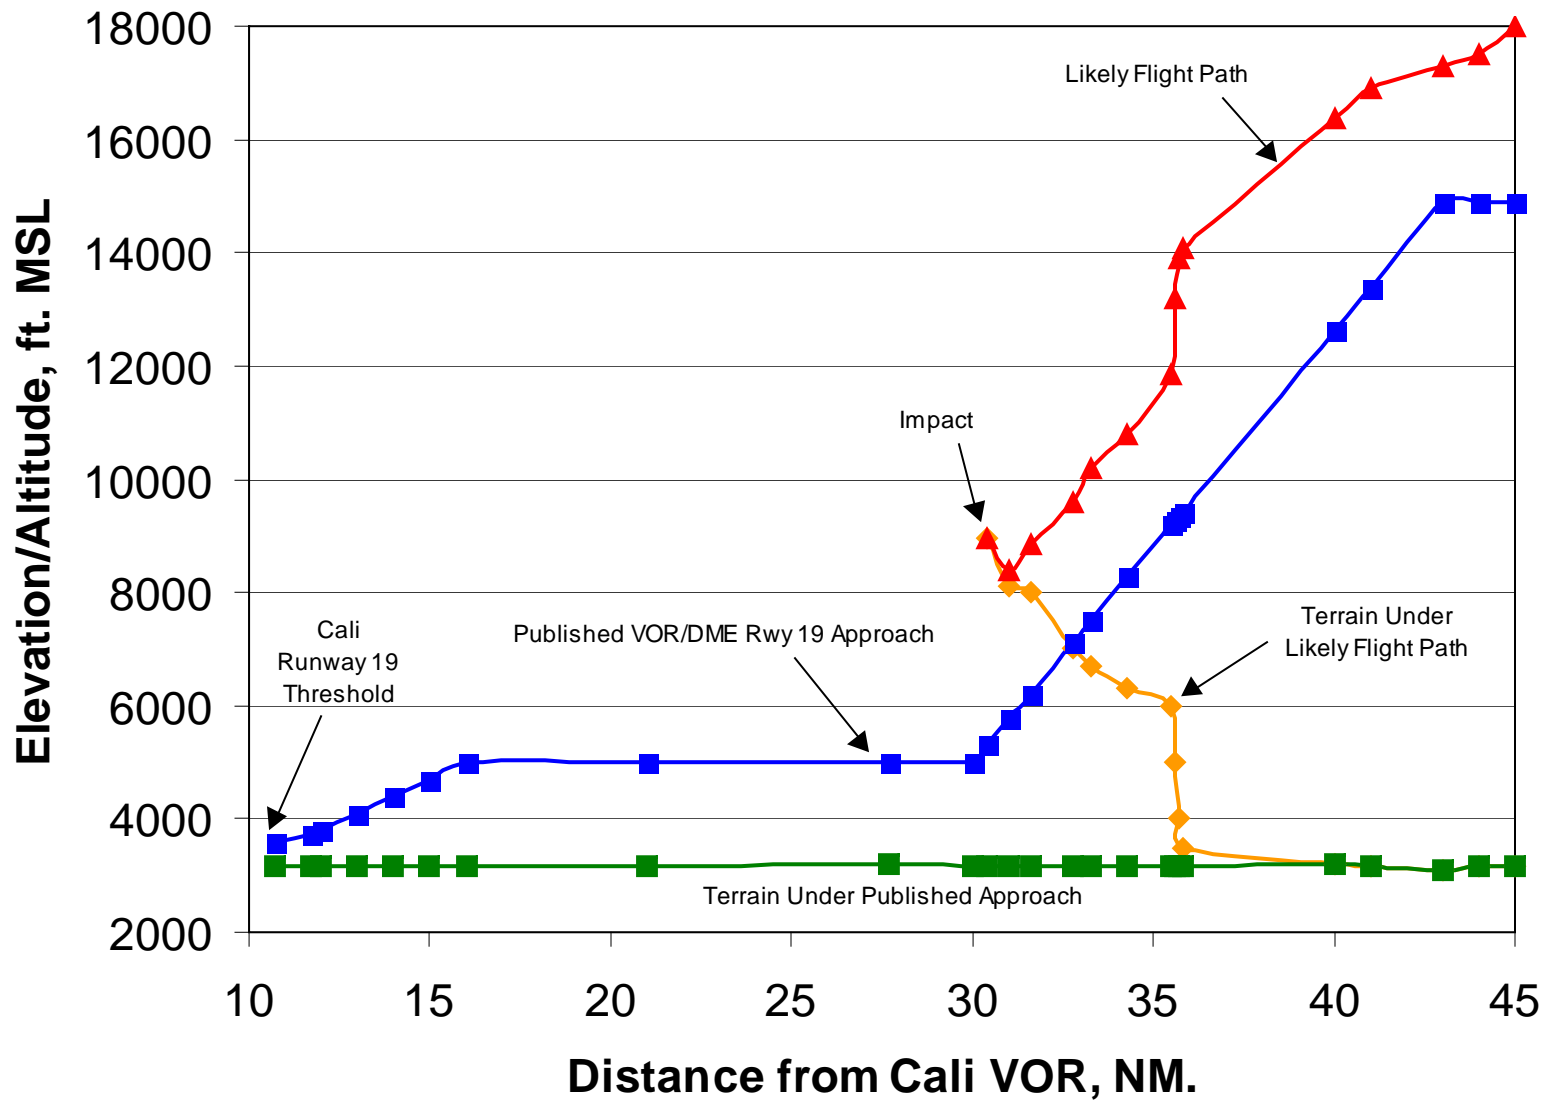
Figure 12.  
Buga, Colombia -- B757-200 -- N651AA -- 12/20/95

The Buga accident involved American Airlines flight 965, a Boeing B-757-200 turbofan on a regularly scheduled FAR Part 121 flight from Miami, FL to Cali, Colombia. The aircraft impacted a ridge on San Jose Mountain, which rises above the town of Buga to 12,900' MSL at its highest point, at approximately the 8960' elevation, on a heading of 221° magnetic, while the aircraft was in approach configuration. Impact was 30.4 NM from the Cali VOR facility. Of the 167 persons aboard, only four passengers survived with serious injuries. Weather in the accident vicinity was classified as dark night, VMC.

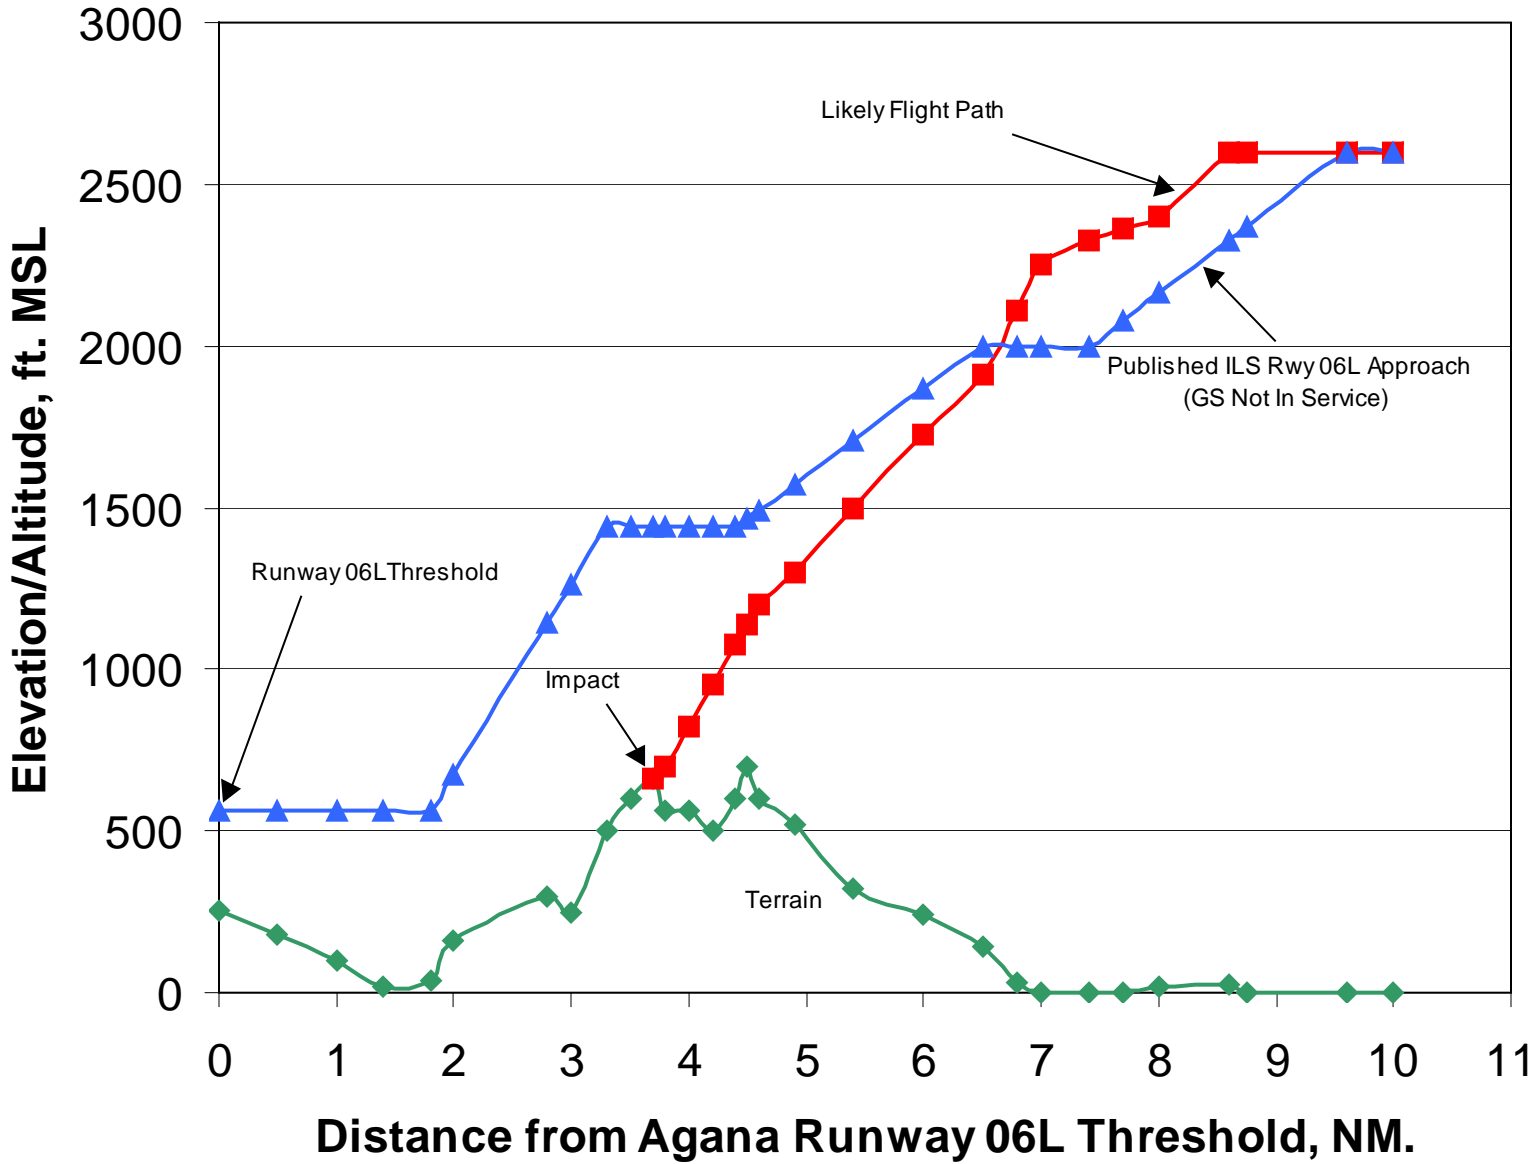
Figure 13.

The Nimitz Hill accident involved Korean Airlines flight 801, a Boeing B-747-300 turbofan, on a regularly-scheduled FAR Part 129 flight from Seoul, South Korea to Agana, Guam. The aircraft, on an ILS approach to Runway 06L at Guam's Won Pat Airport, impacted Nimitz Hill, a 700' MSL peak, at the 662' elevation, and 3.7 NM from the runway threshold. At impact, the aircraft was in landing configuration on a heading of 063° magnetic, on course for Runway 06L. Of the 254 persons aboard, 229 were killed, and 25 survived with serious injuries. Weather in the accident vicinity was classified as dark night, IMC.
