Investigation Report

Type of Occurrence:	Accident
Date:	14 February 2010
Location:	Near Reinhardtsdorf-Schöna
Aircraft:	Airplane
Manufacturer / Model:	Cessna 550 B Citation Bravo
Injuries to Persons:	Two persons fatally injured
Damage:	Aircraft destroyed
Other Damage:	Environmental damage
Information Source:	Investigation by BFU
State File Number:	BFUCX001-10

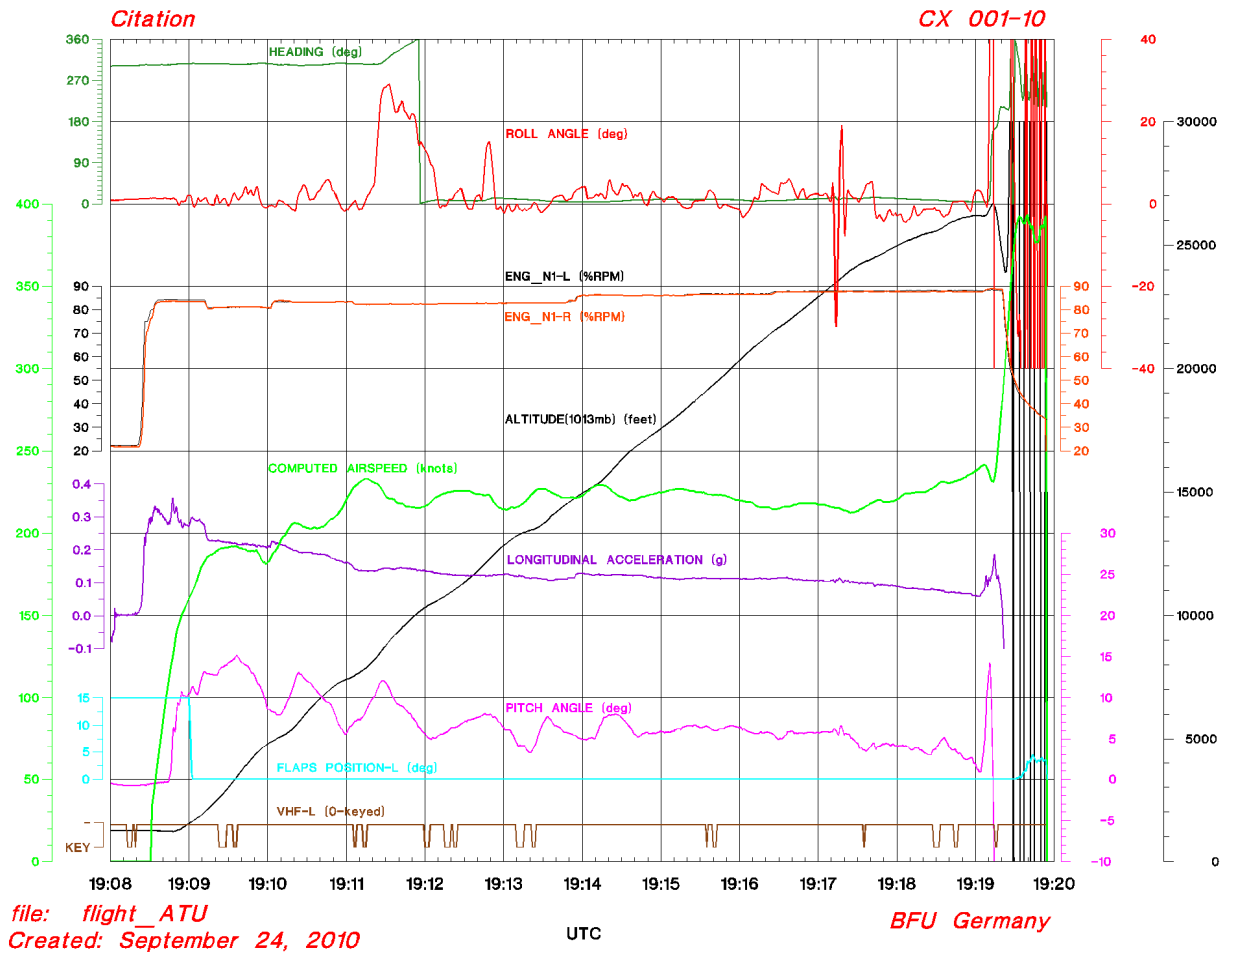
Image 1: Entire flight

Diagram 1 shows the entire flight (time in UTC) and diagram 2 shows the flight from 1918:30 UTC on.

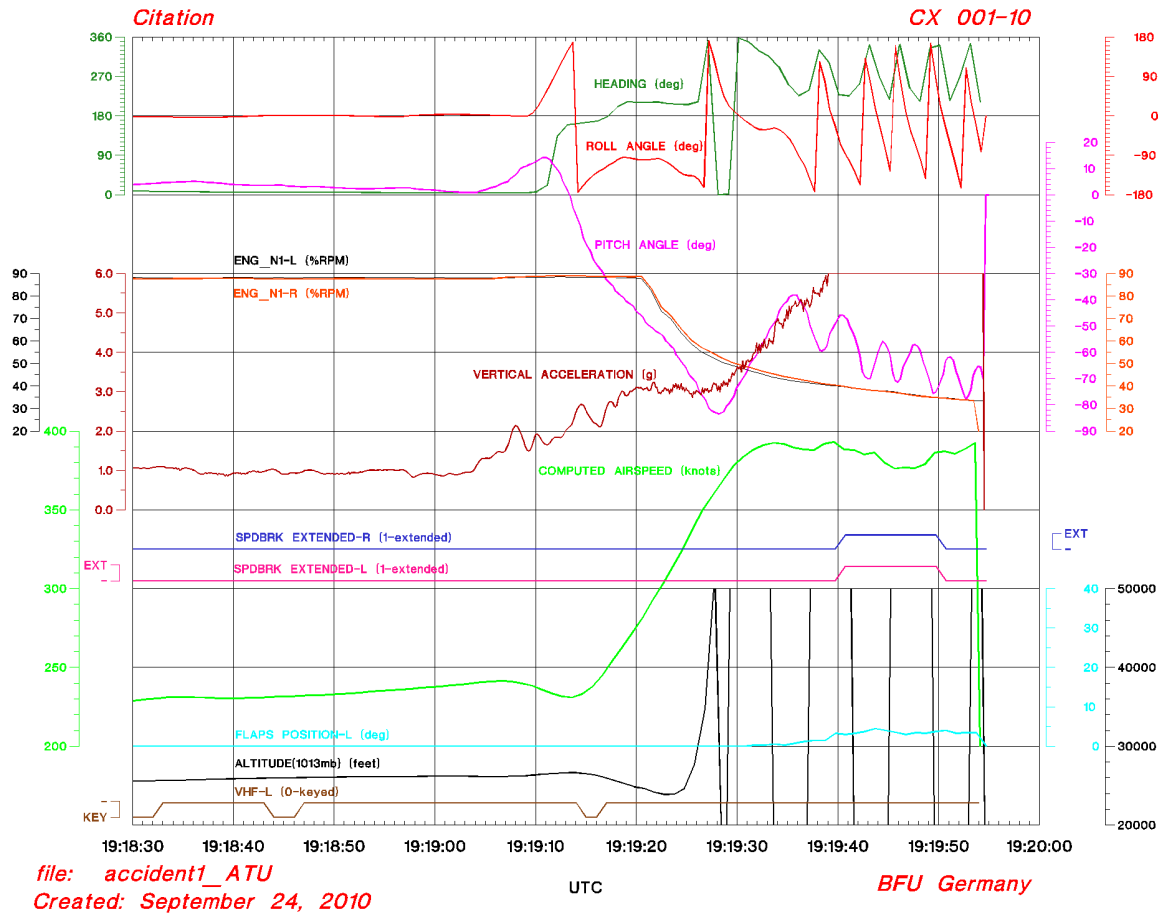
Image 2: Initiation of the roll and the consequences

At 2019:00 hrs the airplane levelled off in FL270, at 2019:05 hrs the airplane nose moved upward until a pitch angle of about 14° was reached. At 2019:09 hrs the aircraft began to roll about its longitudinal axis to the right. Within 4 seconds the airplane reached the inverted flight attitude and in another 4 seconds it rolled another 90°. Simultaneously the heading changed right toward the east, then toward the south and finally toward the west. During the roll the pitch angle decreased to almost -85° which is almost a vertical nose dive. The computed airspeed increased significantly.

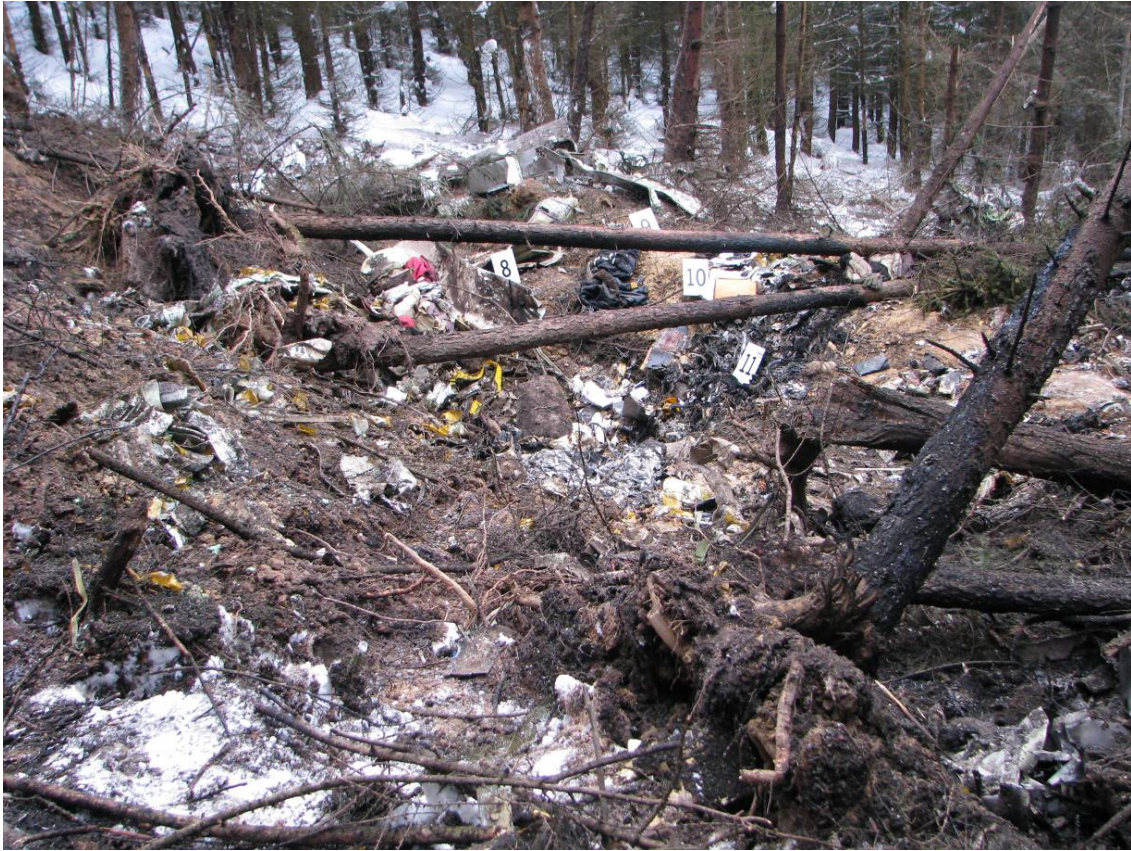
Photo 1: BFU

The impact crater had a depth of approximately two meters and an expansion of about 16 m x 16 m. Most of the wreckage was in the crater or near its vicinity. The wreckage distribution was 180° (toward the south). Several heavier wreckage parts were found about 120 metres from the main wreckage. In the immediate vicinity of the impact crater traces of an impact fire were found. The snow around the accident site was soaked with fuel. Due to the destruction only bigger and more solid components, such as the engines, the two main landing gears and the tail section, could be identified during the field investigation. For further examination the parts were salvaged and transported to the BFU.

Accident site

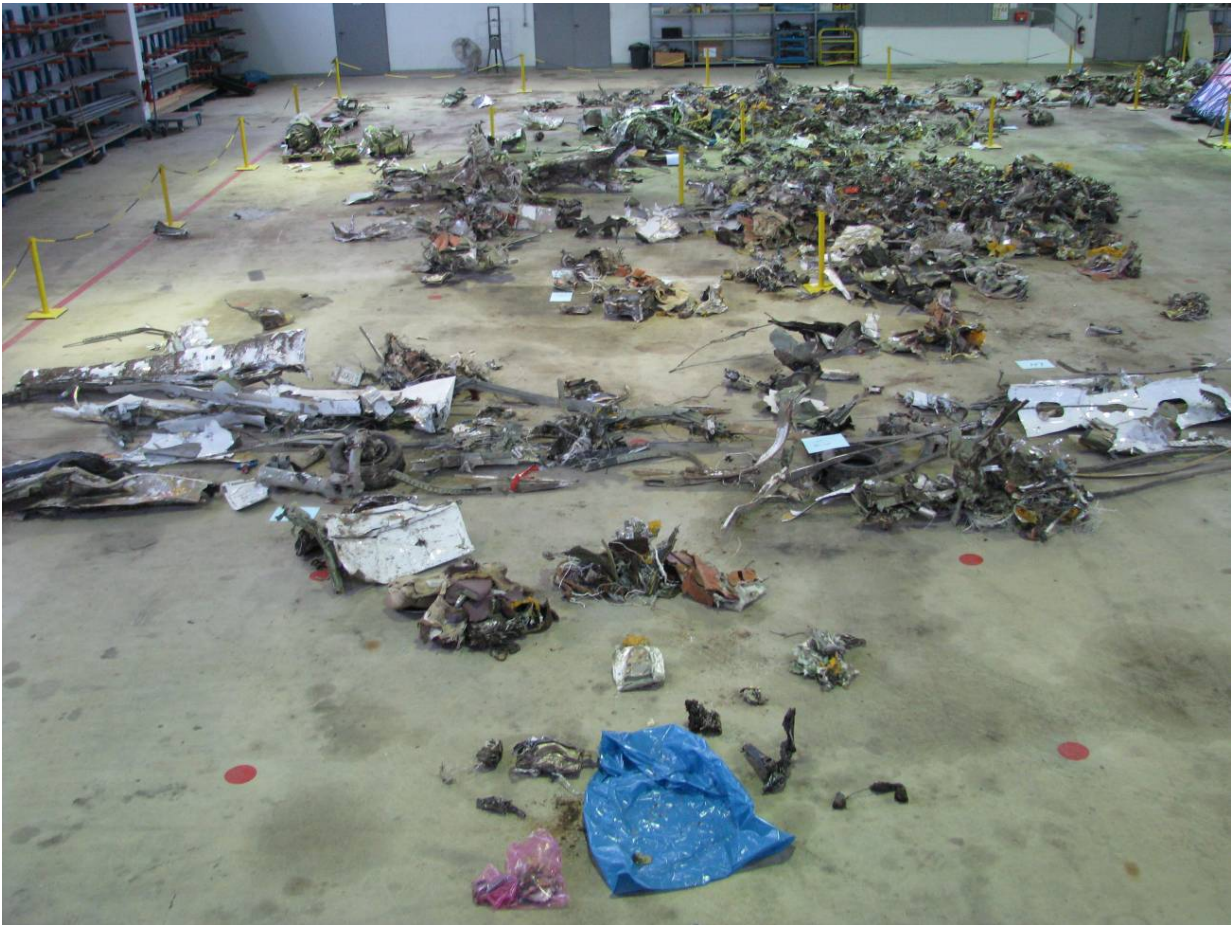
Photo 2: BFU

For the examination of the wreckage parts, the wreckage was laid out in the BFU hangar where the completeness of important structural parts and rudder surfaces was determined.

The situation found at the accident site and the conducted investigations as to the completeness of all significant aircraft components have shown that even though such manoeuvres were not intended for this type of aircraft, up until the impact the aircraft structure remained intact. Therefore, the conclusion can be drawn that the aircraft endured the loads while airborne.

Wreckage parts in the BFU hangar
