REPORT

SL 2013/17

REPORT CONCERNING AIR INCIDENT DURING APPROACH TO OSLO AIRPORT GARDERMOEN ON 19 DECEMBER 2008 WITH AIRBUS A320-214, VP-BWH

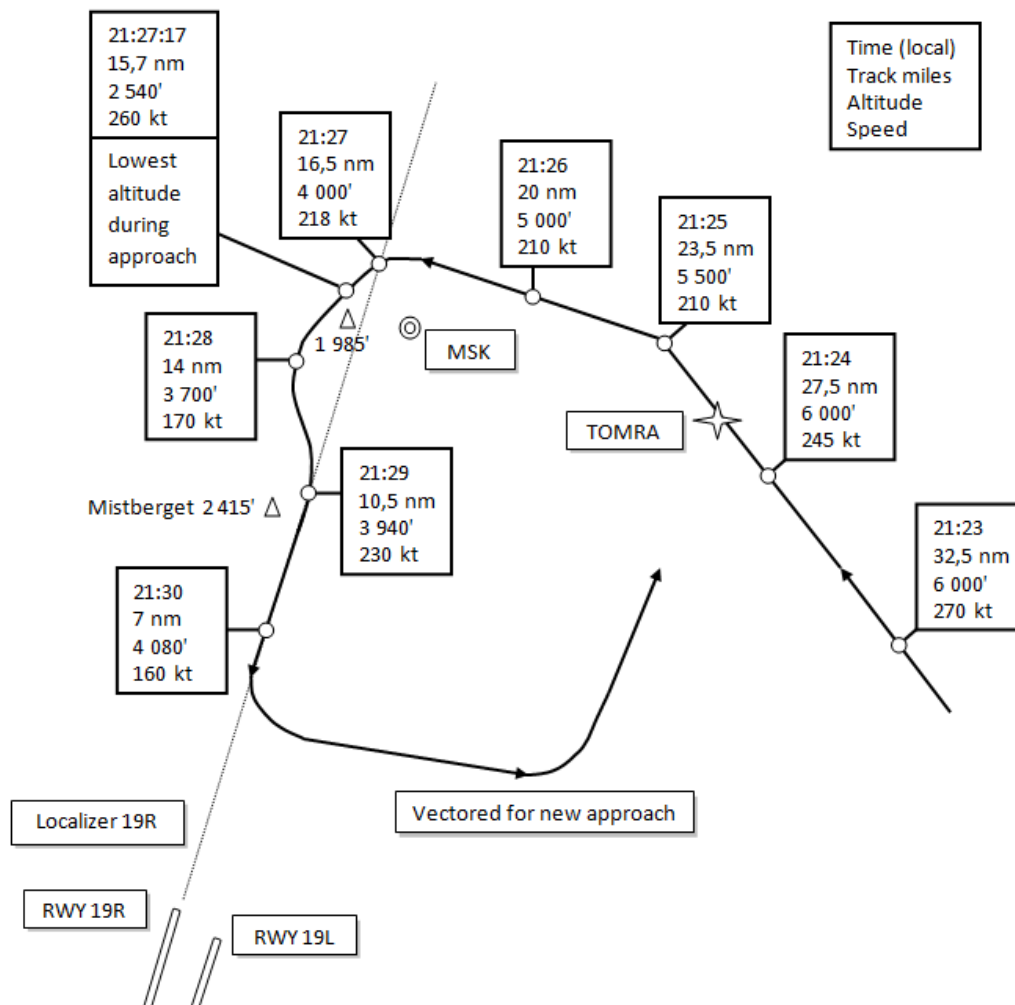
Figure 2: The estimated flight path based on radar data and flight data recorder.

At 21:25:14 hrs, DIR repeated that runway 19R had to be used for landing and that the change was due to weather conditions at the airport. At 21:25:50 hrs, AFL211 acknowledged that they had understood the new instructions. AFL211 then had about 20 NM left to fly before landing at Gardermoen. The aircraft's position was approximately 4 NM from localiser 19R. This means that the crew had about one minute to go before the aircraft would turn onto the final approach (see Figure 2 at 2126 hrs). The aircraft was configured with "Flaps 1" and had a speed of 210 kt. Maximum speed for the configuration is 230 kt.

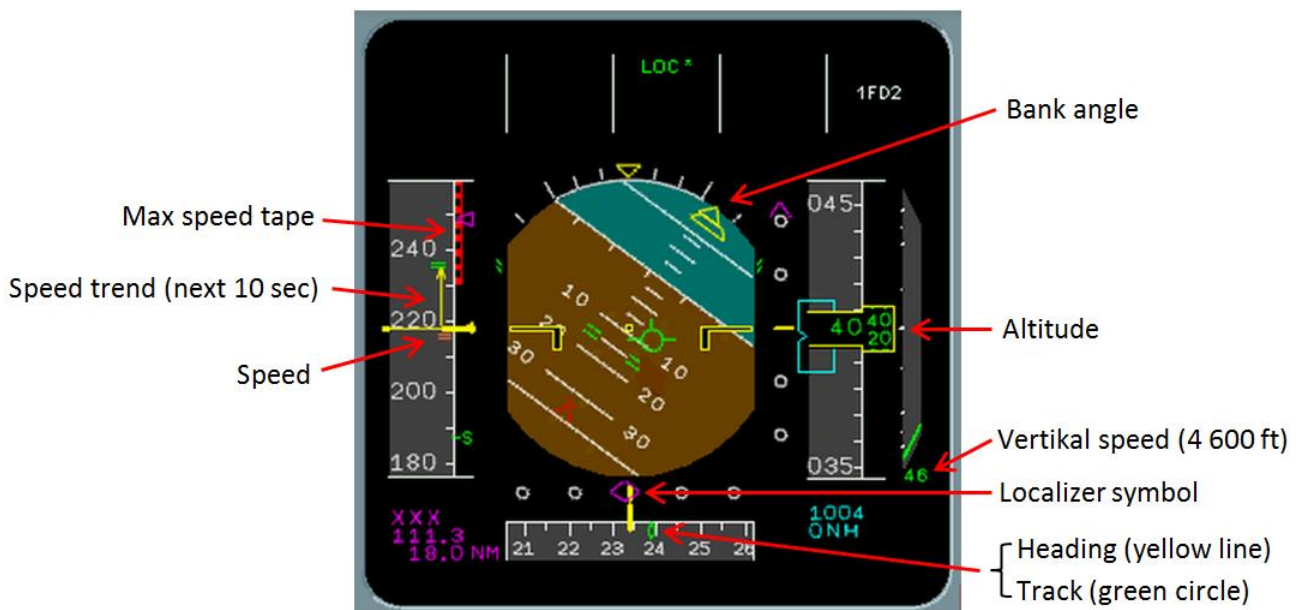
Figure 3: Still picture from animation based on data from the flight data recorder (FDR).

When the commander deactivated the autopilot, the aircraft was at 4 380 ft with a 30° bank to the left and a descent rate of 2 200 ft/min. When the aircraft passed 4 000 ft a few seconds later, the bank was approximately 35° and the descent rate had increased to 4 600 ft/min (see Figure 3). At the same time, the aircraft was flying through the localiser with a heading of approximately 240°, still in a left turn to follow the localiser which has an inbound approach course of 195°.

The aircraft continued with a descent rate which maxed out at 5 800 ft/min before the commander made corrections which reduced the rate. The speed increased due to the high descent rate, and the first officer has explained that he reacted by calling out “speed-speed” to notify the commander that the speed was approaching maximum permitted speed limit. He did not recognise the absence of the commanders’ response as a sign of incapacitation and therefore did not intervene by taking controls. However flight data recorder shows that the co-pilot on two occasions briefly introduced back stick force during the pullout. The EGPWS² terrain warning system was activated: “TERRAIN AHEAD – TERRAIN AHEAD”.

The aircraft was maneuvered to wings level and after a while the commander was able to recover the aircraft back to the cleared altitude of 4 000 ft. The altimeter showed that the aircraft had been down to 2 540 ft at the lowest before it started climbing again. The radar altimeter showed that the lowest altitude above the terrain during the incident was 2 030 ft. About 17 seconds elapsed from when the aircraft passed the cleared altitude of 4 000 ft and until it reached the lowest altitude of 2 540 ft. During this time, the speed increased to 260 kt which is 30 kt higher than the maximum permitted for the configuration with “flaps 1”.
