**SERVICE INQUIRY INVESTIGATION INTO AN INCIDENT INVOLVING VOYAGER ZZ333  
ON 9 FEB 14**

## MAA DG/SI/01/14 – CONVENING ORDER FOR SERVICE INQUIRY INTO AIRCRAFT OCCURRENCE INVOLVING VOYAGER ZZ333 ON 9 FEB 14 AT 1549Z

**PART 1.3 – NARRATIVE OF EVENTS**

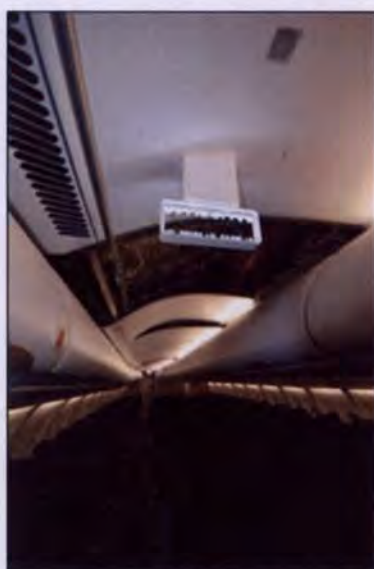
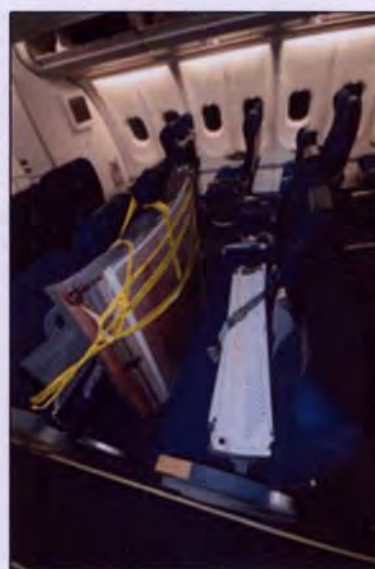
1.3.26 The damage to the aircraft comprised: 50 in-flight entertainment sockets broken or headphone pins sheared inside; seven ceiling panels dented; five florescent light tubes broken; five hand rails damaged; two seat belt brackets bent and one emergency exit sign broken (adjacent to door 2R). Initially, the rear facing lens of the exit sign at door 2R was missing (Figure 1), but it was subsequently found and put back in place for landing. Its cracked frame was sufficiently stable to accept and hold the replaced lens in order that the emergency function was not compromised for the landing.

**Figure 1: Internal damage to ZZ333.**
