**OFFICIAL SENSITIVE – SERVICE INQUIRY**

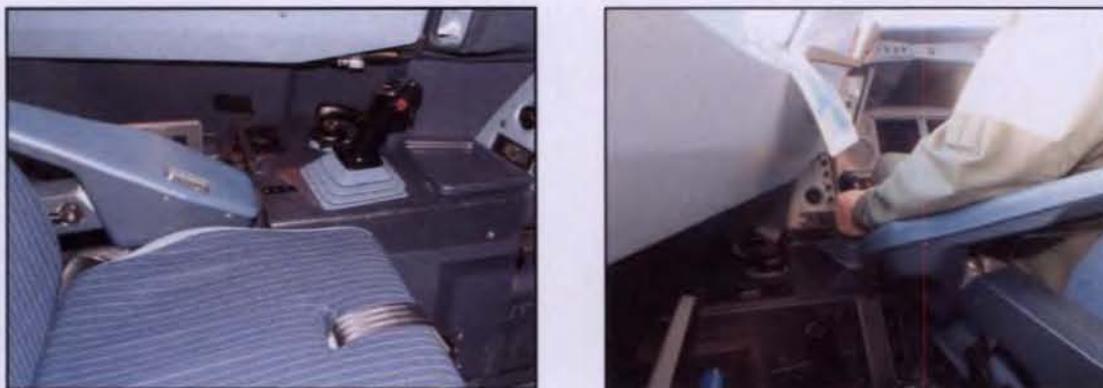
Figure 15: Captain's seat and armrest configuration.

stick, increased the risk of the item becoming jammed. Moving the seat forward against a camera of a similar size to the Captain's with the armrest at different settings (to those in Figure 15) did not result in the side-stick being held forward. **The armrest setting was a contributory factor.**

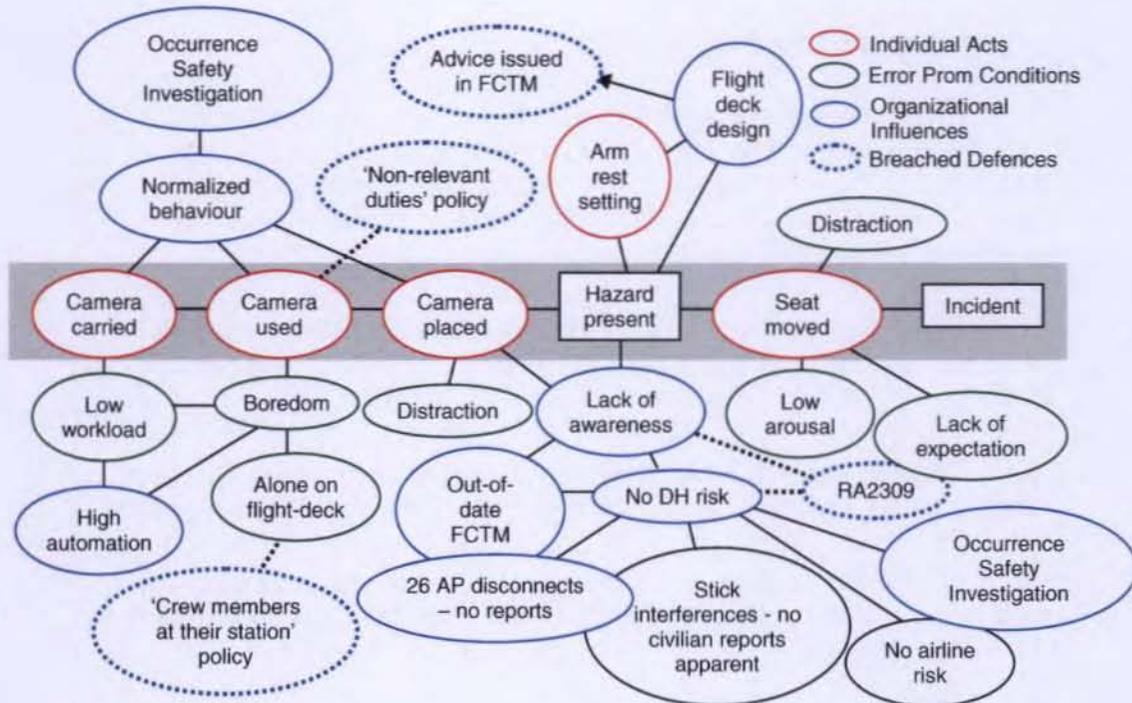
**Figure 10 (Repeated): Diagram of key factors leading to pitch-down command.**

1.4.40 **Summary of factors.** The key factors which made the pitch-down command more likely were summarised as follows:

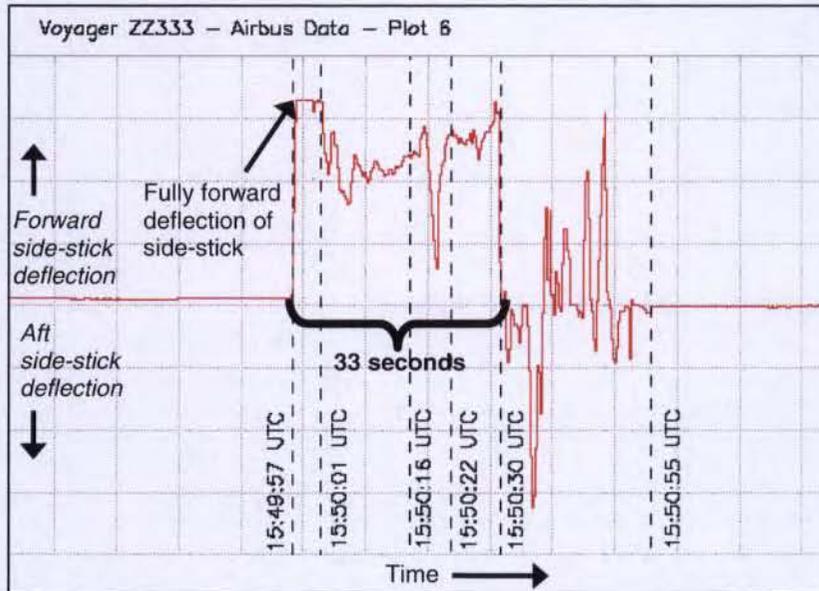
Figure 16: ZZ333 DFDR trace of Captain's side-stick in pitch.

1.4.43 The interference with the side-stick persisted for a total of 33 seconds before the camera became free (illustrated by the bracket in Figure 16). The recovery from the pitch-down command was analysed in three phases: first, the initial response on the flight deck; second, the response of the aircraft; and third, the clearing of the side-stick obstruction.

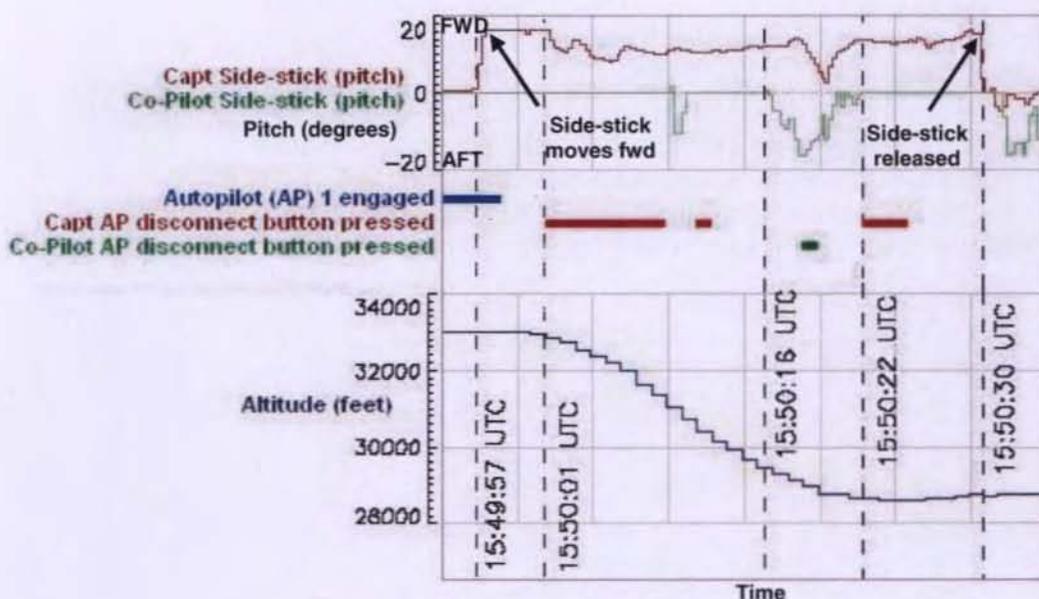
Figure 17: Composite DFDR trace.

1.4.45 Approximately three seconds after the initial pitch-down (1550:01 UTC), the DFDR showed the Captain's side-stick moving rearwards by approximately five degrees from the fully forward position. It was assessed that this movement occurred as a result of the Captain pulling back on the side-stick. The rearward movement achieved, however, was not enough to fully regain control of the aircraft (Figure 17). It was assessed that the side-stick could not be moved fully because, at this stage, the camera and armrest restricted rearward movement. The Captain reported that he interpreted this lack of movement as the side-stick being stuck, thus leading him to believe that the autopilot was engaged.

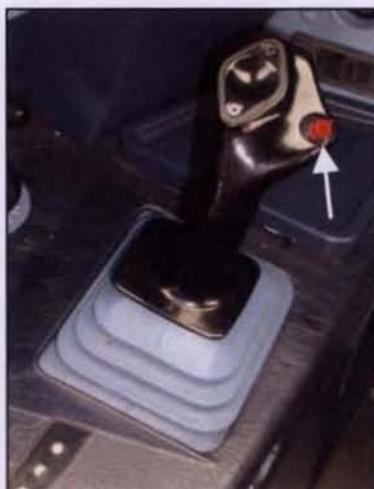
Figure 18: Captain's autopilot disconnect button (indicated by arrow).

1.4.46 The normal method of disconnecting the autopilot is via the side-stick autopilot disconnect button (also known as the instinctive cut-out button), which is located next to the thumb's natural position on each pilot's side-stick (Figure 18). Disconnecting the autopilot using this button triggers an audio warning known as the 'cavalry charge' (because of its distinctive warble); the warning lasts for 1.5 seconds. Disconnecting the autopilot by any other means (for example, by a physical push on the side-stick of at least five deca-Newtons) is classed as an inadvertent disconnection. Such an action also triggers the 'cavalry charge', but as a *continuous* warning, and is accompanied by a flashing red 'master warning' caption in front of the pilot. As the pitch-down command began, a *continuous* 'cavalry charge' sounded and the red 'master warning' caption illuminated to indicate that the autopilot had been disconnected inadvertently.

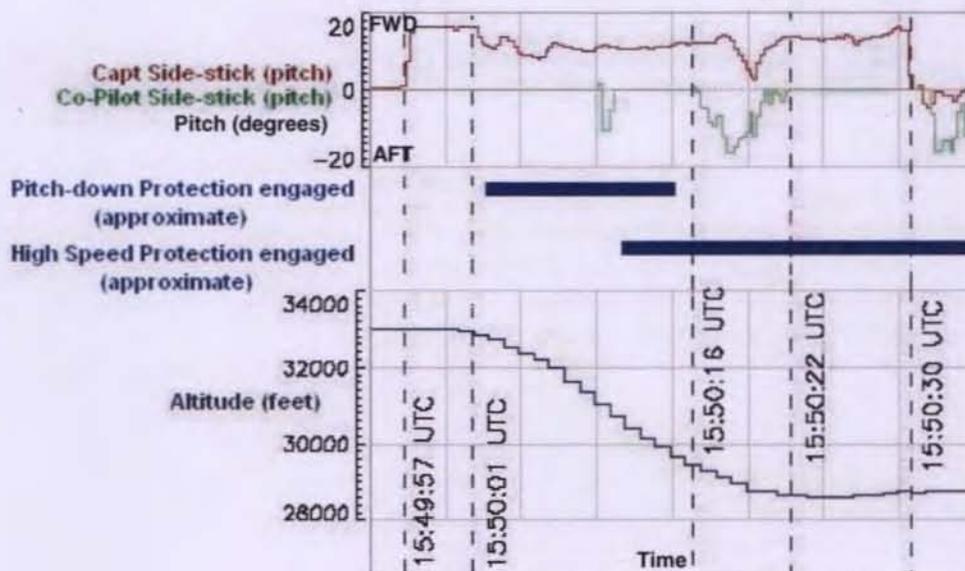
Figure 19: Composite DFDR trace.

altogether at 15 degrees nose-down. The pilots have the authority to override these features by a small margin, but once the protection measures are active both pilots' inputs are limited until parameters fall back within limits. The protection features do not require the autopilot to be engaged. Analysis of the pilots' actions and the aircraft's response during the incident established the following points (Figure 19 refers):

a. Pitch-down protection was triggered approximately three seconds after the pitch-down command. A pitch limit of approximately 17 degrees nose-down was achieved as a result of the Captain's side-stick remaining significantly forward of the neutral position for over 30 seconds. As the 17 degree attitude was approached, the position of the elevators was automatically reduced towards zero.

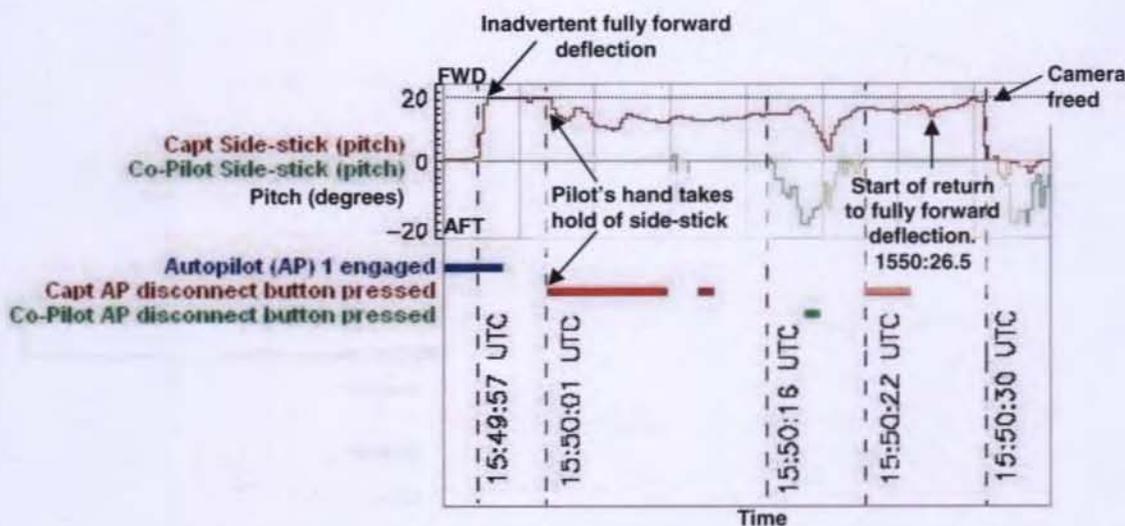
Figure 20: Composite DFDR trace.

1.4.54 Examination of the DFDR/CVR at the point the camera became free produced the following analysis:

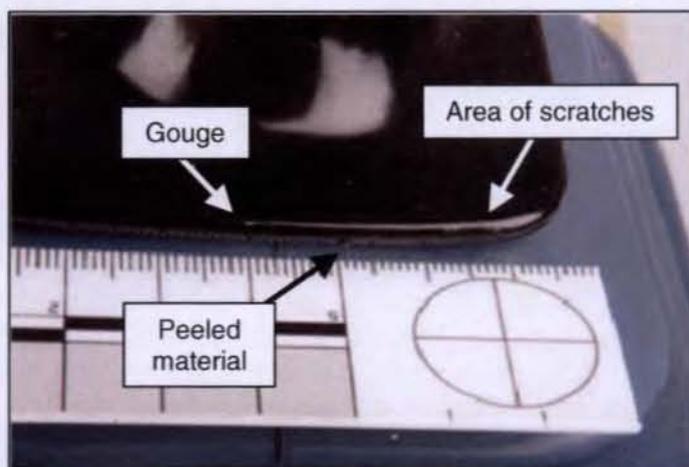
Figure 22: Witness marks on rear right-hand area of side-stick.

hard edge had been pressed into the flange and dragged sideways, peeling away small chunks of material (Figure 22).

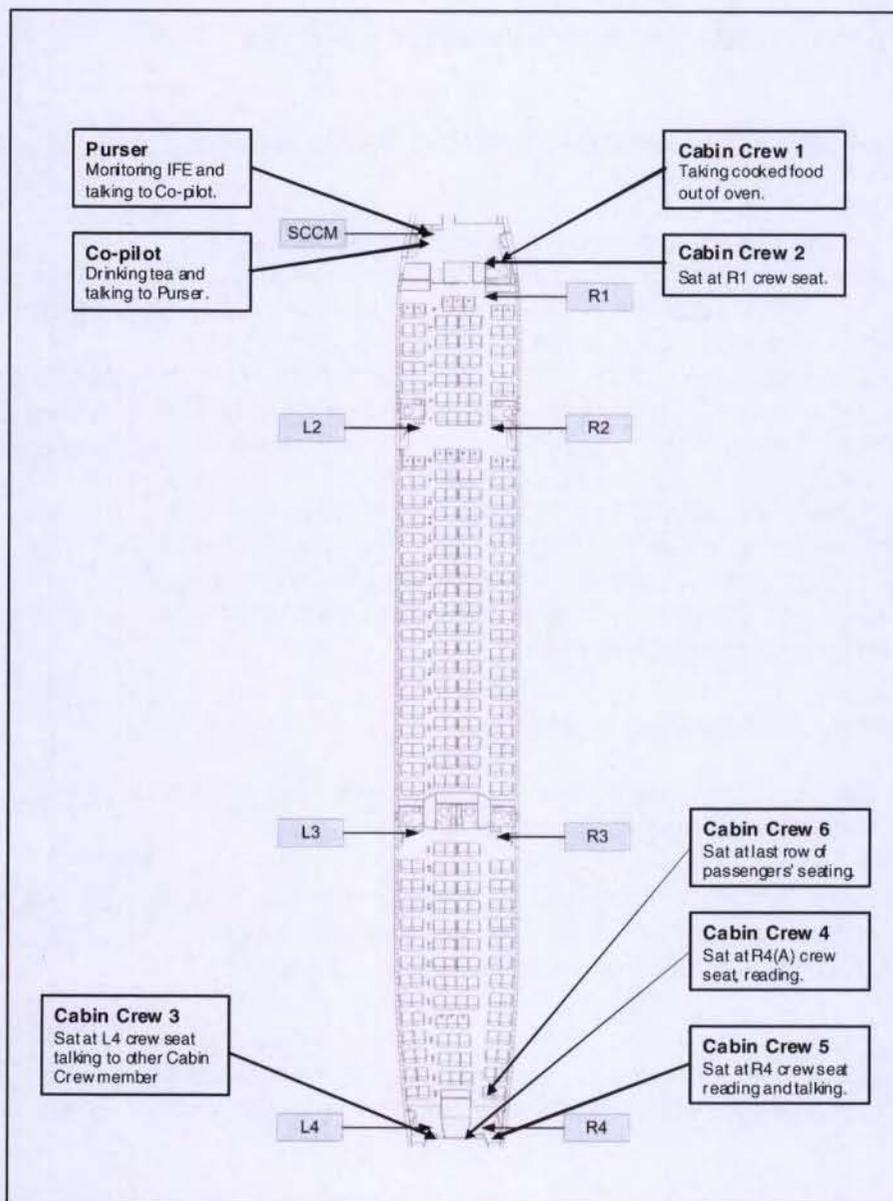
Figure 23: Cabin Crew positions at time of incident.

1.4.62 Amongst the 24 passengers who sustained physical injuries, there was a half-and-half split between those wearing a seatbelt, and those not wearing a seatbelt. All seven Cabin Crew reported physical injuries, of whom five were occupying seated positions, but not wearing a seatbelt. Of the remaining two Cabin Crew, one was standing in the forward galley area adjacent to the forward left door (position L1) along with the Co-pilot, while the other was in the forward galley adjacent to position R1 (Figure 23).
