NATIONAL TRANSPORTATION SAFETY COMMITTEE

AIRCRAFT ACCIDENT REPORT

PT. Garuda Indonesia GA421 B737-300 PK-GWA Bengawan Solo River, Serenan Village, Central Java 16 January 2002

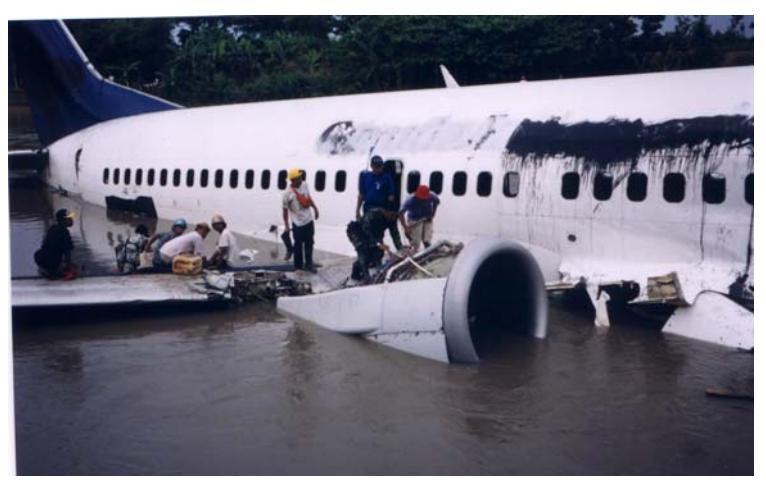
The aircraft was damaged beyond repair and is considered a total loss.

Figure 1 Damage to the aircraft

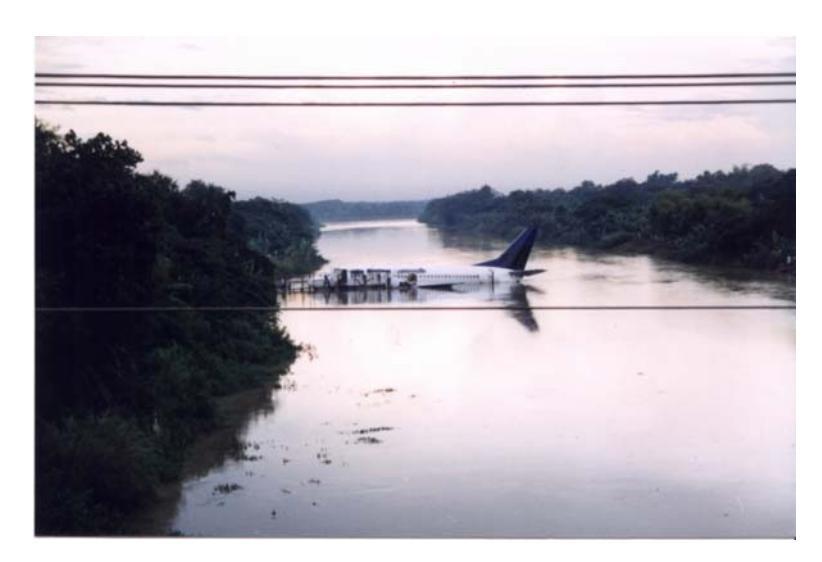
Figure 3 Wreckage location

The APU and battery was found underwater about 4 weeks after the accident downstream approximately 300 meters from the aircraft, and the CVR was found approximately 200 meters from the aircraft. Test performed on the electrical components are discussed on the section 1.16.4. The APU inlet door was found closed (see picture).

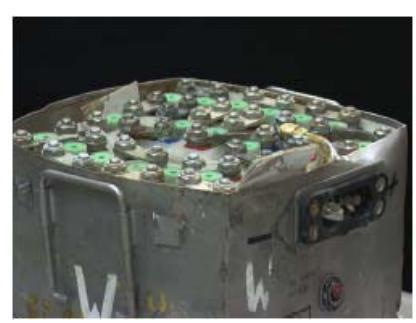
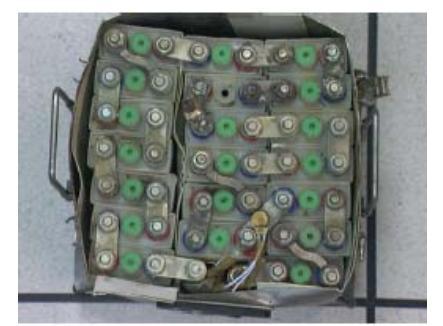
Figure 6 Damage to the battery

Battery examination found that the battery casing was damaged due to impact (see Figure 6), which caused mechanical damage on cells no 1 & 2. The examination also found that the thermostat sensor mounting (at the linkage between cells no 11 to 12) was found severely corroded and the sensor was missing. The metallurgical analysis showed that the corrosion was not caused by being submerged in river water, and therefore has

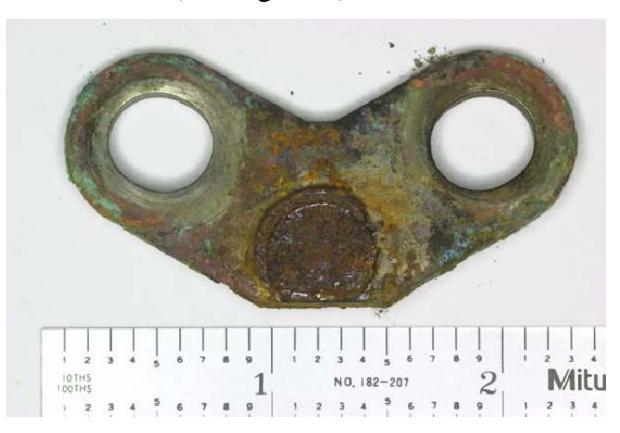
happened before the accident and the detachment of the sensor was not caused by mechanical force (see Figure 7).

Figure 7 Linkage between cells no 11 and 12 (high temp sensor mounting)

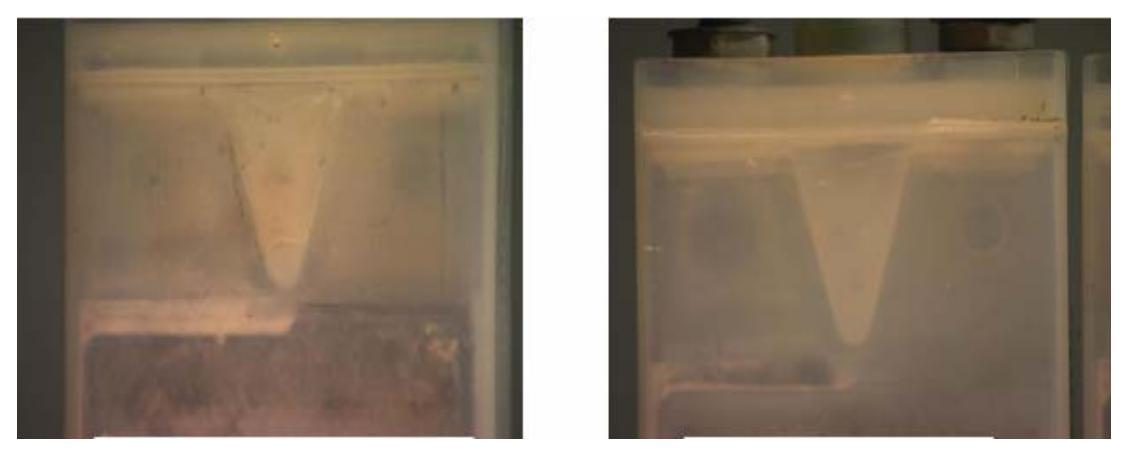
Figure 8 Cell no 12 (left) showed no electrolyte as compared to the cell no 13 (right)

The highlight of the examination result was the cell no. 12, which was found to have very little electrolyte left although the KOH (Potassium Hydroxide) concentration level was calculated to be normal after the cell was reconditioned. It meant that the electrolyte was spewing through the vent valve on the top of the cell (convective movement of KOH and water out of the cell), and not due to evaporation or electrolyze processes. It is to be noted that cell no. 12 is the newest cell in the battery, as it was installed in 1999, while the rest of the cells were installed in 1996. The position of the cell was in the hottest location of the battery, which is why the high temperature sensor is located in the linkage between cells 12 and 11.

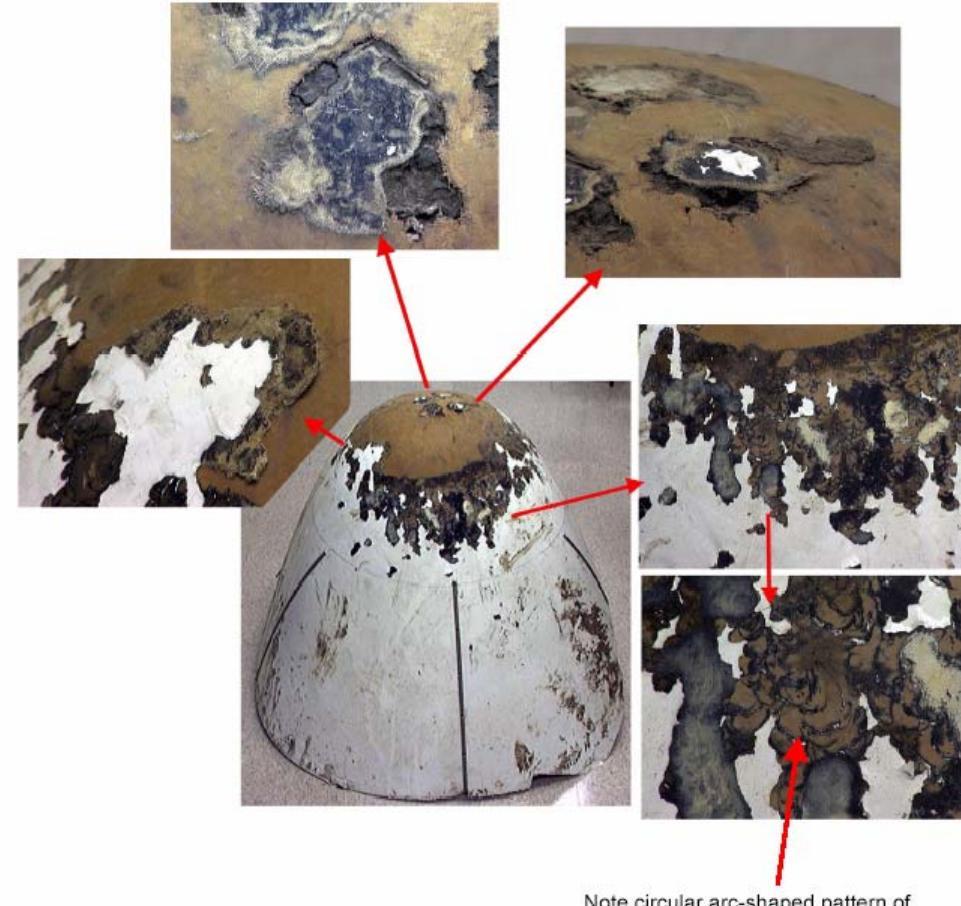
- The paint/coating had been eroded completely to form a circular area, approximately one foot in diameter, at the front.
- Within the eroded area there were four areas of damage to the underlying material. It appeared to be areas of previous damage and repair.
- Around the periphery of the completely eroded area, there were areas of partial erosion and paint damage having arc shaped (partial circular patterns) marks in the remaining coating.
- There were also numerous areas of damage to the paint as well as stains and dirt deposits.

Note circular arc-shaped pattern of marks.

Figure 9 Details of damages on the nose radome.

All the above are indications of damage by external causes.

It could be concluded that damages on the nose radome were caused by external forces, perhaps in the form of hail.
