Investigation Report

5X003-0/08 March 2010

Kind of occurrence:	Serious Incident
Date:	1 March 2008
Location:	Hamburg
Type of aircraft	Commercial Air Transport
Manufacturer / Model	Airbus / A320-211
Injuries to Persons:	None
Damage to Aircraft:	Minor damage
Other Damage:	None
Source of Information:	Investigation by BFU

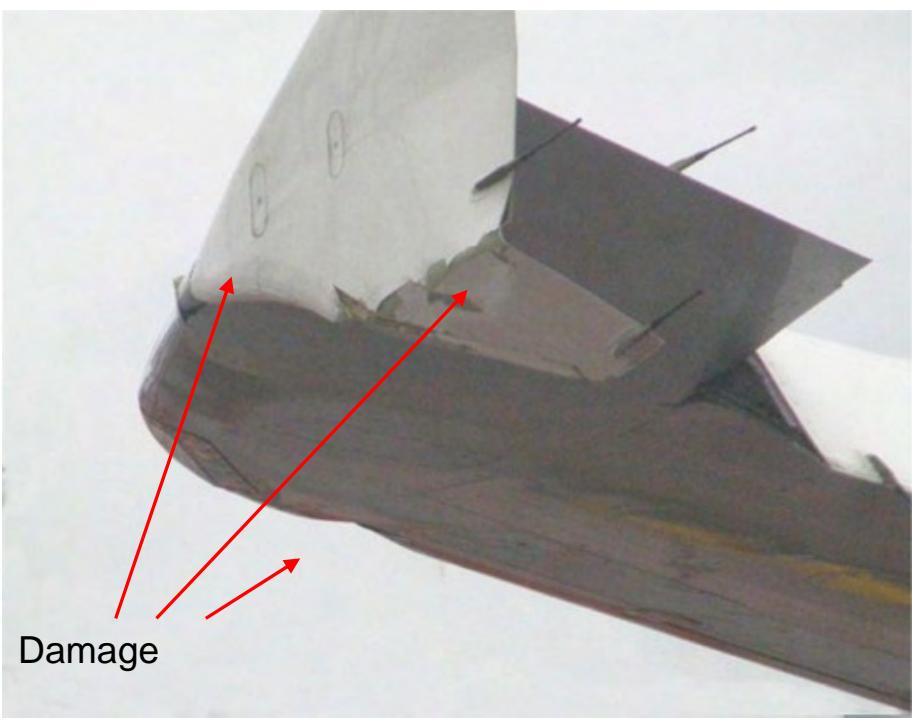
Diag. 12: Damage in the vicinity of the left wingtip

Contact with the runway resulted in damage to the wing tip fence, slat No. 5 and leading edge slat rail guides 11 and 12. These components were replaced before the aircraft was returned to service.

During the repair, a further inspection was made of the airframe, the control surfaces and the main landing gear. The inspection revealed no further damage that could be ascribed to the landing incident.

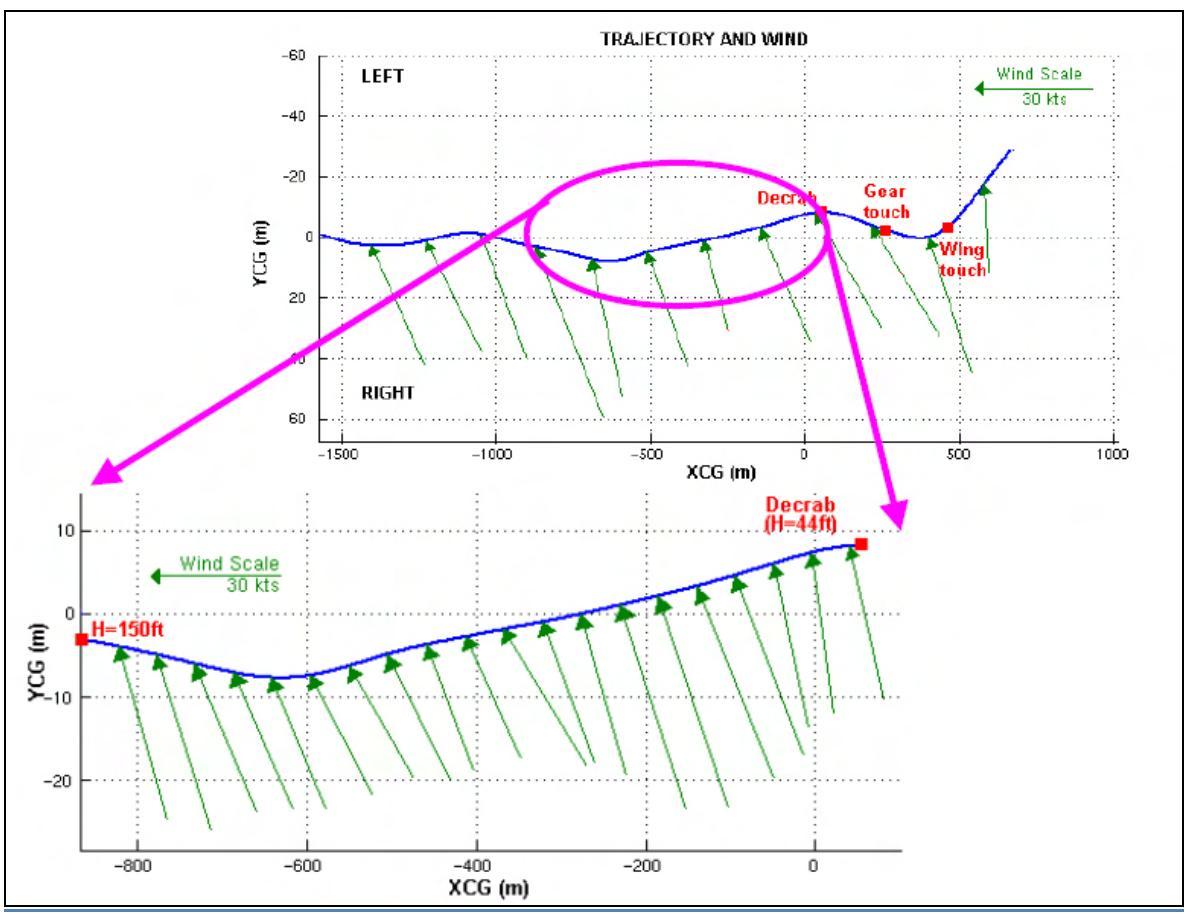
Diag. 16: Wind vector during descent from 150 ft to 44 ft

The horizontal zero line represents the runway centreline and the blue line represents the flight path. The lower horizontal scale represents the distance to the runway threshold. From this drawing it can be determined that the wind speed increased about 200 m prior to the runway threshold. The aircraft shifts left and on arrival over the threshold is about 8 m left of the runway centreline.

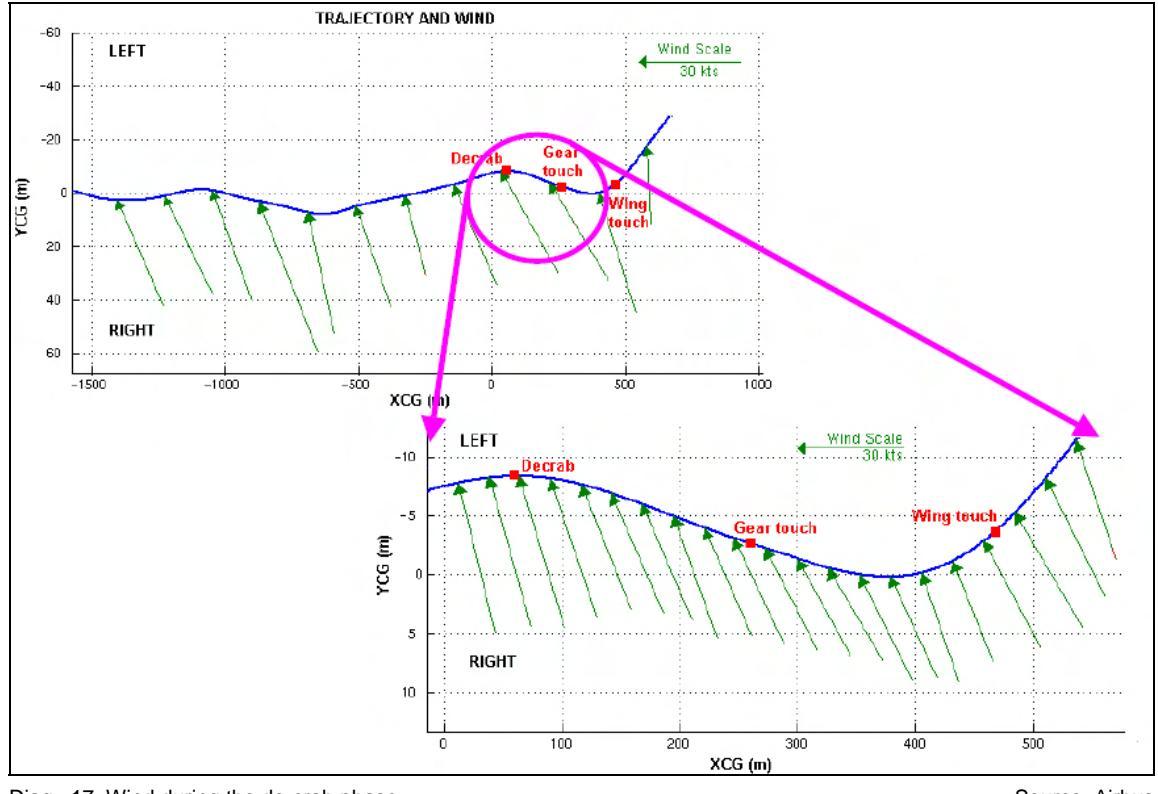
Diag. 17: Wind during the de-crab phase

- Wind Conditions
 - Headwind component 12.5 kt, gusts up to 24 kt
 - Crosswind component 30 kt, gusts up to 40 kt
 - There were no significant gusts during the de-crab procedure
- When at about 100 ft above the ground, a gust shifted the aircraft to the left and was corrected by copilot control input.
- The de-crab procedure was initiated at about 50 ft above ground with the sidestick still deflected on the left hand side while the rudder was deflected on the left hand side. Then, the left rudder deflection increased when the left main landing gear touched down.
- At the time of touch down by the left main landing gear, lateral control changed from Flight Law to Ground Law.

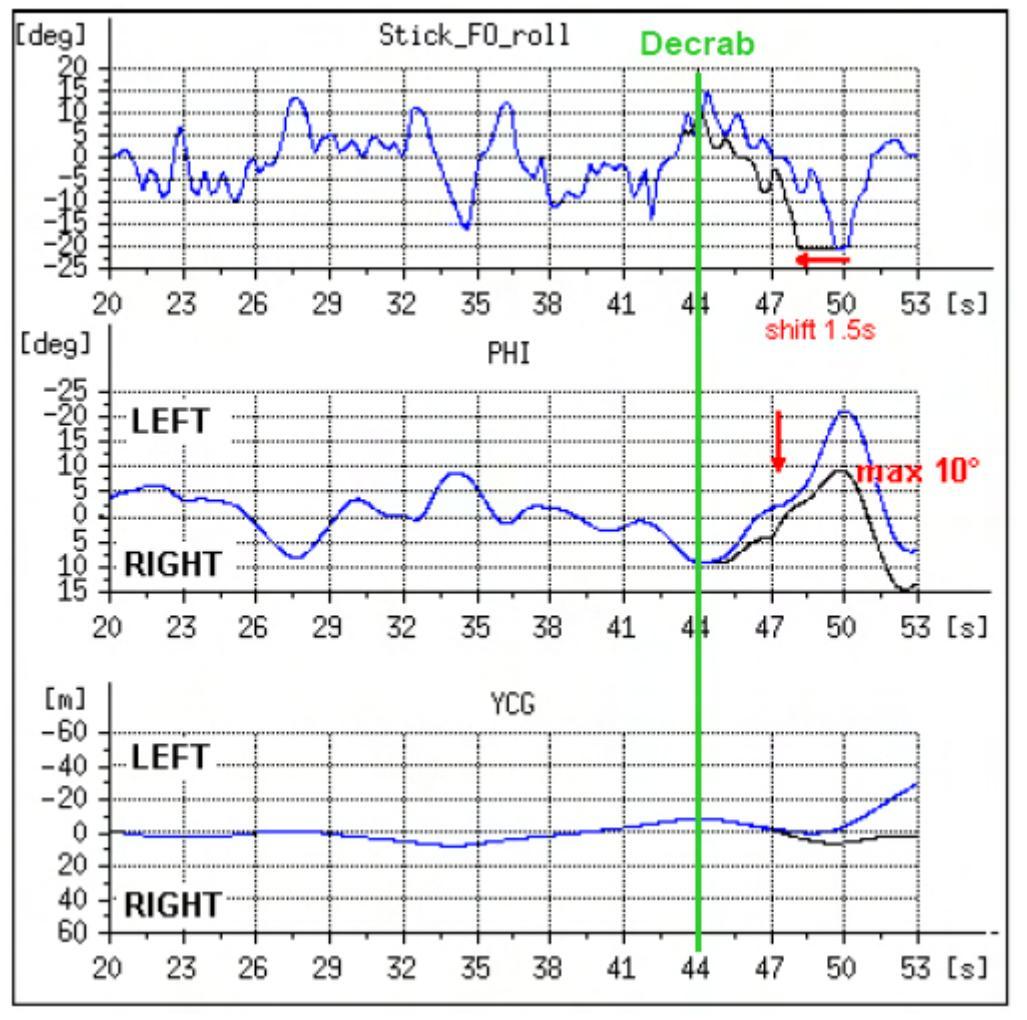
Diag. 18: Postponement of roll input by 1.5 seconds

It is in the opinion of the aircraft manufacturer, that contact between the left wingtip and runway could have been avoided if there had been an earlier, coordinated sidestick roll input, combined with less left rudder deflection.

The exemplary account of the aircraft manufacturer that, if the co-pilot's sidestick input had been delayed by 1.5 seconds the result would have been a maximum of 10° left wing down -- and would thus have avoided wingtip contact with the ground -- is theoretically understandable. However, from the practical point of view of a pilot, this assessment can be queried. With the aircraft under manual control, a time period of about 1.5 seconds would have been difficult to coordinate precisely. Further, it should be noted that in this specific case a reduction of the wing-down angle to a maximum of 10° would have prevented wingtip contact with the ground; but also that pilots are enjoined to avoid unintended changes in attitude just prior to touchdown. Any unintended wing drop to the left was unacceptable.
