FINAL  
KNKT.14.12.29.04

# KOMITE NASIONAL KESELAMATAN TRANSPORTASI

Aircraft Accident Investigation Report

**PT. Indonesia Air Asia**  
**Airbus A320-216; PK-AXC**  
**Karimata Strait**  
**Coordinate 3°37'19"S - 109°42'41"E**  
**Republic of Indonesia**  
**28 December 2014**

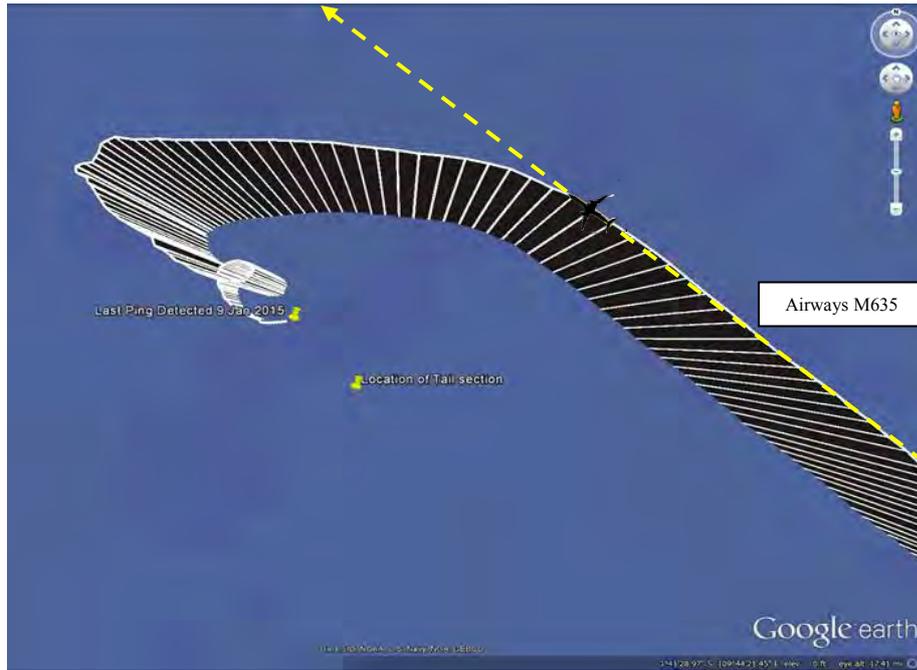
**Figure 19: Flight path based on FDR data superimposed to the Google Earth**

The FDR data showed that while the aircraft was cruising at an altitude of 32,000 feet in normal condition, the aircraft then deviated to the left from airway M635. The master caution triggered by both RTLU problems activated 4 times. The fifth master caution was related to the FAC 1 FAULT activating. The sixth master caution was triggered by the FAC 1+2 FAULT and followed by the autopilot and auto-thrust disengaged and flight control law reverted from Normal Law to Alternate Law.

Subsequently the aircraft entered a steep turn and climb, eventually reaching high angle of attack, the stall warning activated and continued until the end of the recording. The FDR and CVR recording ended at 2320:35 UTC.

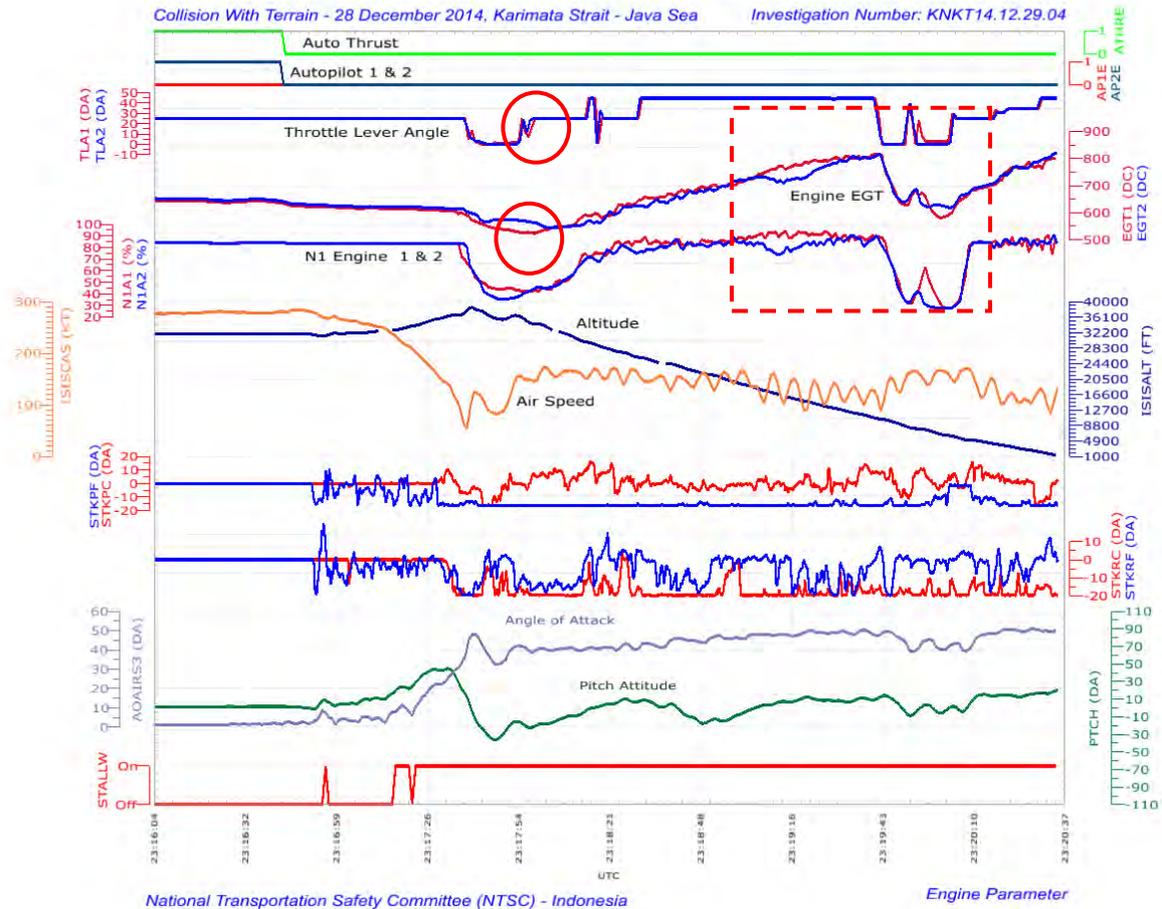
**Figure 23: Thrust levers and side-sticks movement**

- At 2317:41 UTC the aircraft reached the highest altitude of 38,500 feet (ISIS) and largest roll angle at 104° to the left. The aircraft then descended with a rate up to 20,000 feet per minute momentarily afterward the rate of descent was recorded at average of 12,000 feet per minute until the end of recording.

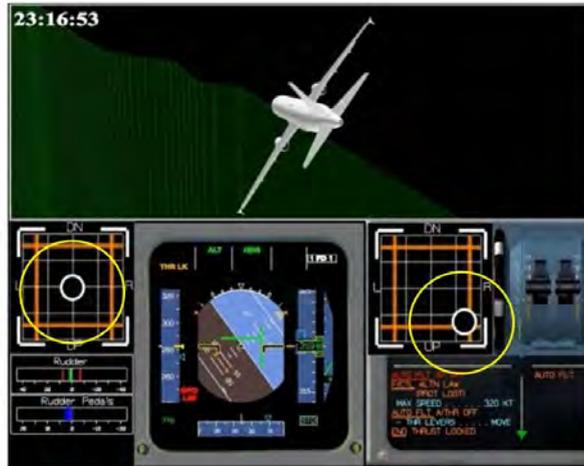
Figure 25: Aircraft rolled 54° to the left

Speed (knots)	277 (ISIS)	282 (CAS)
Alt (feet)	31952	
Rudder	2°	
Roll	54°	
Pitch	-1.1°	
AOA	3.5°	
VS(fpm)	-1088	
N1	83%	
EGT	622 °C	
Sidesticks	<b>PIC</b> P: 0° R: 0°	<b>SIC</b> P: -15° R: +19

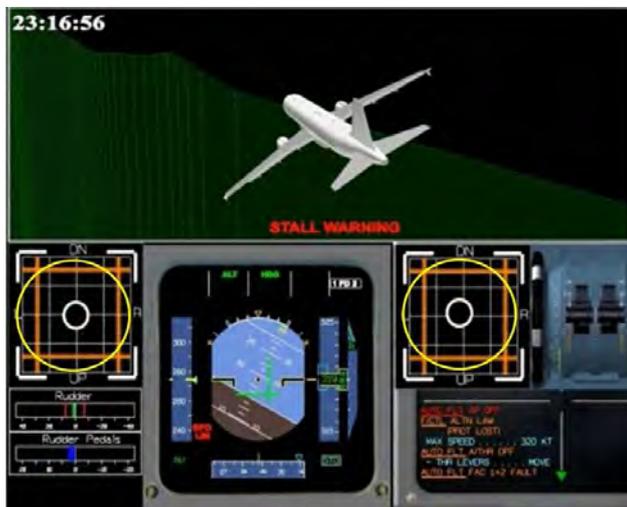
Figure 26: The first aural Stall warning activated

Speed (Knots)	268 (ISIS)	272 (CAS)
Altitude (Feet)	31980 (ISIS)	33900 (GPS)
Rudder	2°	
Roll	19.7°	
Pitch	9.5°	
AOA	8°	
VS (fpm)	2624	
N1	83%	
EGT	621 °C	
Side-sticks	<b>PIC</b> P: 0° R: 0°	<b>SIC</b> P: 7° R: +10°

Time (UTC)	From	To	Description
2317:02	P1		Gave instruction “level...level...level...” (4 times)
2317:15	P1		Gave instruction “pull down...pull down” (2 times)

2317:17	Warning		Aural stall warning announced with cricket sound. Change of external airflow sound.
2317:22	P1	P2	Gave instruction “pull down...pull down” (3 times)

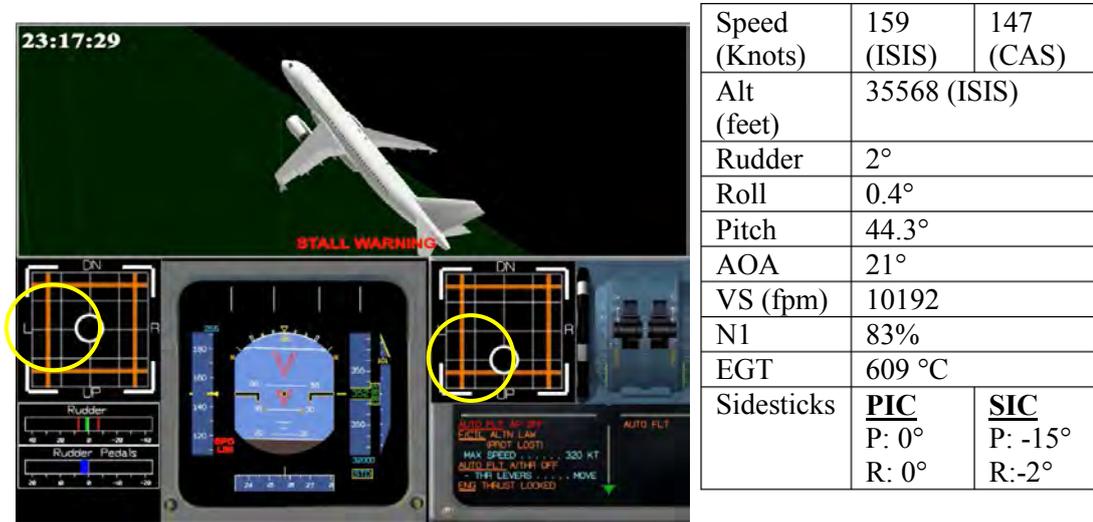
**Figure 27: The aircraft attitude at the highest pitch angle**

Time (UTC)	From	To	Description
2317:23	Warning		Aural stall warning activated with cricket sound and a sound similar to aircraft buffet continued until the end of recording.
2317:25	P1		Gave instruction “pull down...pull down”
2317:29	P2		<i>in French</i> : “What is going wrong”
			The left side stick input continued until the end of recording. Dual input on the side sticks continued until the end of recording.

56	Selected significant events based on CVR and FDR (1.11.4), page 43, Figure 27	Figure 27: The aircraft attitude at the highest pitch angle.	The time indicated on Figure 27 is 23:17:25 UTC, but in the FDR data, the highest pitch angle is at 23:17:32 UTC.	The BEA suggests replacing the animation snapshot of Figure 27 with the equivalent one at 23:17:32 UTC and modifying the values in the associated table.	Accepted
57	Selected significant	Figure 29: Attitude recovered.	The animation snapshot does not	The BEA suggests replacing the animation	Accepted

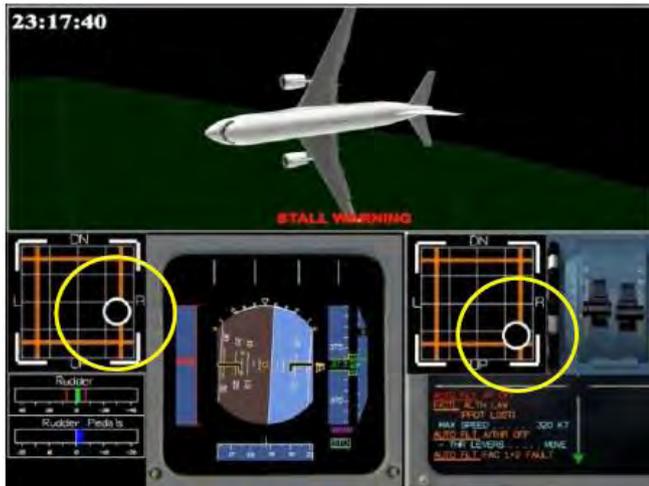
Figure 28: Aircraft in upset<sup>13</sup>situation

Speed (knots)	118 (ISIS)	0 (CAS)
Alt (Feet)	37796 (ISIS)	
Rudder	-5°	
Roll	-104 °	
Pitch	-20.7°	
AOA	46°	
VS (fpm)	-4784	
N1	52%	
EGT	563 °C	
Sidesticks	<u>PIC</u> P: -4° R: -20°	<u>SIC</u> P: -16° R: -17°

Time (UTC)	From	To	Description
2317:41	P1		“My God.”

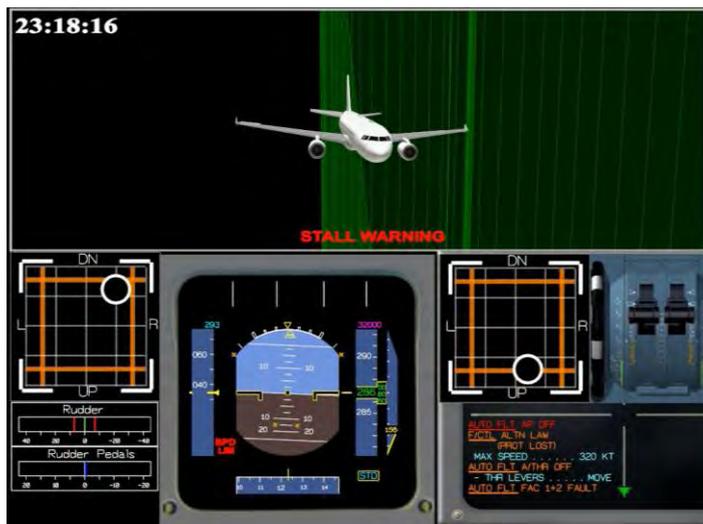
Figure 29: Attitude recovered

Comment Reference	Reference chapter, page, paragraph	Commented extract	Reason for proposed change	Proposed amendment	Remarks
	events based on CVR and FDR (1.11.4), page 44, Figure 29		come from the last version of the animation.	snapshot of Figure 29 with the equivalent one from the last version of the animation.	
58	Selected significant events based on CVR and FDR (1.11.4), page 45, table following Figure 29	2319:58 UTC: P1 to P2: Instructed to select to CAPT 3.	This is not consistent with what is written in paragraph 2.6 page 97-98: "(...) the PIC commanded the SIC to select 'CAPT 3' air data source'. Moreover, the BEA understands something similar to: "captain three" but is not able to clearly understand the meaning of this statement.	2319:58 UTC: P1 to P2: <del>said something similar to "captain three"</del>  Then, the possible meanings of this statement could be analyzed in part 2 of the report (for instance, paragraph 2.6).	Proposal rejected

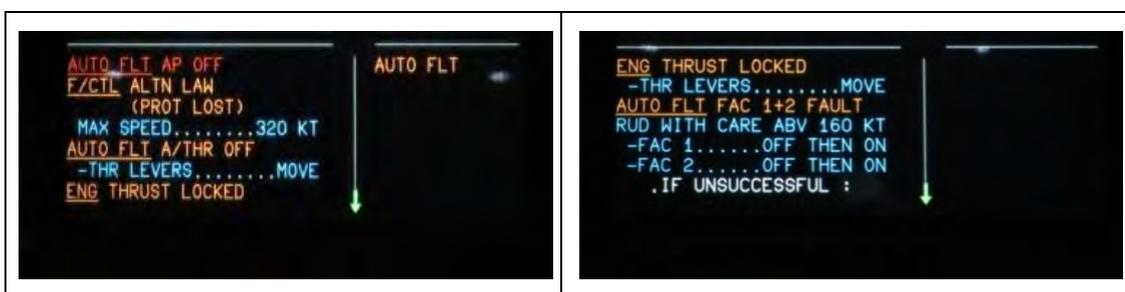
Figure 33: The page 1 and 2 of the ECAM messages after CBs of FAC 1 and 2 being reset

- Similar ECAM messages to the data recorded on the FDR appeared when the FAC CBs were pulled.
- Dual input resulted in rapid movement of the aircraft compared to single input
- Dual input in different direction of the side-sticks reduced the ability to control the aircraft.
- The Emergency Cancel Button was effective to prevent pilot distraction for a repetitive malfunction.

61	Flight Simulation 1 (1.16.1), page 50, Figure 33	Figure 33: Display of the ECAM message during RTLU 1+2 malfunction	The ECAM message displayed on Figure 33 contains FAC 1 FAULT that does not correspond to RTLU 1+2 malfunction.	The BEA suggests replacing the ECAM message displayed on Figure 33 with the one corresponding to RTLU 1+2 malfunction only (cf. document "Flight synopsis-phase1-withECAM" provided to KNKT during the meeting of July 2015).	Accepted
62	Flight Simulation 1 (1.16.1), page 51	Figure 36 + During stall the PFD indicated: - Flight director commanded to set pitch up (climb); - Vertical Speed Indicator indicated down; - Speed below stalling speed.	This paragraph is ambiguous and the reader could understand that the statements of these three bullets represent exactly what happened during the accident flight. The behavior of the aircraft in a situation of stall at high angle of attack is not known. Therefore the <del>the</del> <del>of</del> <del>are</del> are not representative at all of the real aircraft in a situation of a developed stall and cannot serve as a reference in this investigation.	The BEA suggests to suppress the figure 36 and the following sentences : <del>Crewing still does not understand the flight director commanded to set pitch up</del> <del>Example:</del> <del>Adopting a new 1 minute for increased stall speed</del> <del>Speed below stalling speed</del>	Accepted

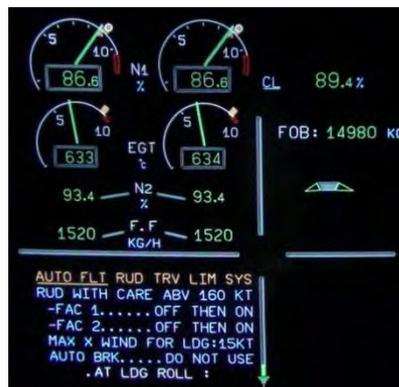
**Figure 34: The ECAM messages after RTLU 1 and 2 fault**

As requested by the KNKT, BEA and Airbus performed the simulator session which referred to FDR data on the engineering simulator. The simulation intended to recreate ECAM messages appeared on the accident flight. The ECAM message during the RUD TRIM LIM SYS problem is presented in the following figure:
