# THE PENTAGON BUILDING PERFORMANCE REPORT

January 2003

## ABSTRACT

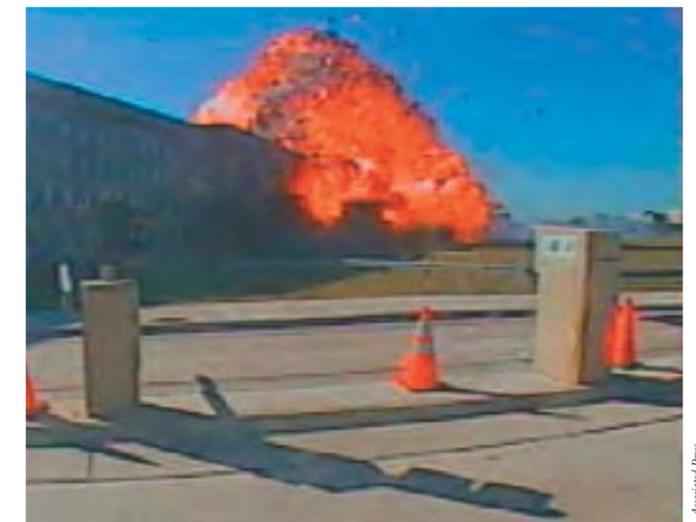
Figure 1.2 Aircraft impact

At 9:38 A.M. on September 11 an airliner was flown into the first story of the Pentagon. The impact occurred in the renovated portion of the building approximately 140 ft to the south of the boundary between the renovated section and the next section scheduled to be renovated. (Figure 1.2, a photograph taken by a security camera, shows the plane impacting the building at ground level.) The aircraft sliced through the building into the section not yet renovated. The impact and the fire initiated by the fuel in the airplane that immediately spread widely in the structure took the lives of all 64 people aboard the aircraft and 125 occupants of the Pentagon.

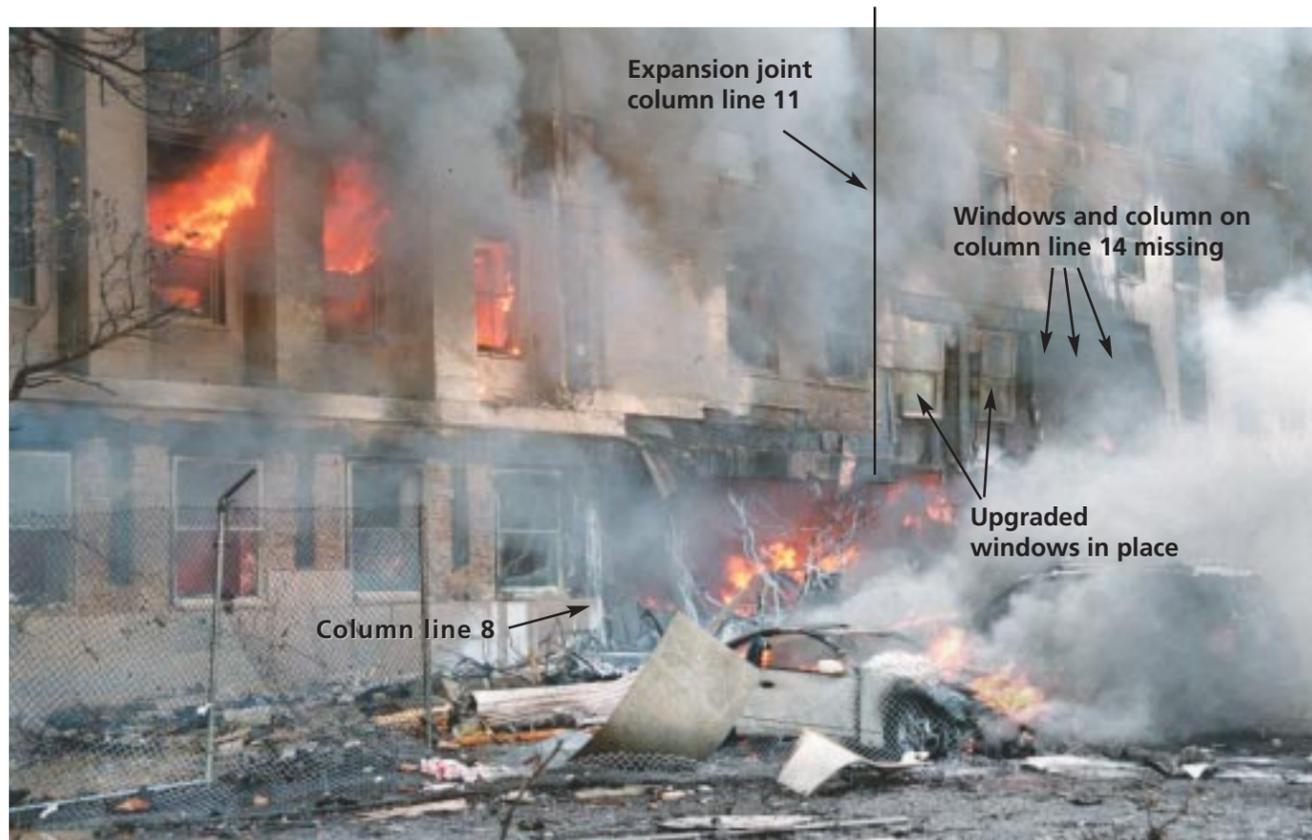
Figure 3.8 Northern portion of impact area before collapse

A photograph (figure 3.8) taken by the Associated Press before the building to the south of the expansion joint collapsed provides useful information that the BPS team could not observe at the site. This photograph shows that the portion of the building that subsequently collapsed was displaced vertically by approximately 18 in. to 2 ft relative to the building north of the expansion joint. The facade was missing on the first floor as far north as column line 8 (the expansion joint is at column line 11), and on the second floor, the facade was missing between column lines 11 and 15. However, windows and their reinforcing frames were still in place between column lines 11 and 13 on the second floor.

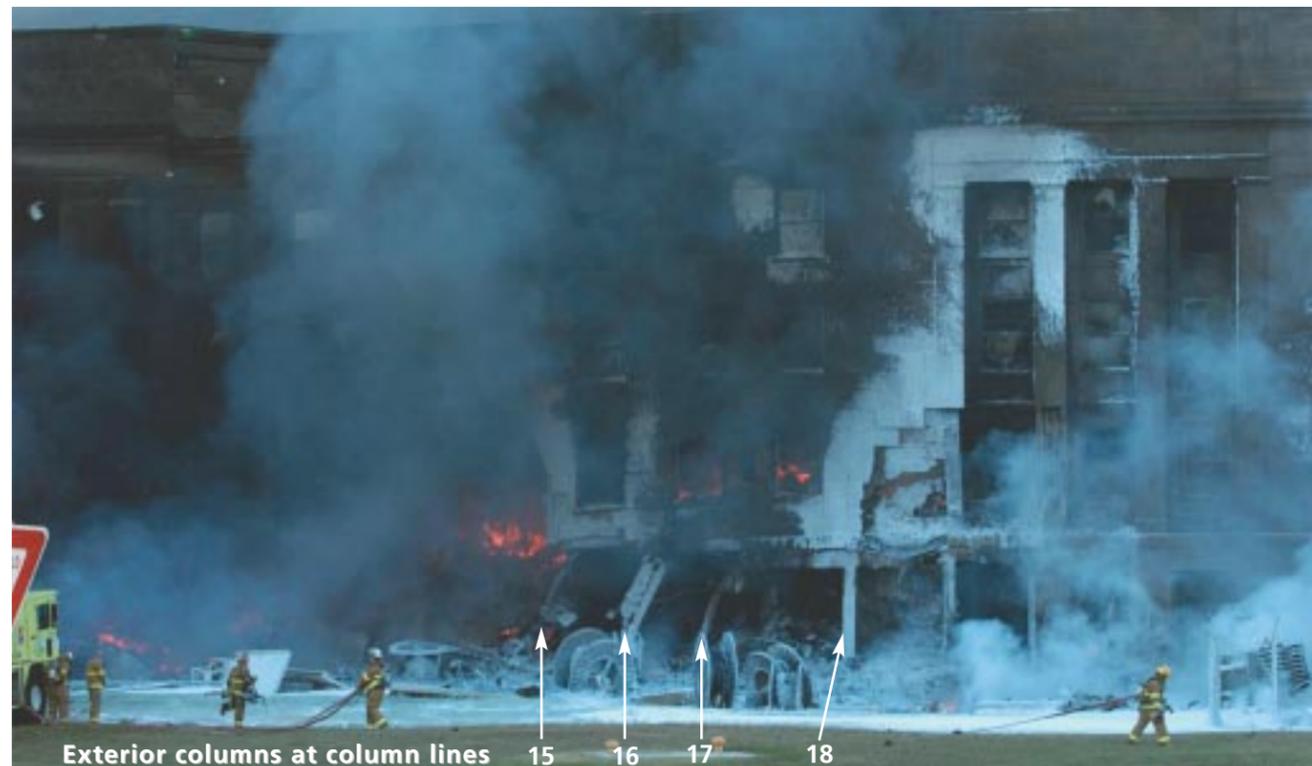
Figure 3.9 Southern portion of impact area before collapse

A second photograph (figure 3.9) taken before the collapse reveals that first-floor exterior columns on column lines 15, 16, and 17 were severely distorted but still attached at least at their top ends to the second-floor framing. The vertical displacement noted previously also is evident in this photograph.

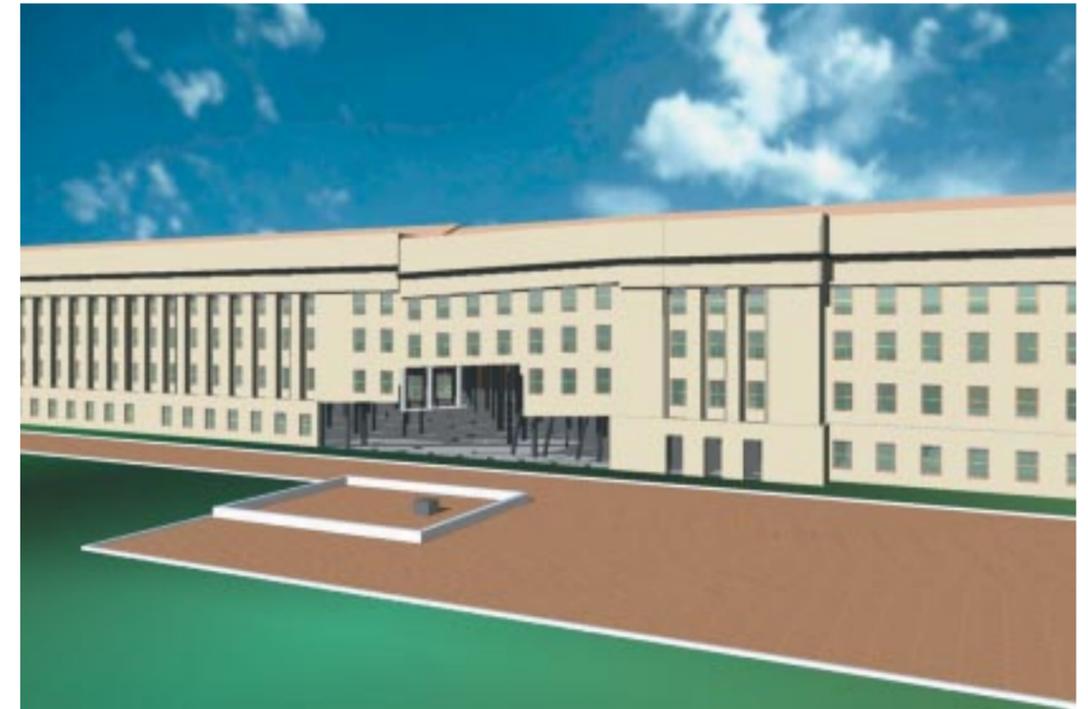
Figure 3.10 Impact location before collapse

The precollapse state of the structure is illustrated for clarity in figure 3.10.

Immediately upon impact, the Ring E structure deflected downward over the region from an expansion joint on column line 11 south to the west exterior column on column line 18 (figures 3.8–3.10). The deformation was the most severe at the expansion joint, where the deflection was approximately 18 in. to 2 ft.

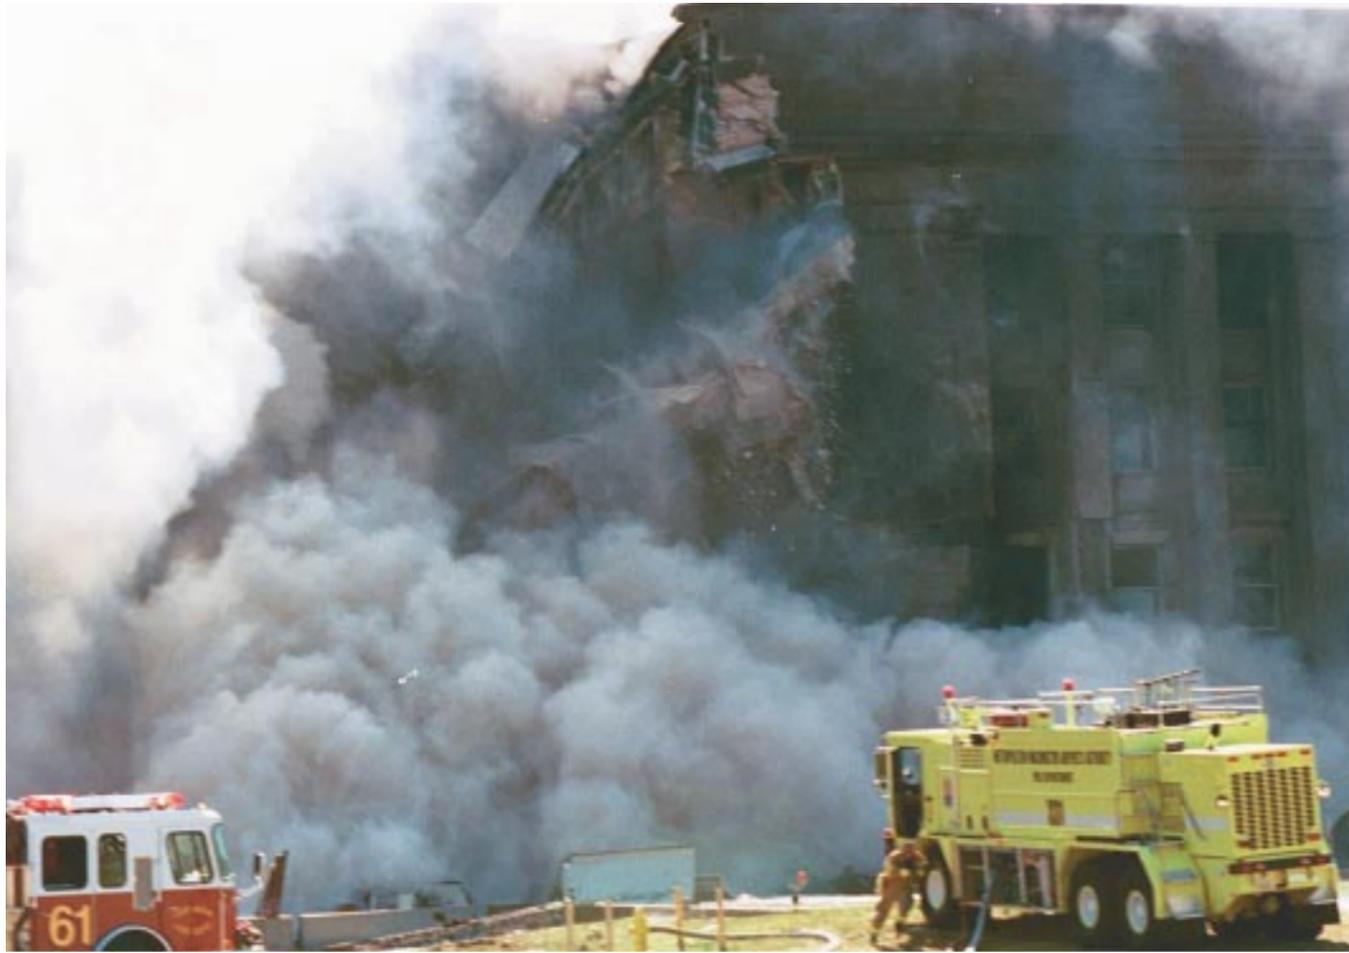
Figure 3.11 is a photograph taken at the moment of collapse, approximately 20 minutes after the aircraft struck the west wall of the Pentagon. The collapse extended to approximately column line 18 on the west face of the building.

Figure 3.11 Portion of Ring E at moment of collapse

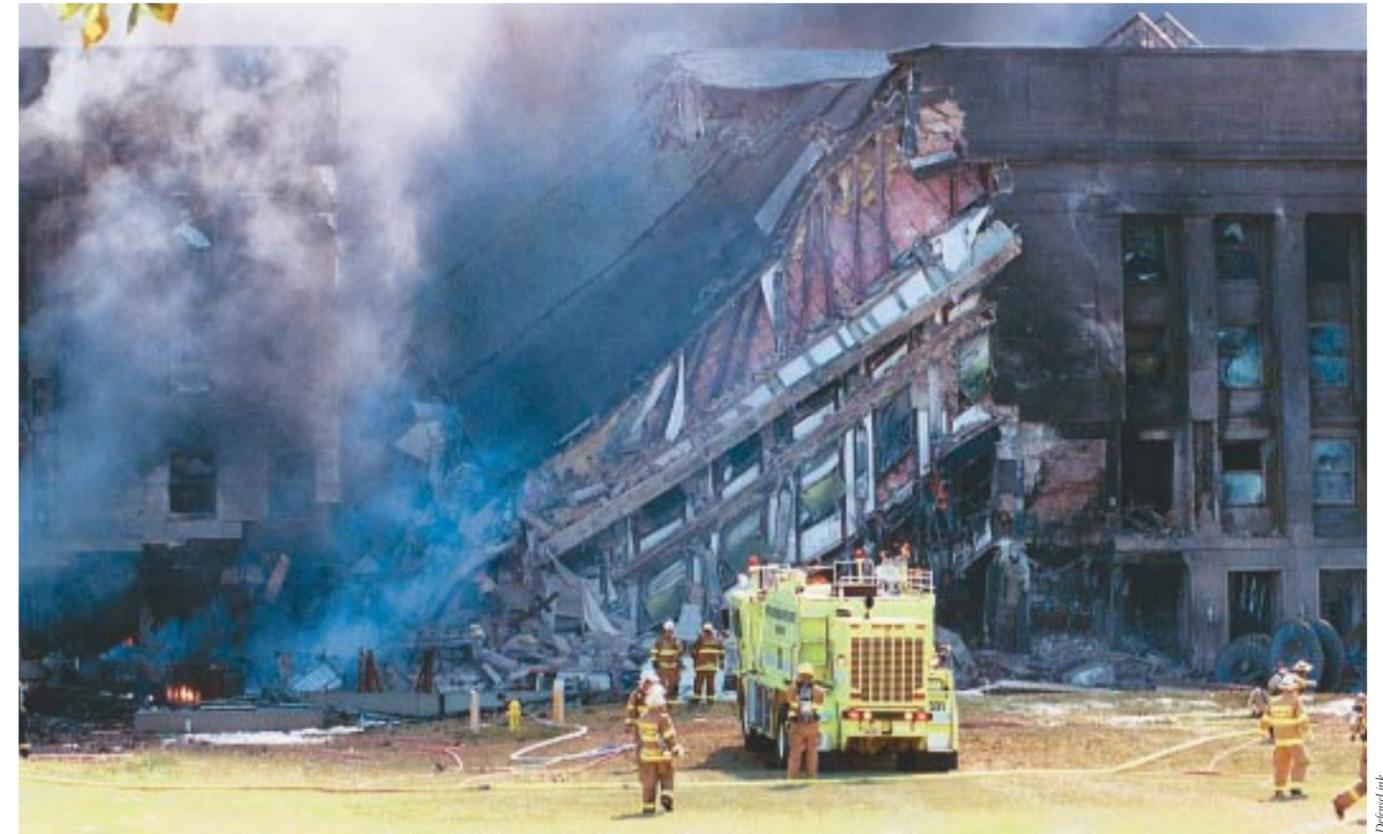
Figure 3.12—a photograph taken after the fire was extinguished, but before significant debris was removed from the collapse area or shoring was installed—shows the condition of the building after the collapse. The collapsed portion of Ring E extends from an expansion joint on column line 11 to approximately column line 18 on the west facade.

Figure 3.12 Ring E after collapse

The structure was able to maintain this deformed shape for approximately 20 minutes, at which point all five levels of Ring E collapsed from column line 11 to approximately column line 18 (figure 3.12).

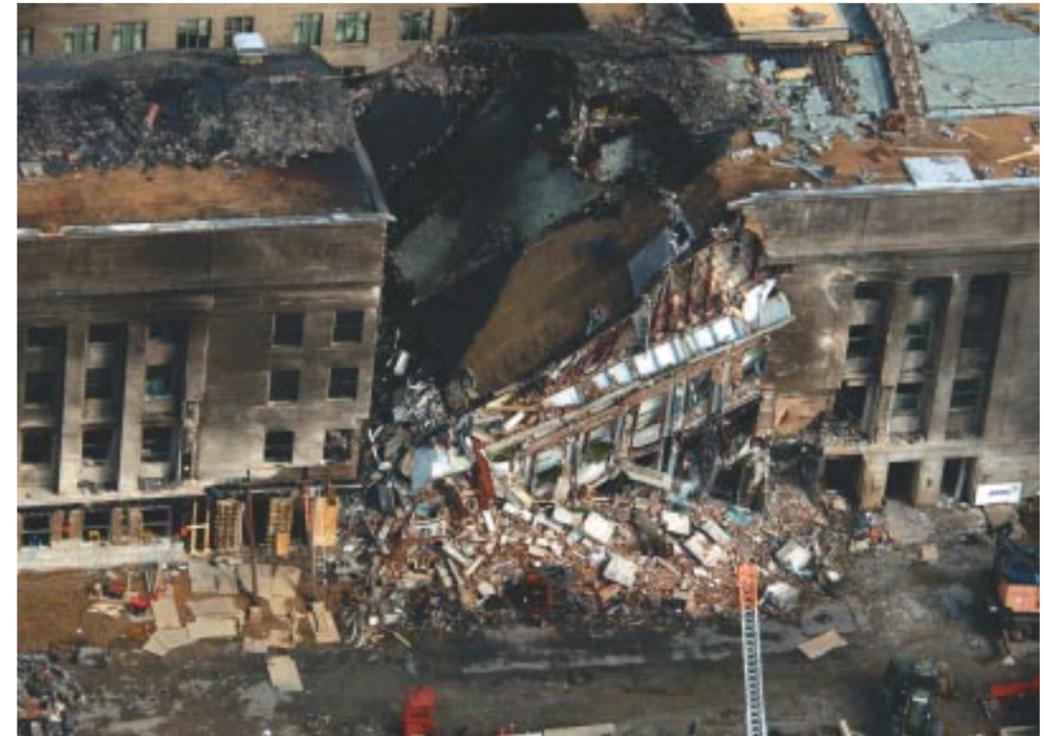
The collapsed portion of Ring E was immediately south of an expansion joint on column line 11 (figures 5.2 and 5.3). The collapsed area extended south from the expansion joint to approxi-

Figure 5.3 Aerial view of collapsed portion of Ring E

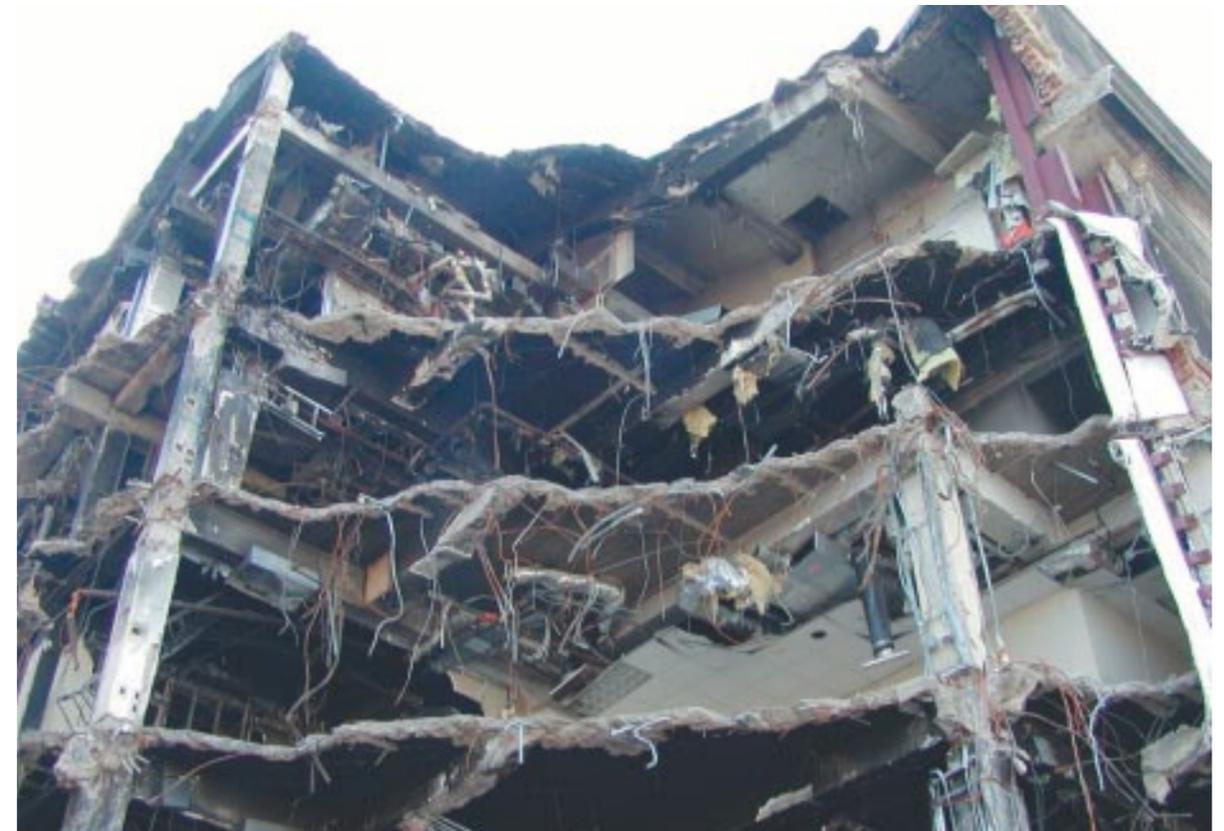
Figure 5.4 Remaining structure at southern extreme of collapse area

mately column line 15 on the east side of Ring E and to approximately column line 18 on the west side of Ring E (figure 5.4). No portion of Ring D or Ring C collapsed; nor did either of the two-story sections between the rings.

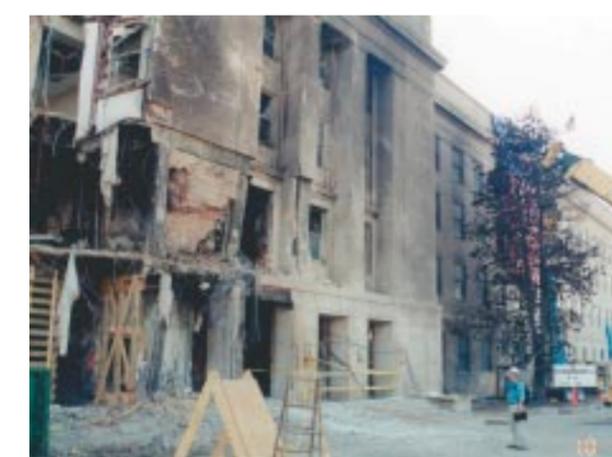
Figure 5.10 Exterior evidence of fire to the south of the impact area

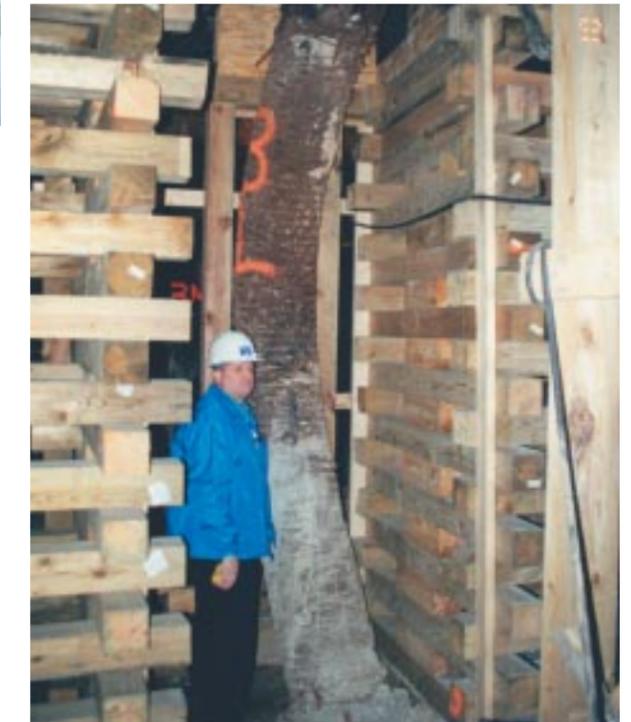
Figure 5.20 Column 3L with large deformation and discrete hinges

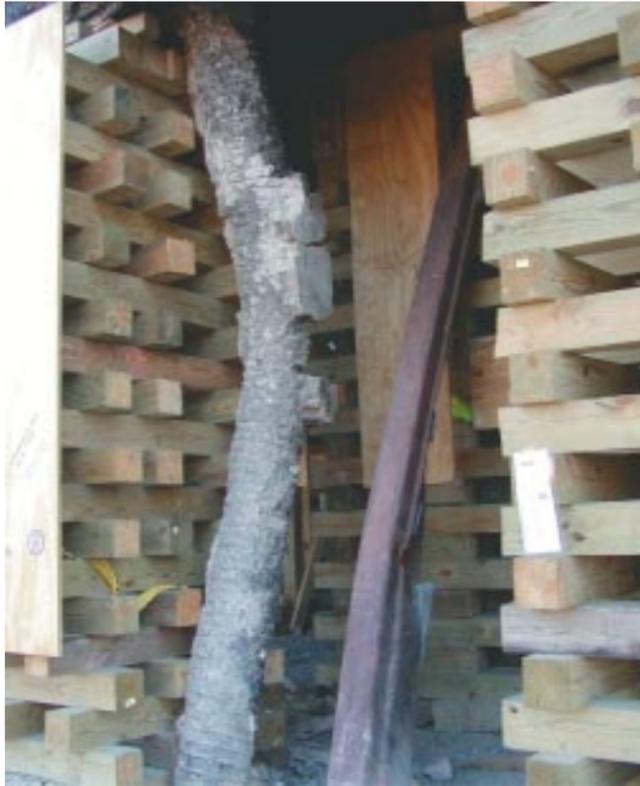
Figure 5.21 Column with triple curvature

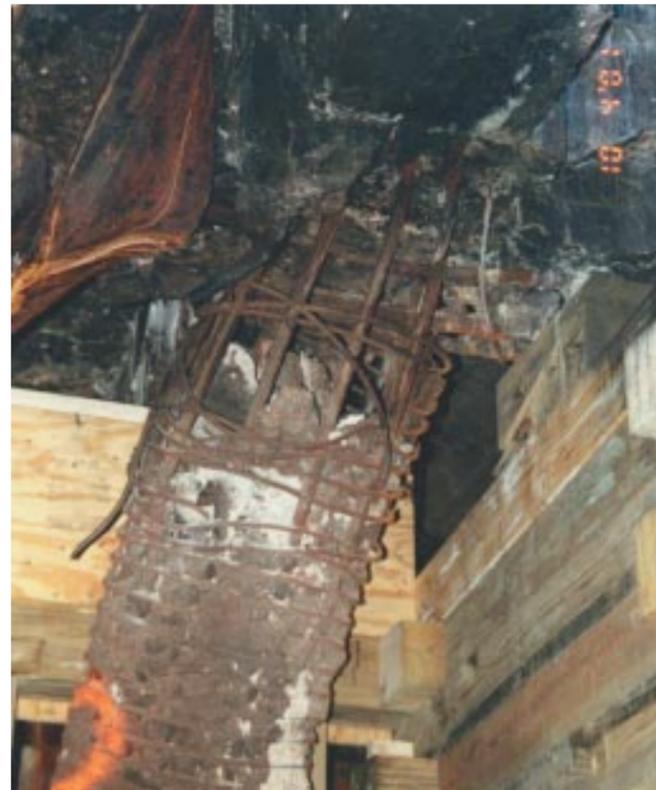
Figure 5.22 Top of column 3L, still attached to underside of second-floor framing

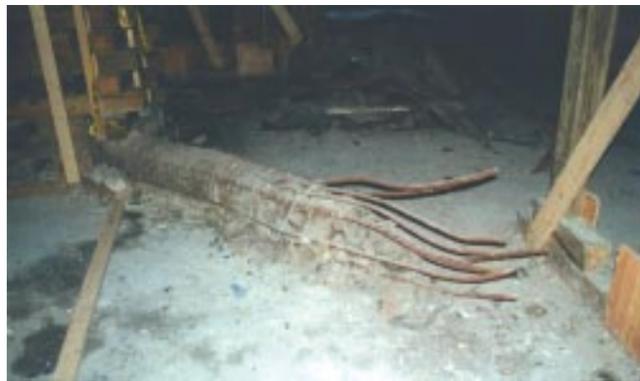
Figure 5.23 Severed column 5H

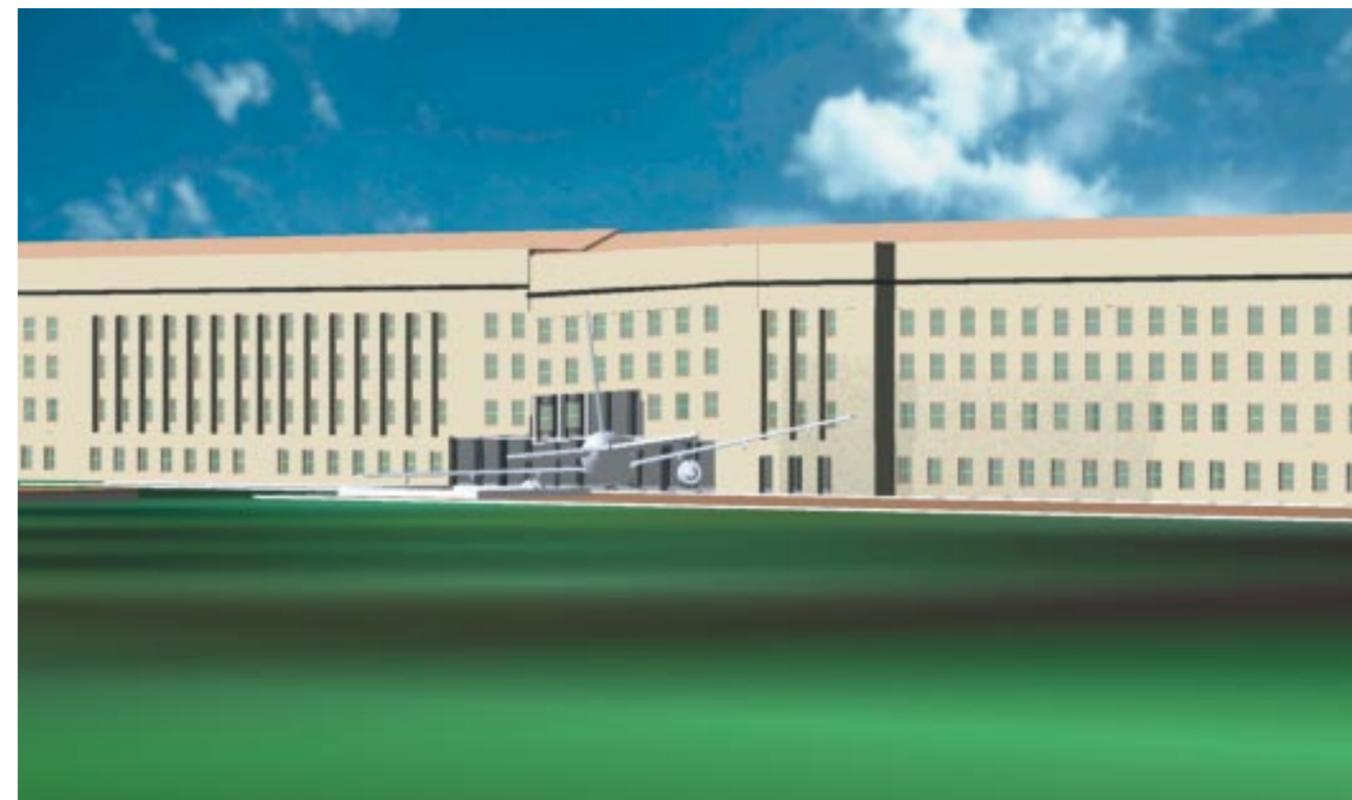
It is possible that less of the right wing than the left wing entered the building because the right wing struck the facade crossing the level of the second-floor slab. The strength of the second-floor slab in its own plane would have severed the right wing approximately at the location of the right engine. The left wing did not encounter a slab, so it penetrated more easily.

In any event, the evidence suggests that the tips of both wings did not make direct contact with the facade of the building and that portions of the wings might have been separated from the

Figure 6.1 Aircraft aligned with damage on west facade

fuselage before the aircraft struck the building. This is consistent with eyewitness statements that the right wing struck a large generator before the aircraft struck the building and that the left engine struck a ground-level, external vent structure. It is possible that these impacts, which occurred not more than 100 ft before the nose of the aircraft struck the building, may have damaged the wings and caused debris to strike the Pentagon facade and the heliport control building.

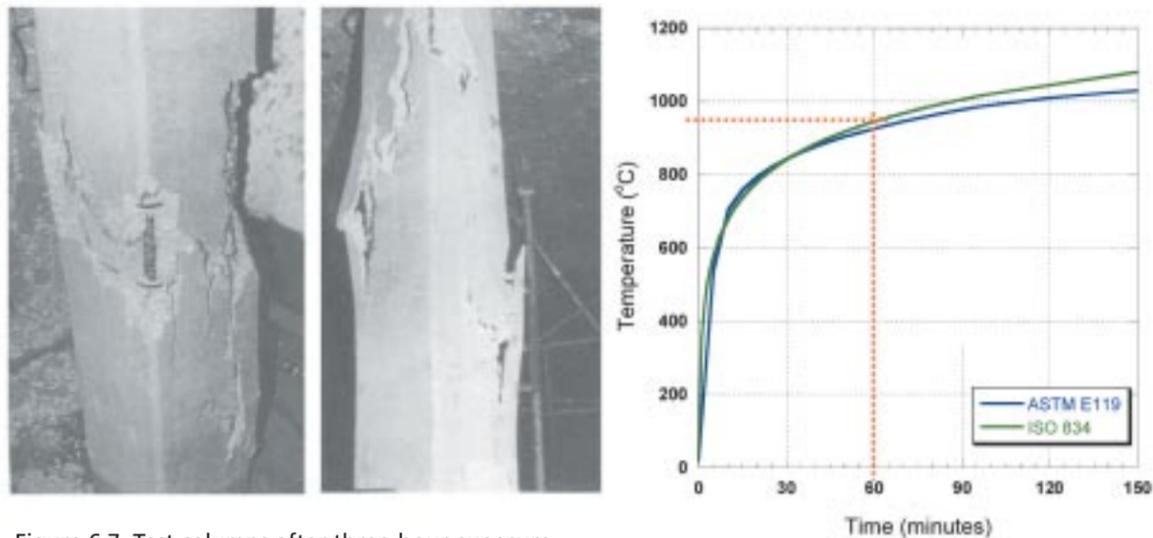
Figure 6.7 Test columns after three-hour exposure

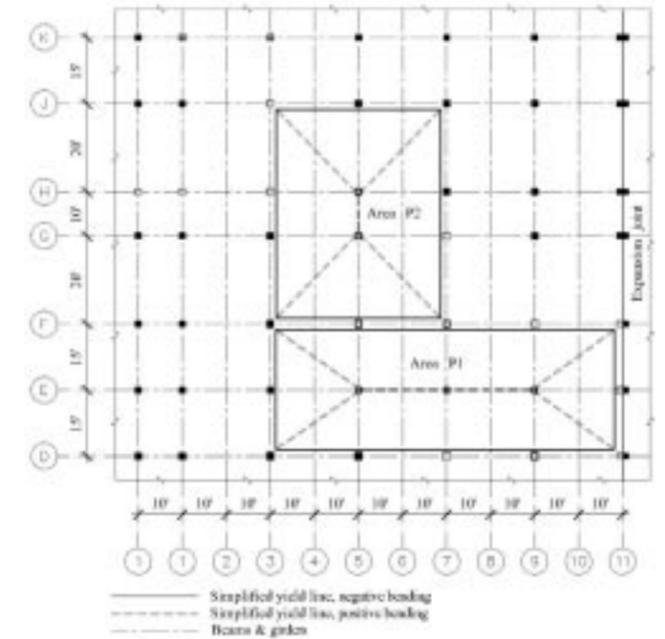
column lines, why the structure could tolerate losses of columns. Simplified yield line analyses were also performed for areas within segment P that were missing several columns. Figure 7.6a shows two such areas, P1 and P2. The two areas are shown divided because the light well wall above (see figure 2.10, section 2) provides a stiff and strong support, and the second-story columns were able to act as hangers because the column vertical reinforcement was sufficiently well developed (having the lap enclosed within a spiral may have been a factor). The calculated capacities of the floor systems within P1 and P2 were both over 350 psf, more than twice the dead load. The light well wall was also analyzed for the loads that the area P1 and P2 mechanisms would deliver to it, and this analysis showed that some support from the two significantly impaired columns at 9 and 11 F would have been required to prevent a failure. The spiral reinforcement in those two columns must have been a key factor in preventing a widespread collapse.

Figure 7.6a Yield line analysis of area with missing columns

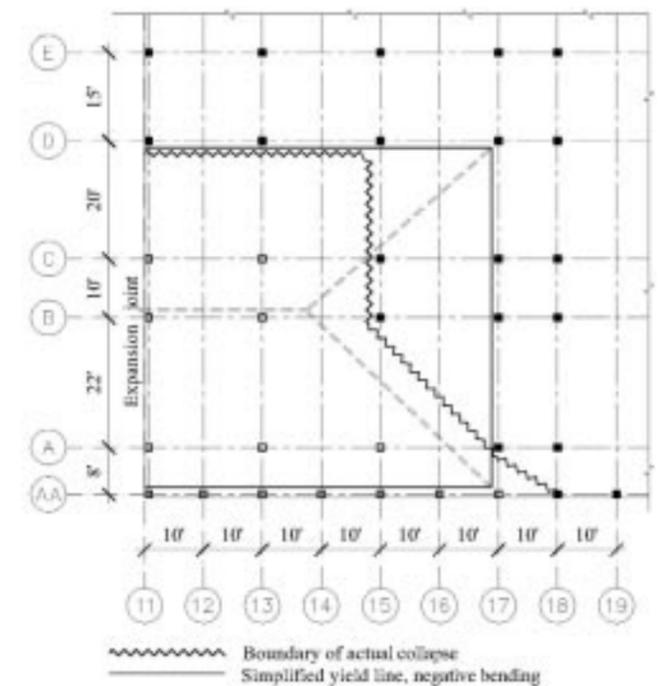
Figure 7.6b Yield line analysis of collapse area, segment Q

Figure 7.6b depicts the segment of the building between column lines 11 and 17 and AA and D. To obtain another perspective of the intrinsic strength of the floor system, its capacity to resist load at room temperature was estimated by assuming that all columns at the intersections of column lines 12 through 16 and AA, A, B, and C were lost. The assumed locations of the negative- and positive-moment yield lines are shown in the figure. The floor-system edge along line 11—the location of the expansion joint—was assumed to be unsupported. The support along line AA was considered to be provided by the facade wall that had not been destroyed by the impact. (An example of a similar phenomenon at a different building is shown in figure 7.7.)

The calculated capacity for the failure condition shown ideally in figure 7.6b was approximately 160 psf (with the dimension  $x$  set at 35 ft, corresponding to the minimum calculated yield load). For the assumed boundary, material, and support conditions, the floor system at level two would have been able to support itself over the assumed unsupported area. It is plausible to assume that the columns at the intersections of line AA with lines 11 through 16 were not functional at the time the photograph that constitutes figure 3.8 (section 3) was taken. Photographs taken immediately after the impact (figures 3.8 and 3.9, section 3) indicate that segment Q might have derived some support from segment P before collapsing. The partial support might have provided a collateral

mechanism for resisting the overall gravity loads on segment Q considered as a building block, but the floor system would still have had to be able to carry itself. The eventual collapse of this section is attributed to the effects of heat from the fire or high-strain creep, possibly exacerbated by the water pumped into the structure to quell the fire.

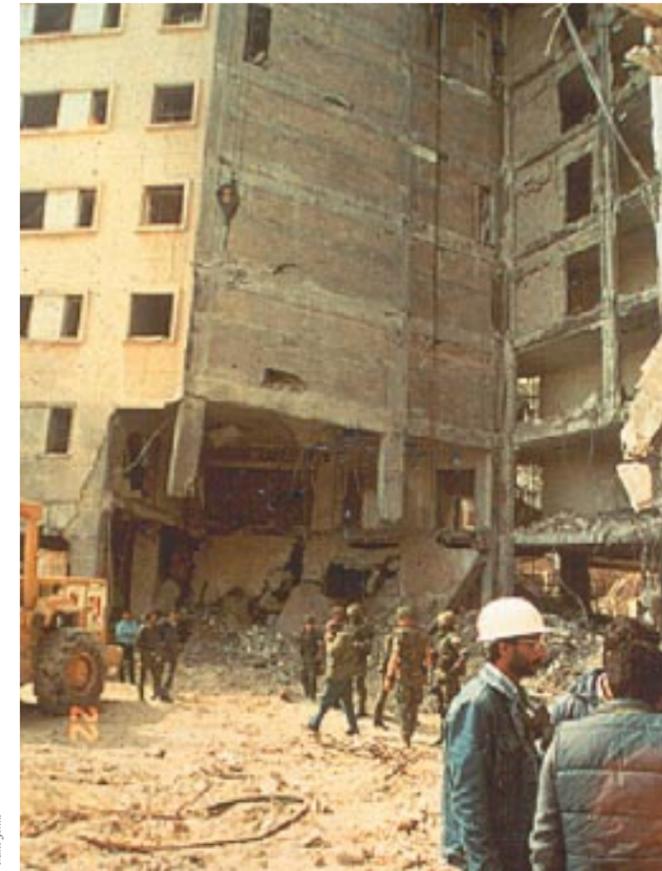
Figure 7.7 Reinforced-concrete frame with masonry filler walls acting as a vertical diaphragm to compensate for column loss

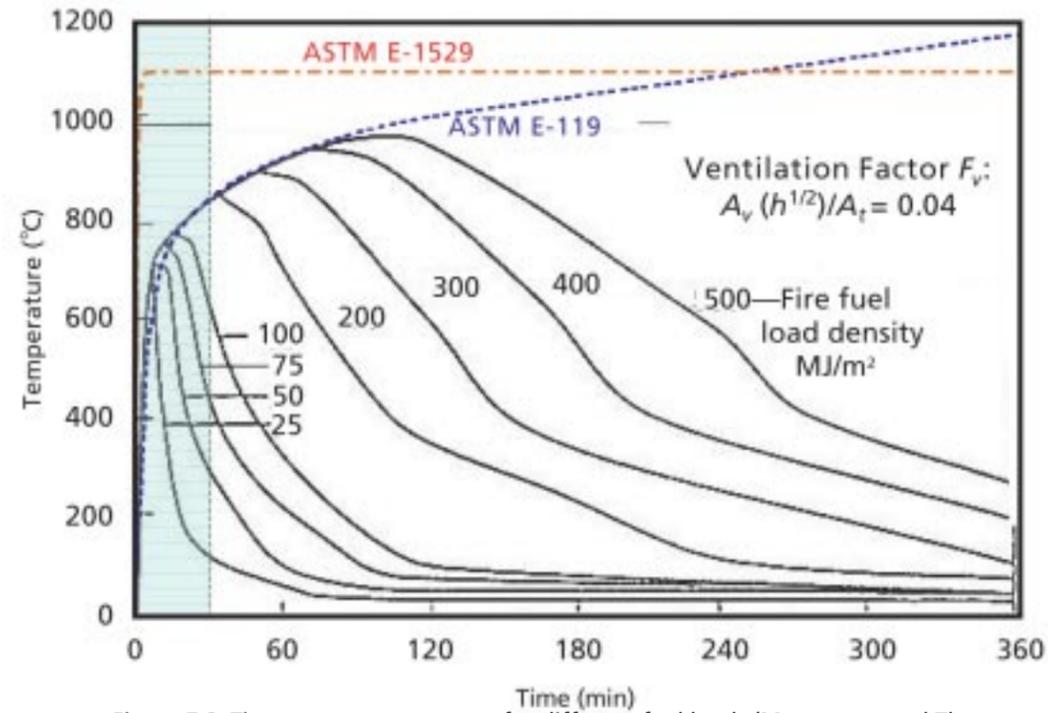
Figure 7.8 Time-temperature curves for different fuel loads (Magnusson and Thelandersson 1970)

in figure 7.8. Since the estimated lower bound of the fire fuel load is 33,325 Btu/sq ft (378 MJ/m<sup>2</sup>), the time-temperature curve for the fire can be estimated to be between the curves for 26,416 Btu/sq ft (300 MJ/m<sup>2</sup>) and 35,222 Btu/sq ft (400 MJ/m<sup>2</sup>) in this figure, which means an estimated maximum temperature of close to 1,560°F (850°C) in a little more than 30 minutes.

It should be noted that the estimated time-temperature curves for all fire fuel loads in this figure have the same initial rate of temperature rise (the first 10 minutes of the fire), and this initial rate of temperature rise is higher than that prescribed for standard fire ASTM E-119 but lower than that of standard hydrocarbon pool fire ASTM E-1529. Similarly, within the first half-hour of the fire (prior to collapse) the temperature of the estimated fire was slightly higher than the ASTM E-119 temperature but lower than the temperature prescribed by ASTM E-1529. The shaded portion of figure 7.8 highlights the temperature profile of the first half-hour of the estimated fire.

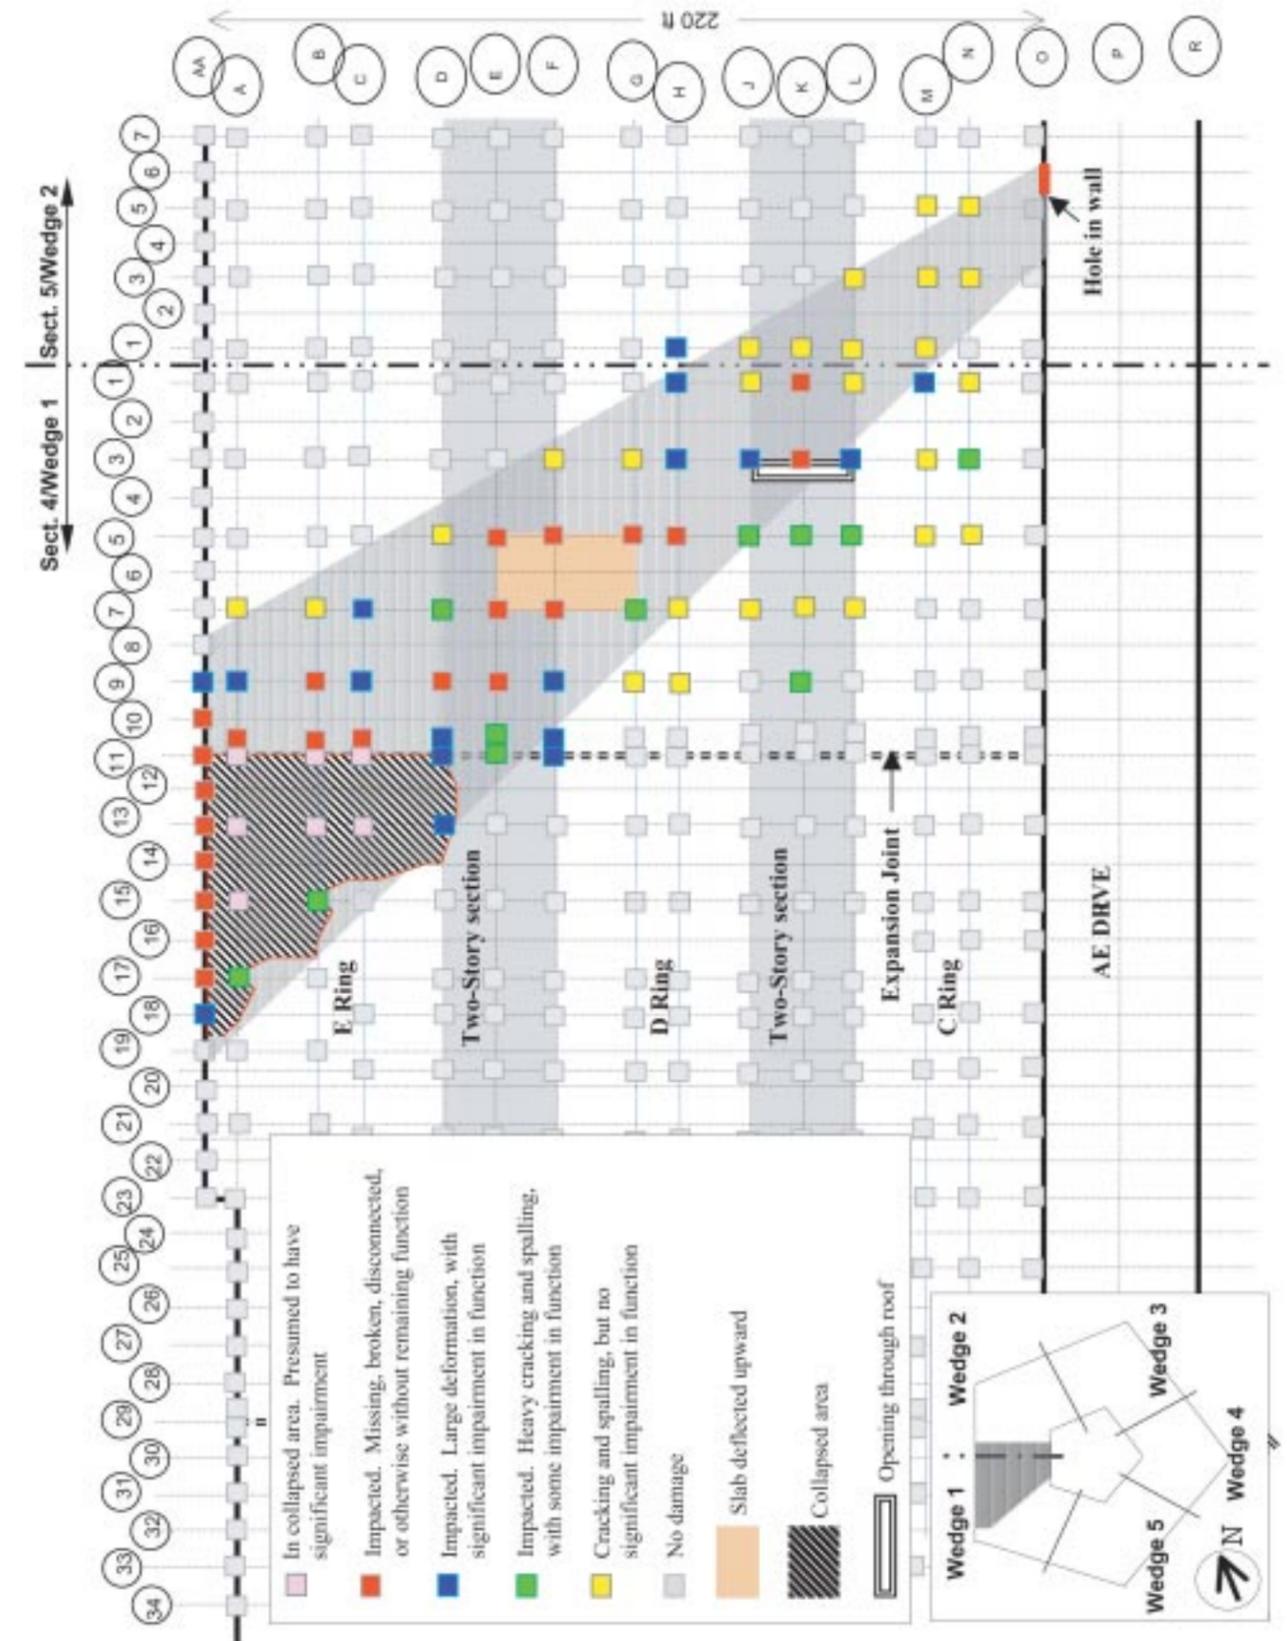
Figure 7.9 Path of ejected fuel in the first story

It is assumed that the fuel was initially contained within the first floor, in a “room” bounded by the path of damage caused by the impact of the airplane (shaded gray in figure 7.9). The estimated total surface area,  $A_t$  (floor, ceiling, and bounding walls including windows and openings), of the room is about 36,597 sq ft (3,400 m<sup>2</sup>). The fire fuel load,  $e_{f,a}$ , contributed by the available jet A fuel alone can be computed as

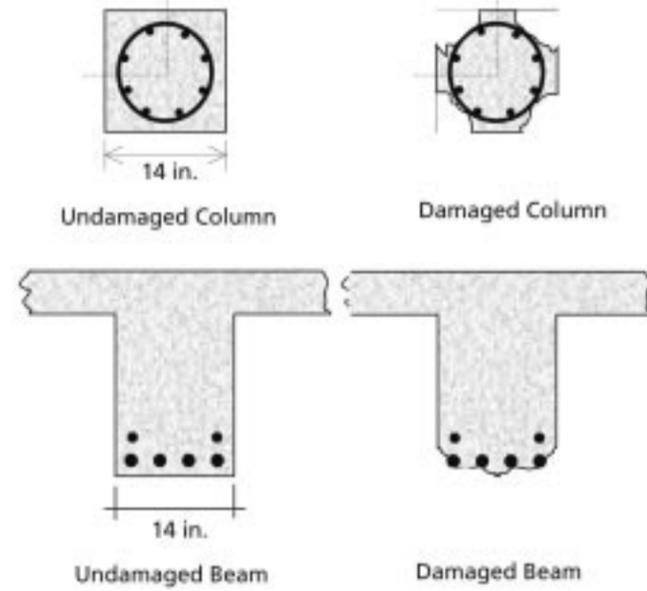
Figure 7.10 Cross-sectional properties of beams and columns analyzed

A typical column (type 5, 14 by 14 in.) and main girder (14 by 20 in.) were subjected to thermal analysis. The column and girder were analyzed in two conditions: undamaged and damaged. Damaged columns and girders were members that had lost a portion of the concrete cover for the main reinforcement as a consequence of the impact but were not broken. This damaged condition was simulated by removing the concrete finite elements that modeled the reinforcement cover at one corner of the column and girder, thereby exposing the reinforcing spiral and the longi-

tudinal rebar directly to heat. Figure 7.10 shows the dimensions and reinforcement details of the column and girder analyzed.
