# THE PENTAGON BUILDING PERFORMANCE REPORT

January 2003

## ABSTRACT

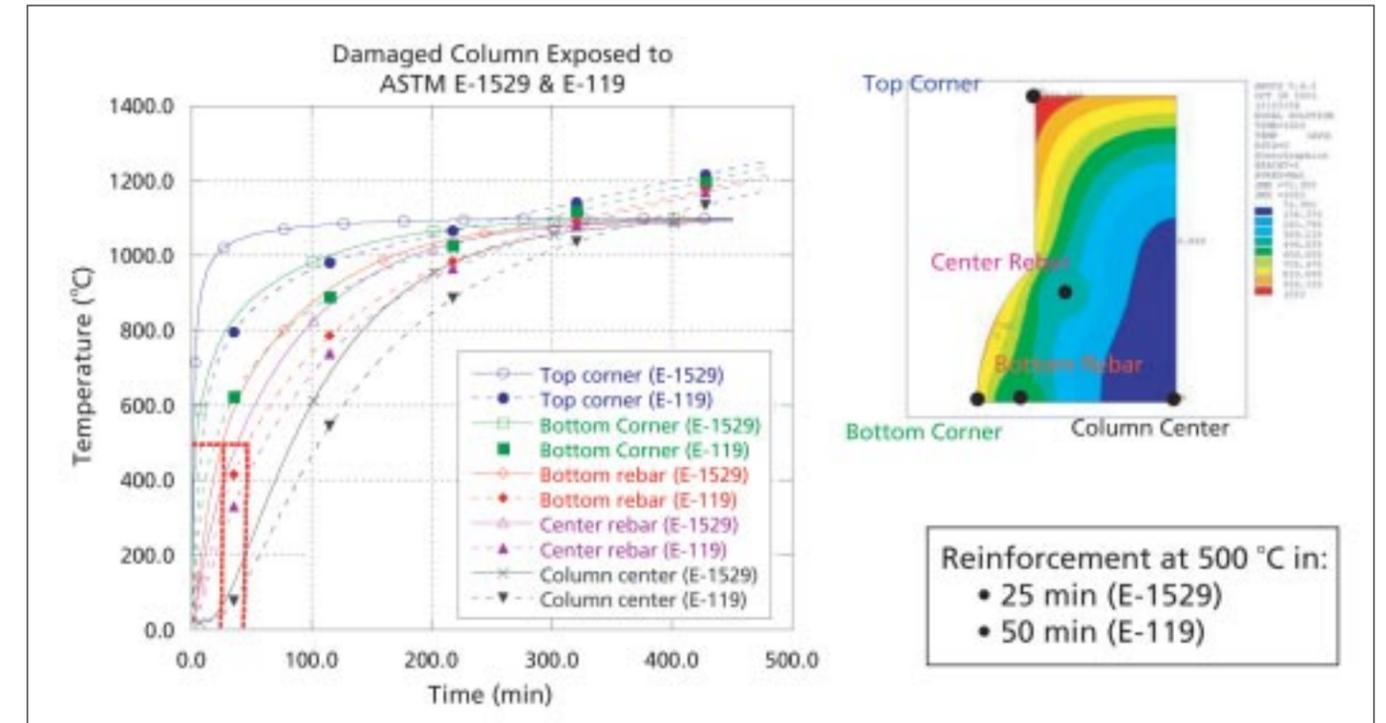
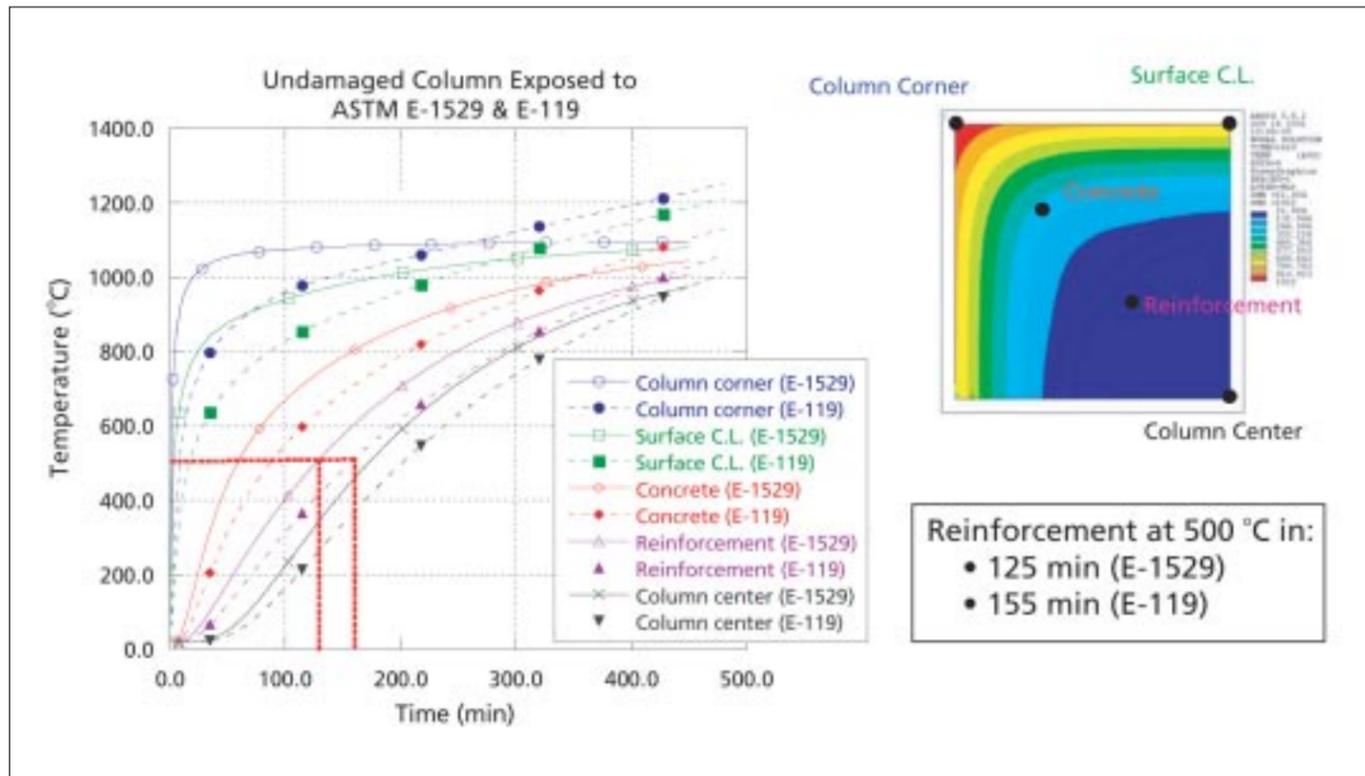
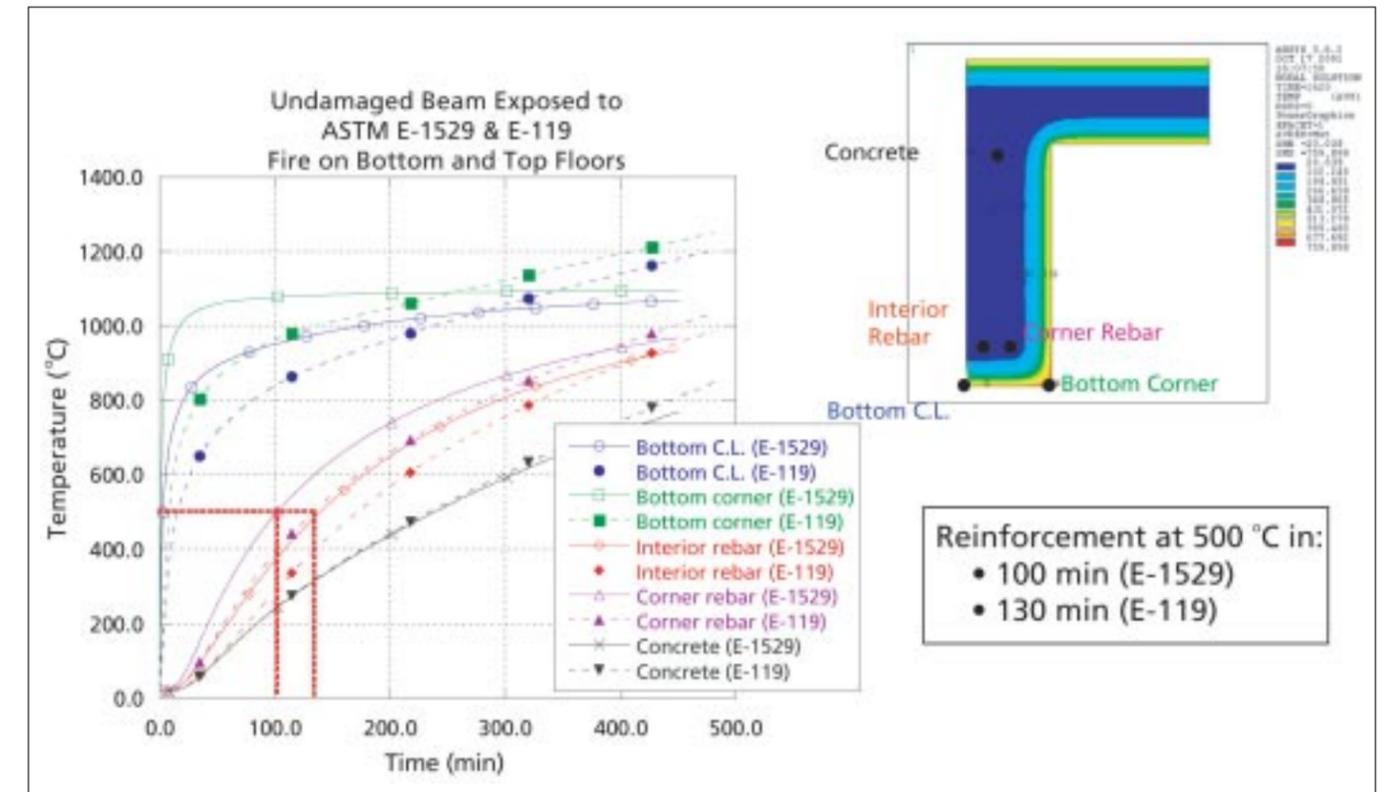
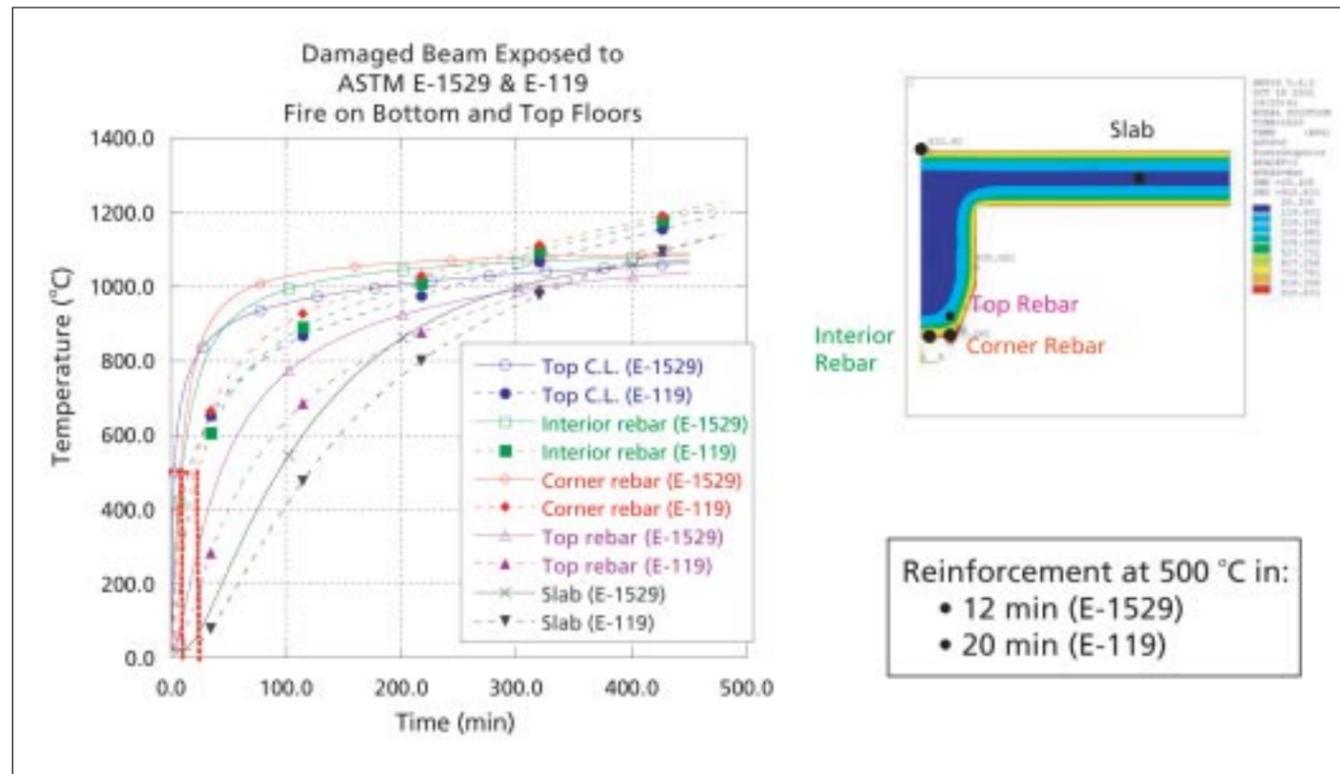
In the analysis, all interior finishes that provided added fire protection to the columns and girder were assumed to have been stripped off by the impact. Figures 7.11 through 7.14 summarize the results of this analysis.

and 120 minutes under the ISO 834 fire exposure. This represents the lower bound in fire endurance of the undamaged column and girder. However, once portions of the concrete cover for the reinforcement have been stripped off, the structural capacities of the damaged columns and girders can quickly be compromised, as reflected in the shortened fire endurance times obtained from the thermal analysis shown in figures 7.11 through 7.14 and listed in table 7.2. The fire endurance times for the column and beam are determined as the times for the main reinforcing steel to reach critical temperature (932°F [500°C], impending yielding temperature of steel reinforcement as defined in the Eurocode). For the column, the fire endurance time when damaged ranges from 25 minutes (based on the upper-bound fire ASTM E-1529) to 50 minutes (based on the lower-bound fire ASTM E-119). For the girder, the fire endurance time when damaged ranges from 12 minutes (ASTM E-1529) to 20 minutes (ASTM E-119). These endurance times compare well with the observed time to collapse after the initiation of the fire.

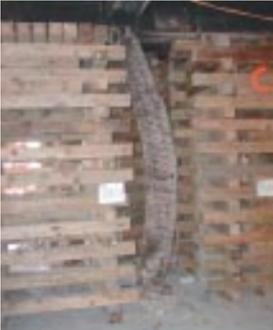
| COLUMN LABEL | DESCRIPTION OF DAMAGE | PHOTO (IF AVAILABLE) |
|---|--|---|
| 9C | <ul style="list-style-type: none"> <li>• Severely bowed</li> <li>• Stripped to spiral reinforcement</li> <li>• Lost some concrete inside spiral reinforcement</li> <li>• Shored</li> </ul> | |

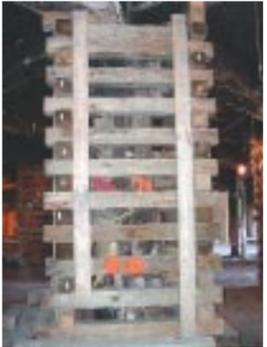
| COLUMN LABEL | DESCRIPTION OF DAMAGE | PHOTO (IF AVAILABLE) |
|---|--|---|
| 7D | <ul style="list-style-type: none"> <li>• Split by vertical crack that looks typically like thermal cracking</li> <li>• Shored</li> </ul> | |

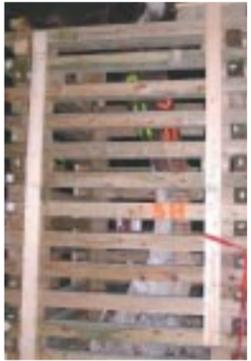
| COLUMN LABEL | DESCRIPTION OF DAMAGE | PHOTO (IF AVAILABLE) |
|---|---|---|
| 3H | <ul style="list-style-type: none"> <li>• Bowed</li> <li>• Stripped to spiral reinforcement at mid-height</li> <li>• Shored</li> </ul> | |
