NATIONAL TRANSPORTATION SAFETY COMMITTEE

AIRCRAFT ACCIDENT REPORT

PT. Garuda Indonesia GA421 B737-300 PK-GWA Bengawan Solo River, Serenan Village, Central Java 16 January 2002

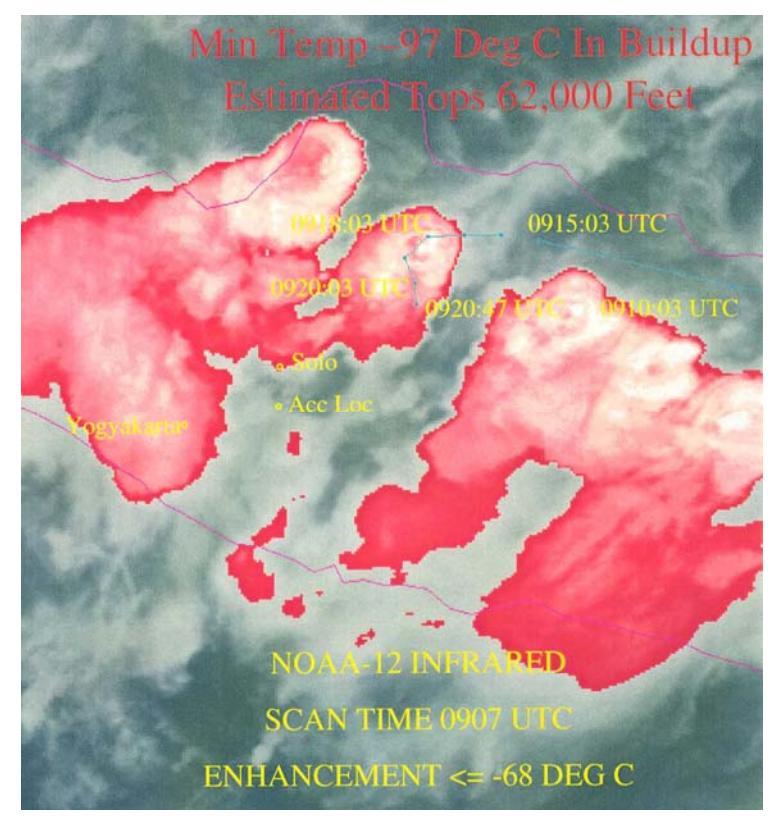
Figure 2 NOAA cloud coverage

The NOAA satellite cloud picture (at 09.07 UTC) shows the active super cell of the Cumulonimbus (Cb) Cloud along the track. January is the peak season over most of the Java Island, in which high frequency activity of the convective cloud is a common weather condition.

On 16 January 2002, the satellite observed an active super cell over the area as indicated by NOAA Cloud Coverage in Figure 2. As the cell of Cb. was active over land during afternoon hours, the mature stage of Cb. cloud would disturb the aircraft. As forecasted over the Solo/Adi Sumarmo Airport between 09.00 - 12.00 UTC would be temporary rain showers and thunderstorm. However, no weather information was made available about adverse weather condition along the airplane track (SIGMET).

The NOAA weather satellite image 14 minutes prior to the accident indicated that there was a super cell of Cumulonimbus clouds (see Figure 2), that may have topped out as high as 63,000 ft. The NTSB meteorology experts believe that such cells would feed-up each other and that it is possible for most probable adverse weather condition.

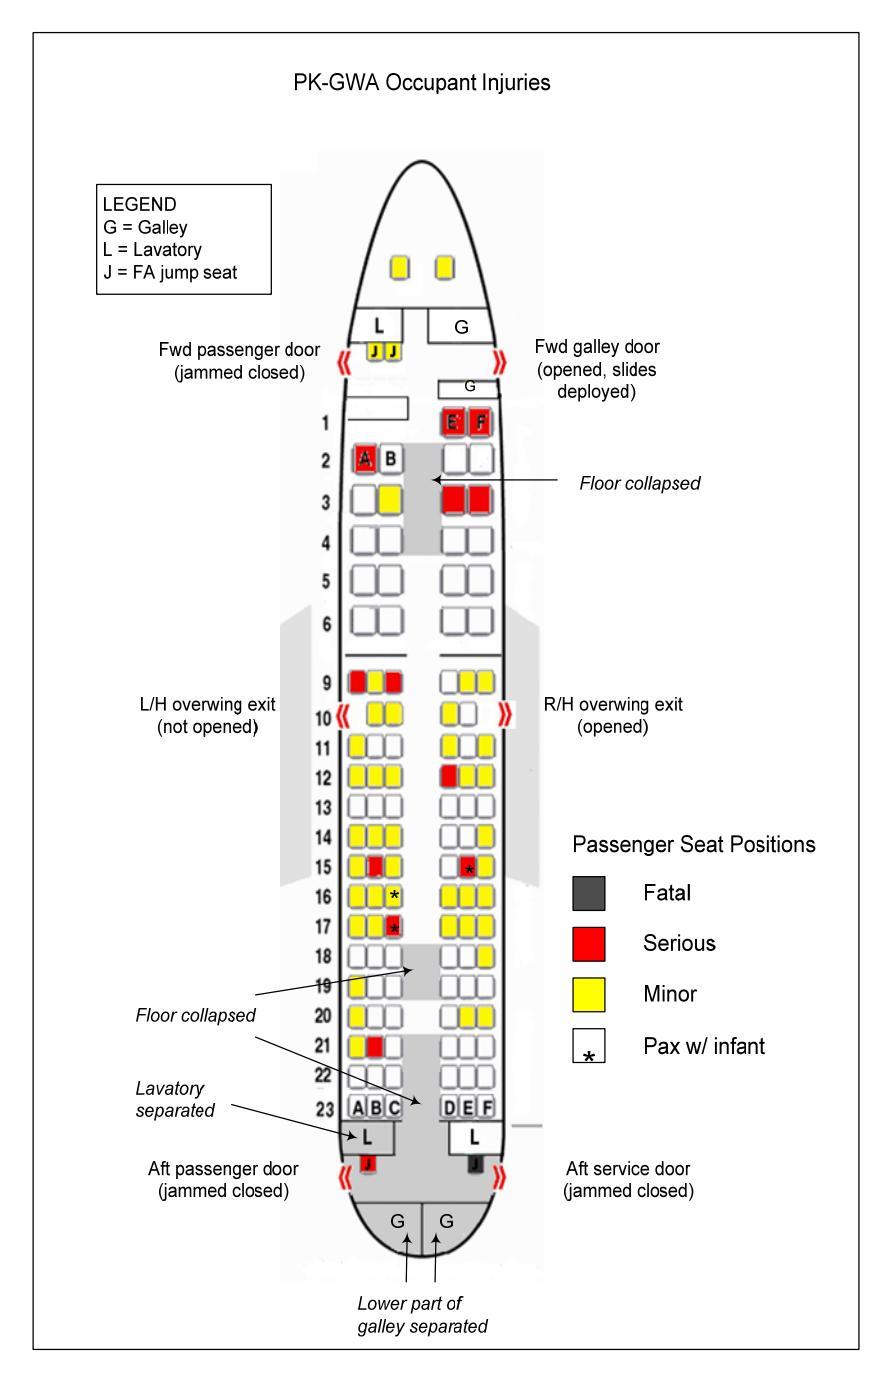
Figure 4 Interior Airplane Configurations and Occupant Injuries Map

Ditching the aircraft into the river was considered by the crew to be the safest option for a forced landing. Fifty three occupants were safely evacuated to the river bank. One flight attendant who was seated at the aft jump-seat was found severely wounded on the river, and one another flight attendant was found fatally injured on the river

The aircraft was configured with 104 passenger seats; 22 in business class and 82 in economy class. An aft-facing, double-occupancy flight attendant jump-seat was located by the forward passenger door; an aft-facing, single occupancy flight attendant jump-seat was mounted behind the right-hand and left-hand aft lavatory. Figure 4 It shows the interior airplane configuration and the injuries sustained by the passengers and crewmembers according to the seat location.

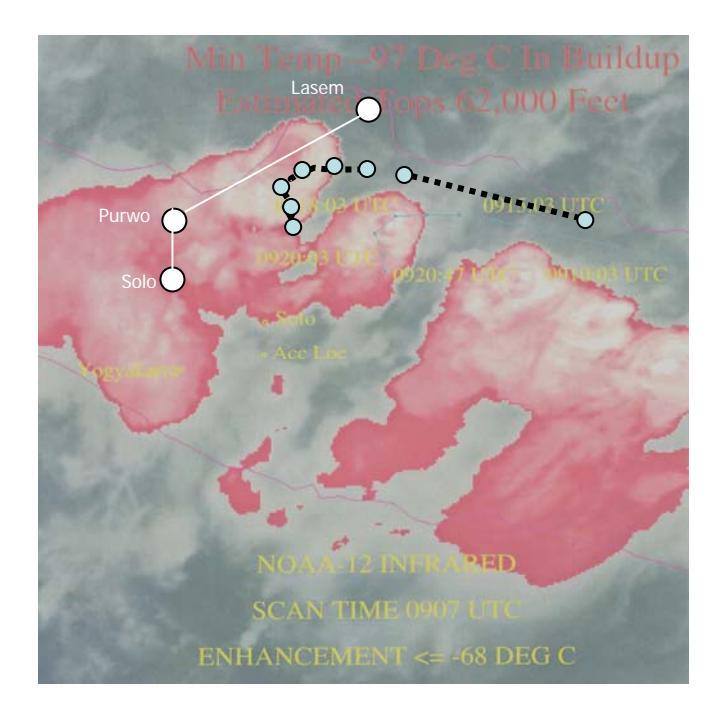
Figure 10 Shows the actual flight track flown (as a black line), and part of the air way W-16 from Lasem, W-17 N Purwo and Solo (as White line)

Pilot interview mention that PiC had decided to turn left considering that an area between two formations of clouds displayed on radar was the safest area due to the fact that mountainous area (quote: Merapi mountain was on his right aircraft position) and military restricted area on his left. NOAA 12 cloud picture at 09.07 UTC showed that further left was the clearer weather.

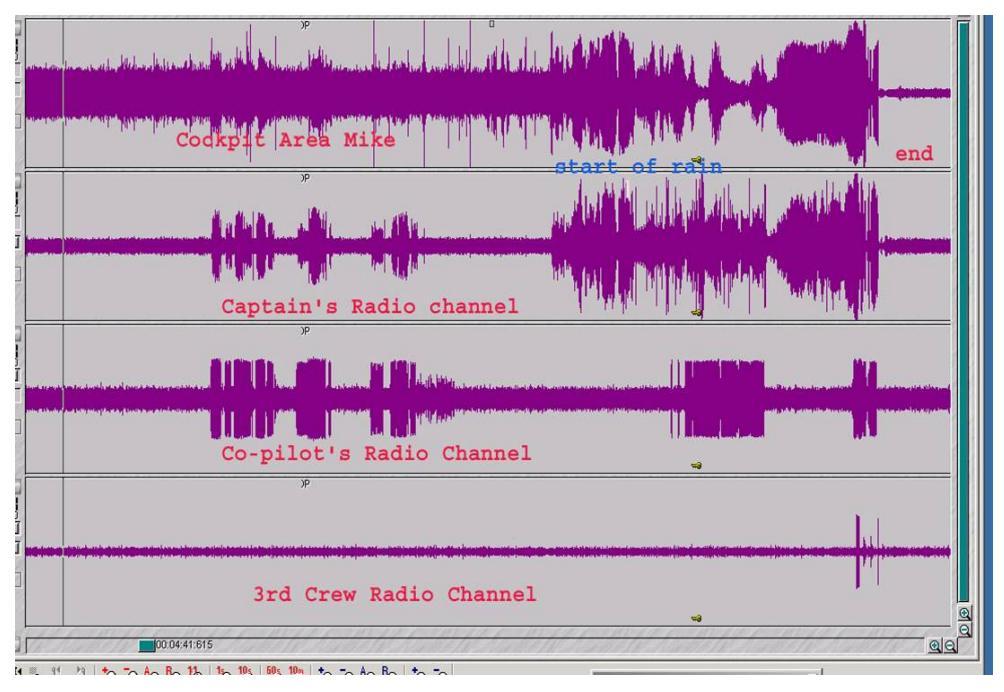
Figure 14 Plot of the recorded sound intensity prior to the engine flame out

The third method to quantify the hail is by using the sound recorded in the cockpit when the aircraft encounter the rain/hail (see Figure 14). Sound energy level reading was synchronized with the DFDR fuel flow data. The data showed positive linear correlation. It is known that the fuel flow is a function of the amount of hail-water ingested by the engine. Therefore, the sound energy level can be correlated with the amount of hail-water ingested. Extrapolation from the CVR sound energy level indicated that the level of hail/water content encountered by PK-GWA at the time of engine flameout could have been as high as 18 grams of hail/m³ of air, depending on the size

From preceding discussions, it can be concluded that the aircraft had encountered hail beyond the engines' certified capabilities which subsequently caused both engines flame out.

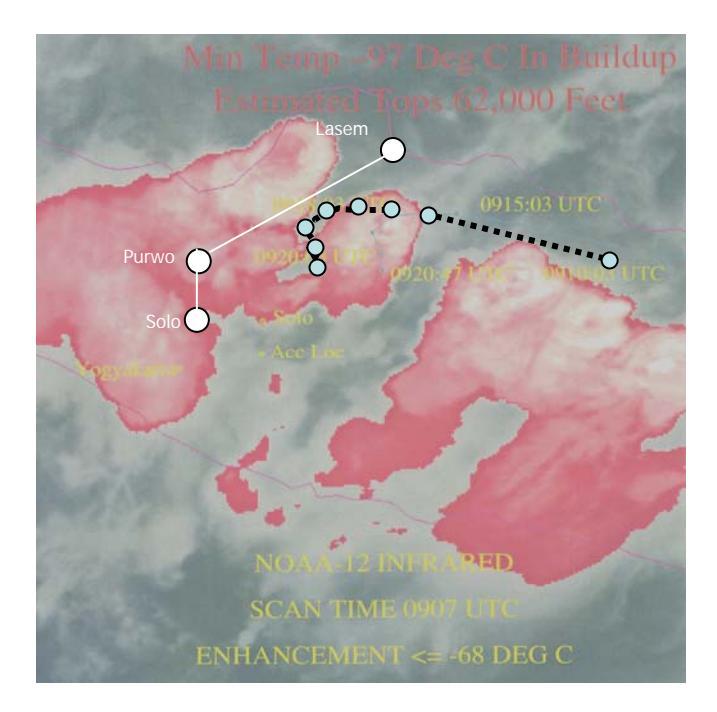
Figure 15 NOAA cloud coverage inside Military Restricted Area

The measurement (plotted from the Scanned weather chart) from clearer weather area was about 10 till 15 nm wide down way through the south west direction in the military restricted area.

At 0920:47 was the last point of aircraft recorded by the NOAA-12 radar, while this point was about 5 nm from the area of clearer weather areas, it indicated that: this clearer weather area is inside the Military Restricted Area which can be flown by the civil aircraft in coordination with ATC authorities.
