Investigation Report

5X003-0/08 March 2010

Kind of occurrence:	Serious Incident
Date:	1 March 2008
Location:	Hamburg
Type of aircraft	Commercial Air Transport
Manufacturer / Model	Airbus / A320-211
Injuries to Persons:	None
Damage to Aircraft:	Minor damage
Other Damage:	None
Source of Information:	Investigation by BFU

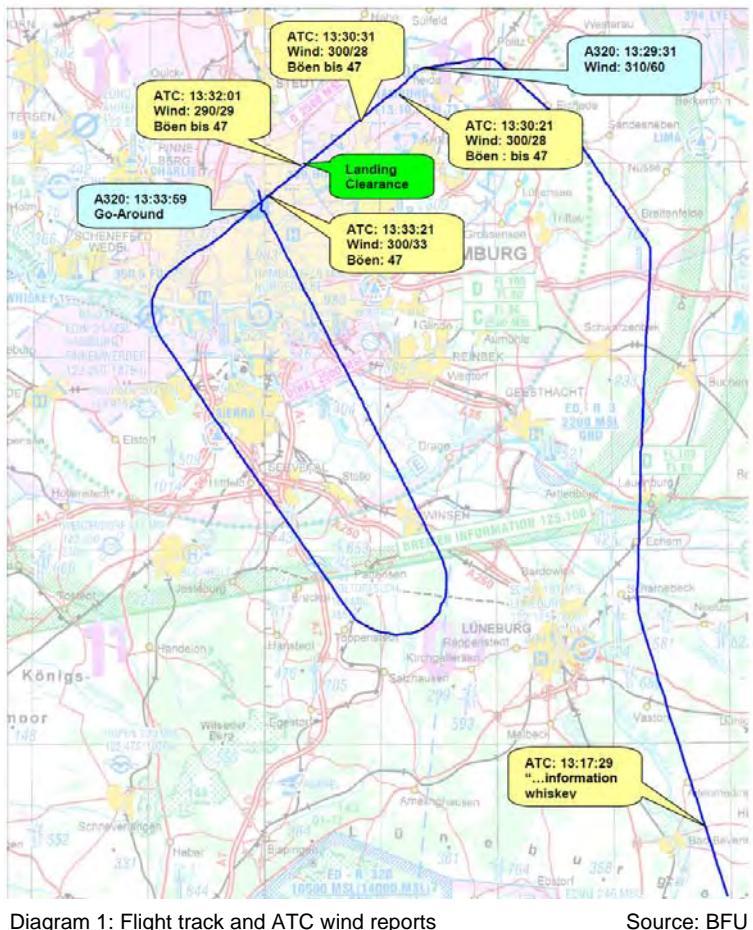
Diagram 1: Flight track and ATC wind reports

The aerodrome controller gave revised wind reports at 1348:29 hrs, 1349:08 hrs, 1350:06 hrs and 1350:29 hrs (300°/33 gusting 50; 290°/32 gusting 49; 290°/28 gusting 49; and 290°/27 gusting 49 kt).

At 1352 hrs the A320 landed on Runway 33. None of the occupants was injured. The aircraft had suffered damage to the left wingtip.

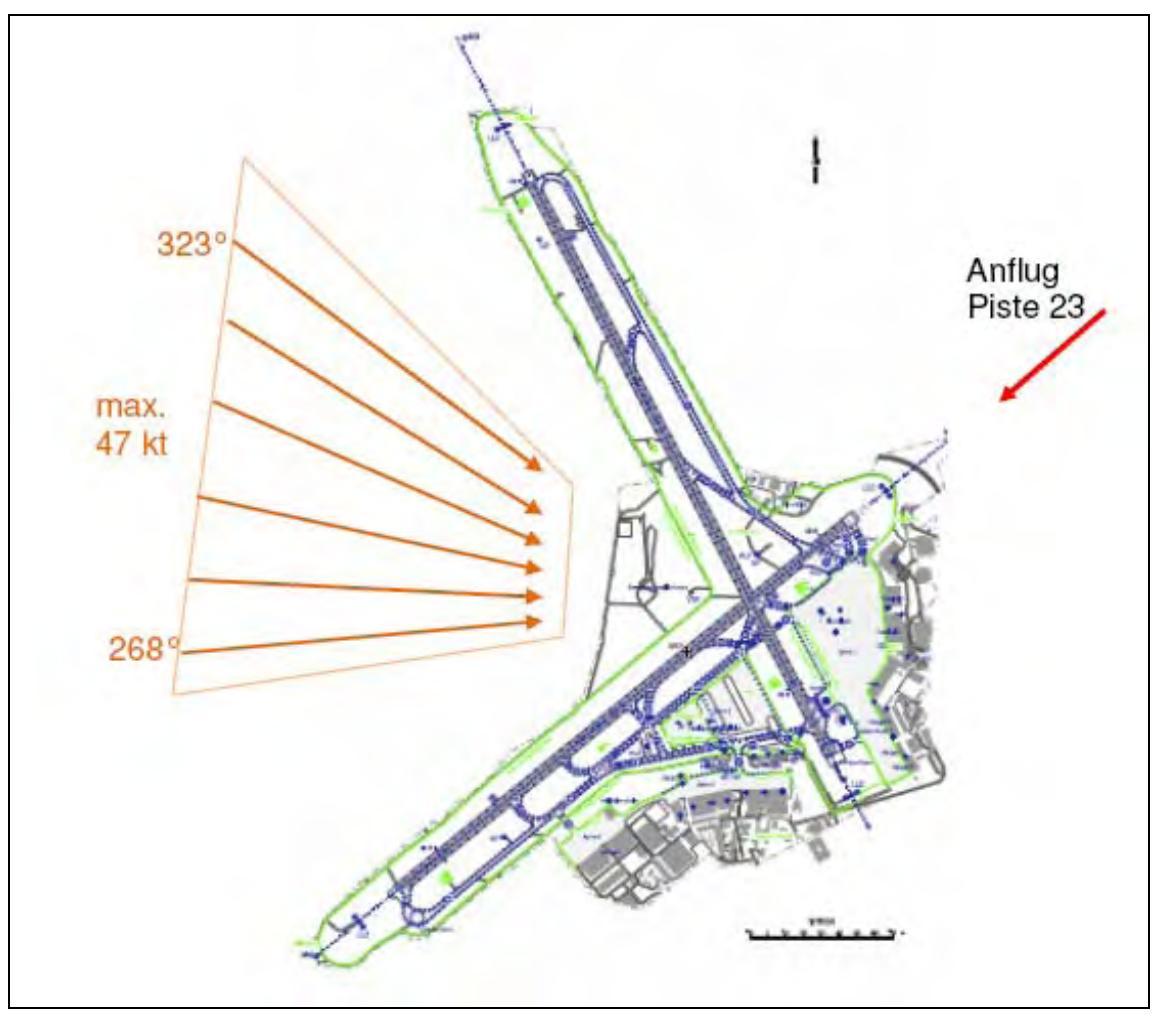
Diag. 4: Surface wind in the last 10 minutes prior to touch down.

At 1333:40 hrs the anemometer near the threshold of Runway 23/33 registered the surface wind as 299°/32 kt (here: 2-minute mean value). No change was registered in the wind at 1334:00 hrs (wind direction 299°).

In the final ten minutes prior to the occurrence the wind direction varied between 268° (minimum) and 323° (maximum). In this period, the maximum gust speed recorded was 47 kt.
